# Service Bulletin

Bulletin No.: 23-NA-151

**Subject: Hybrid/EV Battery Stability, High Priority DTCs, Potential Loss of Isolation, Vehicle Handling and Battery Pack Return Shipping Requirements**

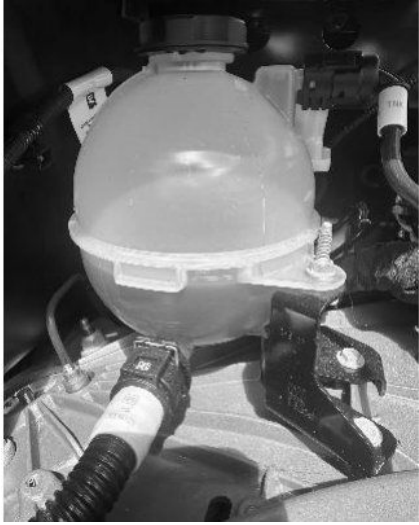
<p><b>Figure 1 (Coolant Level - Passed)</b></p>

4. Visually inspect the coolant level in the high-voltage battery surge tank (Fig 1 and 2) and document via photo. Inform TAC if coolant has previously been added.

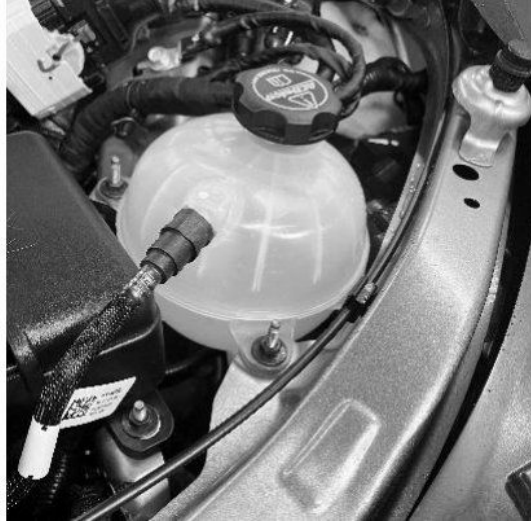
Figure 2 (Coolant Level - Failed)

**Danger: DO NOT add coolant without first confirming the Lithium-Ion Hybrid/EV Battery Pack internal coolant passage can maintain proper vacuum and pressure. Adding coolant to the coolant system with an internal lithium-ion Hybrid/EV Battery Pack coolant leak may result in Fire, which could result in vehicle or component damage, and cause severe body injury or death.**

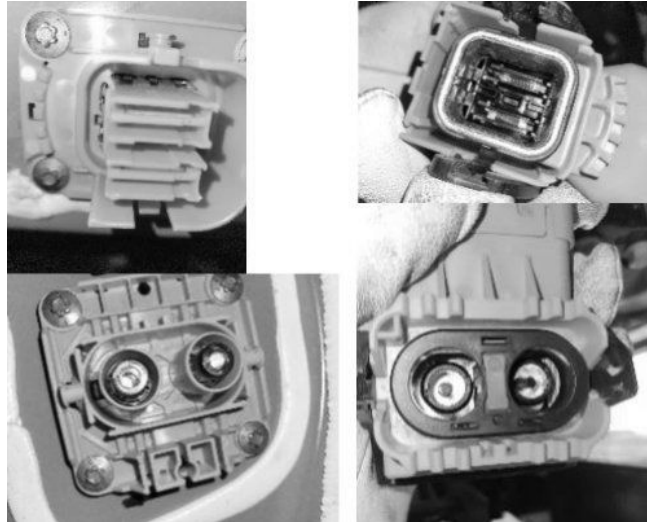
**Figure 8 (Battery Pack Connectors  
- Passed)**

9. Following SI Procedure for high voltage battery removal, Hybrid/Electric Vehicle Battery Pack Removal, and Installation:
- 9.1. Inspect the High Voltage Connectors at the High Voltage Battery for corrosion, moisture, and/or soot. Take clear, close-up photos of the vehicle side HV connectors and High Voltage Battery connection headers. Review Fig 8-10 for examples of light and heavy soot and the photo clarity required. Attach photos to TAC Case.

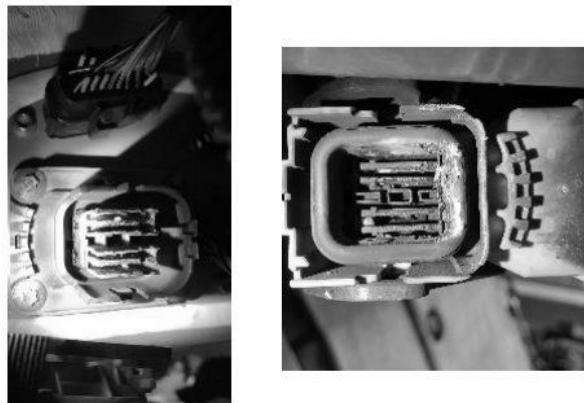
**Figure 9 Battery Pack Connectors  
- Failed w/Heavy Soot)**

**Note:** If soot, corrosion or moisture is observed, continue but contact TAC immediately upon completion.

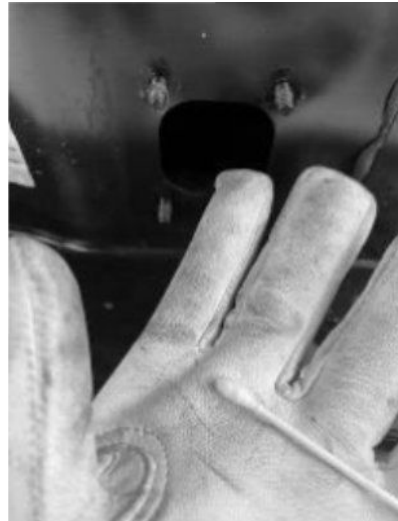
**Figure 11 (Battery Pack Swab Test – Passed)**

- 9.3. Remove the High Voltage Battery Pressure Equalizer Vent and Battery Inspection plug (if equipped) (Fig 11 and 12). The equalizer vents have 4 fasteners, never remove the vent valves that fasten with 2 fasteners. Using a cotton swab or paper towel to swab inside the enclosure for moisture/coolant and/or soot. Take photos and attach to TAC case.

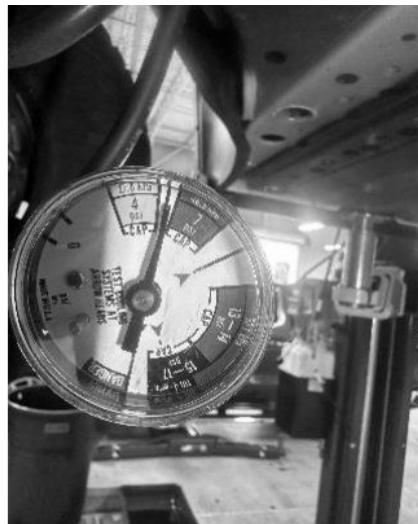
**Figure 15 (Coolant Passage Pressure Leak Test – Passed)**

- 9.6. Pressure test the High Voltage Battery coolant circuit for leaks (Only complete if passes vacuum test). See Hybrid Battery Pack Coolant Passage Leak Test (Fig 15 and 16). Attach photos to the TAC case.

Hybrid Battery Pack Coolant Passage Leak Test. Inspect coolant passage for leaks, should maintain 5 psi of pressure for 2 minutes. Photograph and advise TAC of findings. <b>Note: ONLY PERFORM PRESSURE TEST IF VACUUM TEST WAS PASSED</b>	Passed Example Refer to Figure 15	Failed Example Refer to Figure 16	Pass Fail Pictures Captured/Submitted
<b>Stable to Ship determination</b>			<b>RESULTS</b>
If moisture/coolant/soot was detected at the HV connectors the HV battery is NOT STABLE. If moisture/coolant/soot is detected at the equalizer vent and/or inspection plug the HV battery is NOT STABLE.			
<b>NOT STABLE</b>		<b>STABLE</b>	
Immediately Place the HV battery in the provided DDR Crate (if available) and move to a stable location outdoors, away from buildings, vehicles and foot traffic. Cover the HV battery or DDR crate with a tarp. Photograph location and immediately advise TAC.		Place the HV battery in the provided DDR crate. Advise TAC of the results and request the core return process.
