SIB 51 29 24

TAILGATE/TRUNK DOES NOT LATCH WHEN CLOSED

2024-12-05

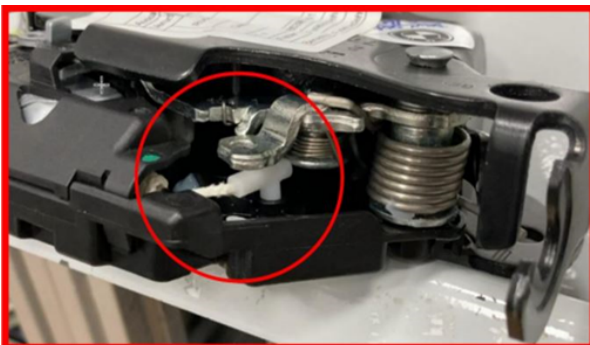
## MODEL

The white clip at the end of the ribbon cable can move out of its position and get jammed behind the latch mechanism.

## BAD

- Latch will need to be replaced
- **DO NOT** replace the SCA (Soft close actuator) if the vehicle is equipped with it

- When installing the new latch, make sure that the new latch has a production date after July 29, 2024 (yymmdd: 240730)
