SIB 52 09 20

HEAD RESTRAINT AND/OR BACKREST OF 3RD ROW SEATS CANNOT BE FOLDED DOWN

E-Series	Model Description
G07	X7 Sports Activity Vehicle

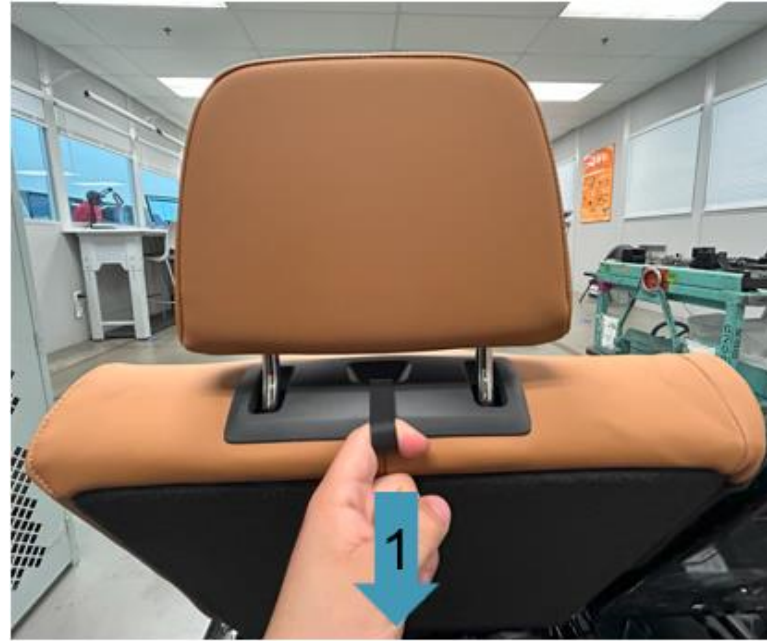
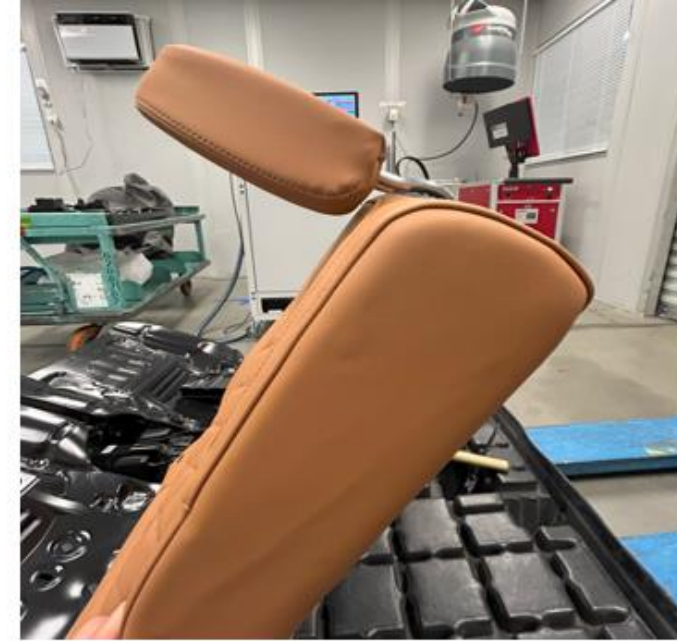
1. Pull the Headrest strap towards the back of the seat (the headrest will fall into a horizontal position).

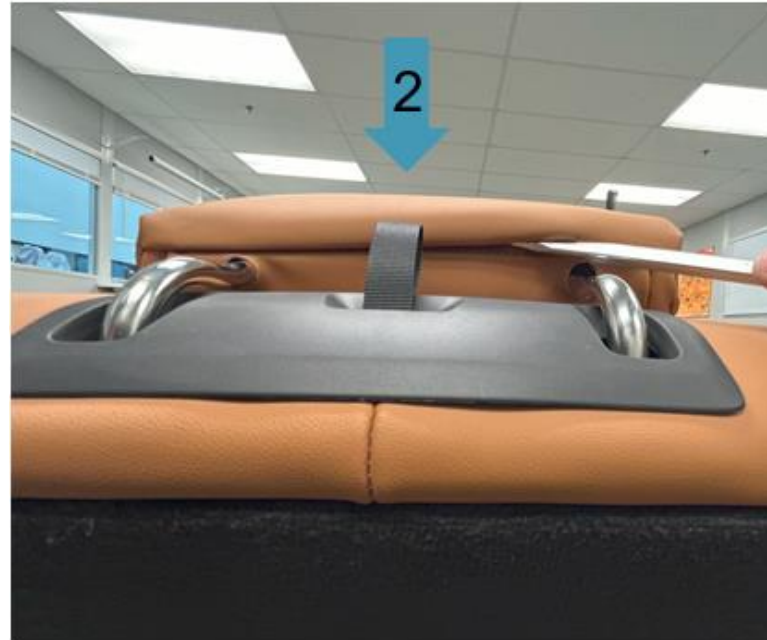
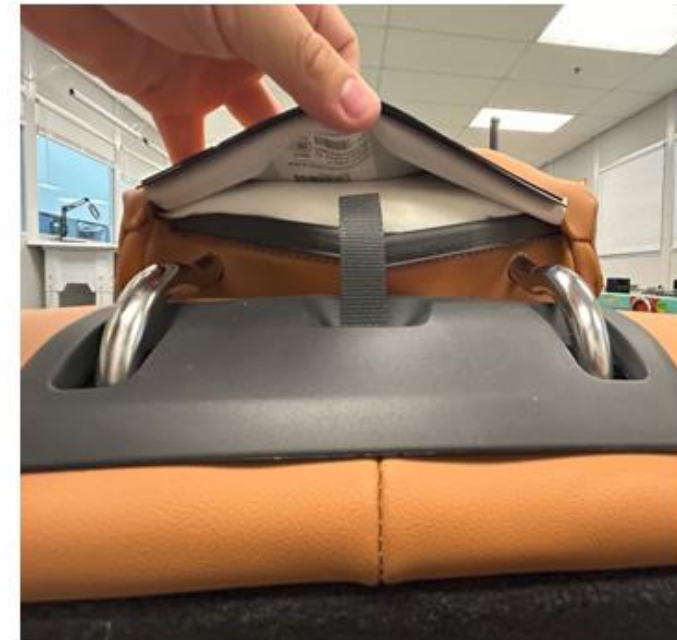
2. Open the plastic retainer of the headrest with a flat screwdriver or plastic trim tool, without causing damage to the headrest.

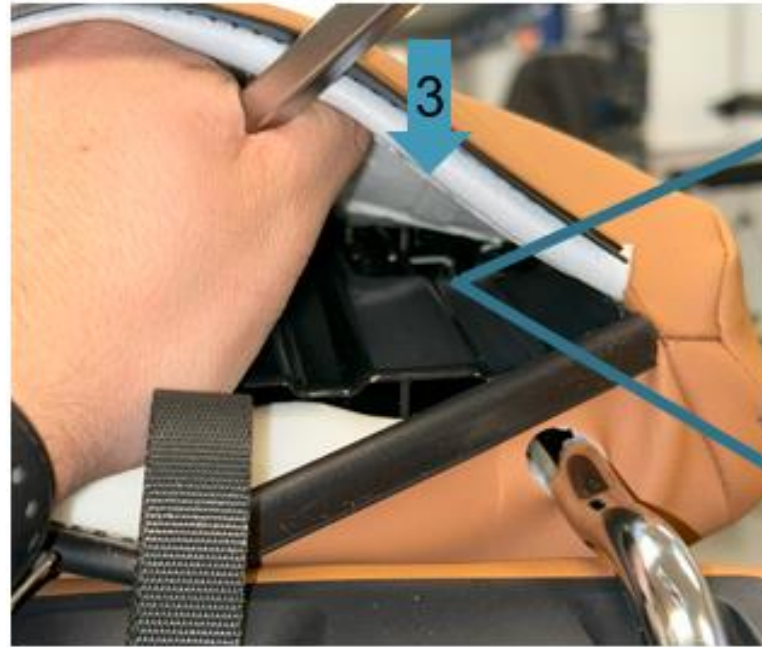
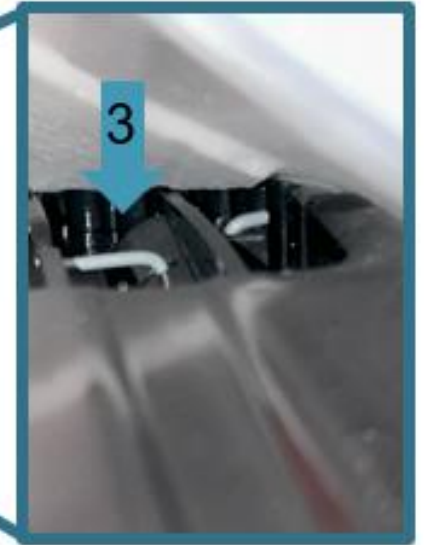
3. Locate the metal clips that are inside the headrest foam and are inserted into the inner plastic component.

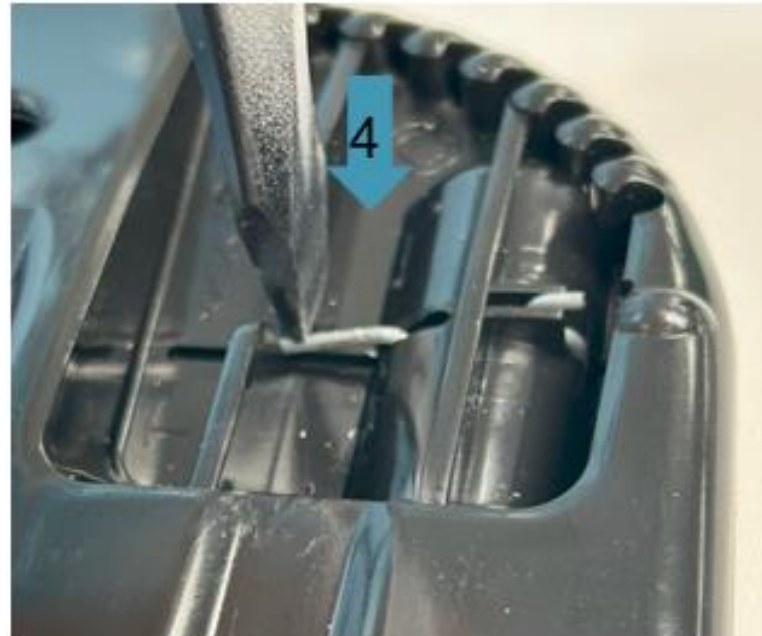
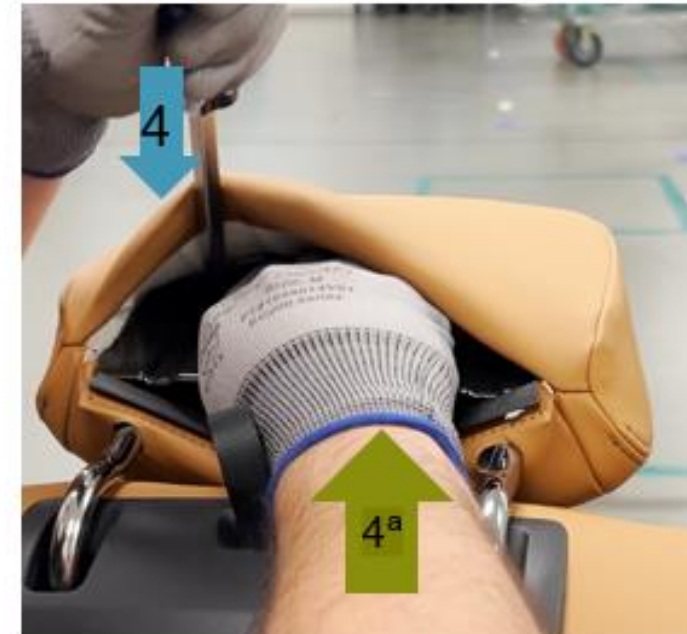
4. Use the screwdriver to press the inner part of the metal clip down.
  - a. At the same time push that side of the headrest forward to remove it from the headrest rods.

Note: Do the same process for the right side and the left side.

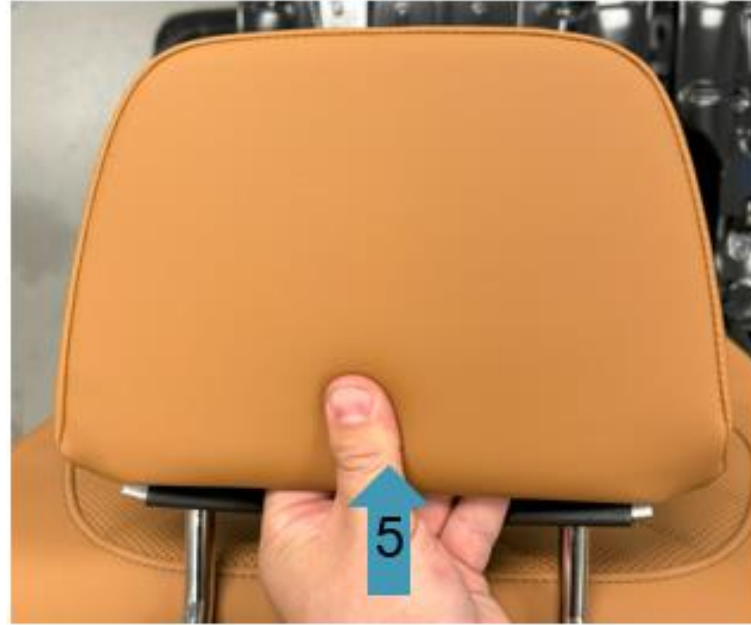
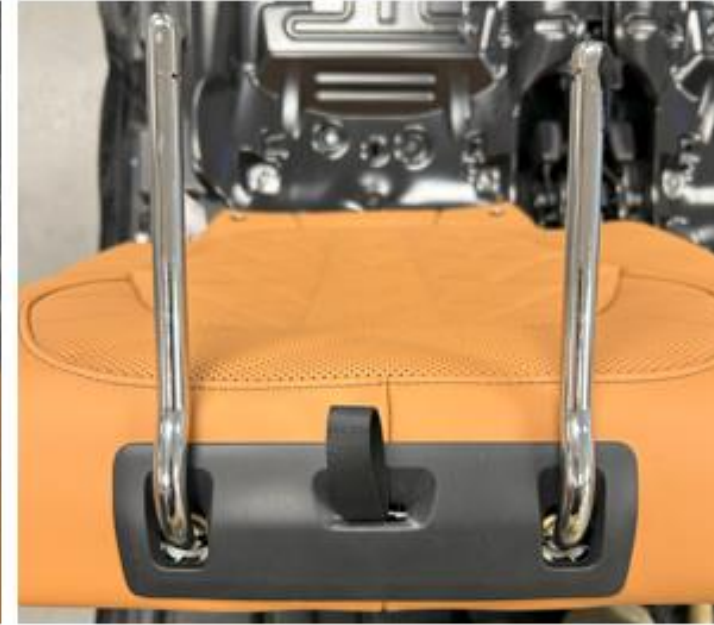
5. Push the headrest forward from the middle so that it comes off both rods simultaneously.

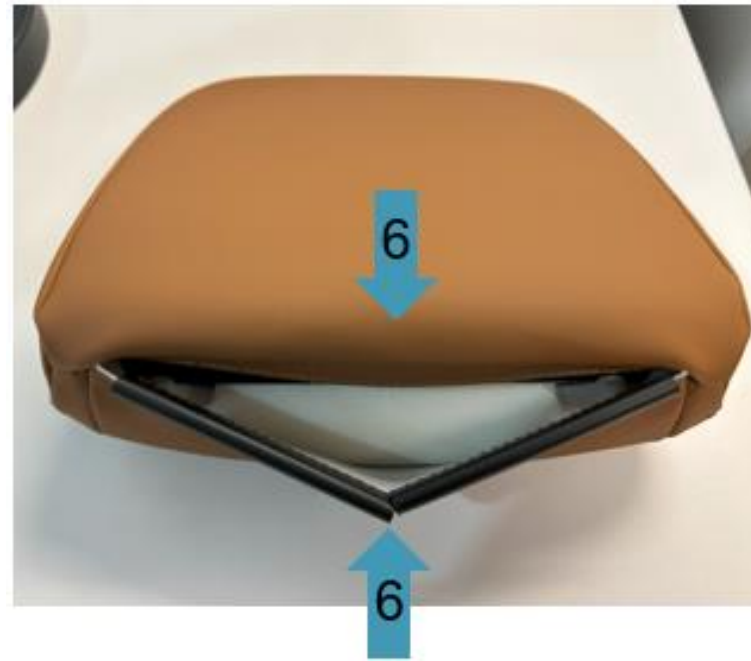
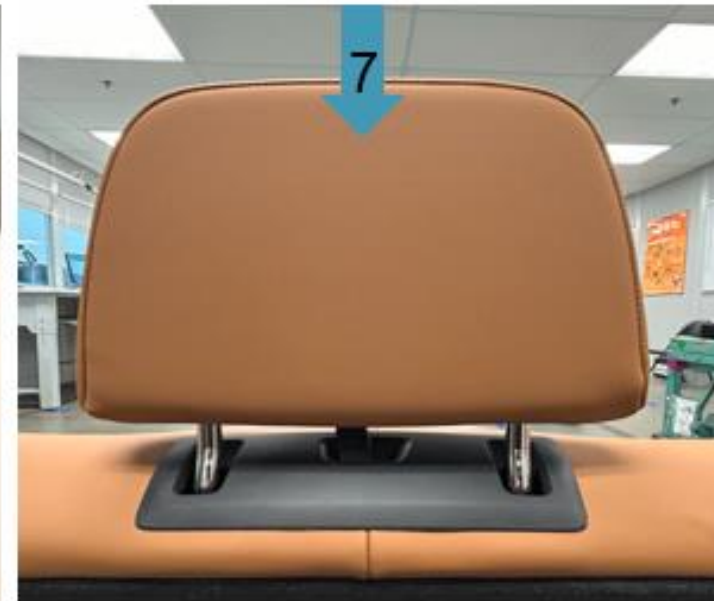
5. To reassemble the headrest, push the two plastic retainers (top and bottom) together to close the headrest.
6. To re-secure the headrest, place it inside the rods and push firmly on top to secure metal clips. Pull from bottom of headrest to check complete installation.

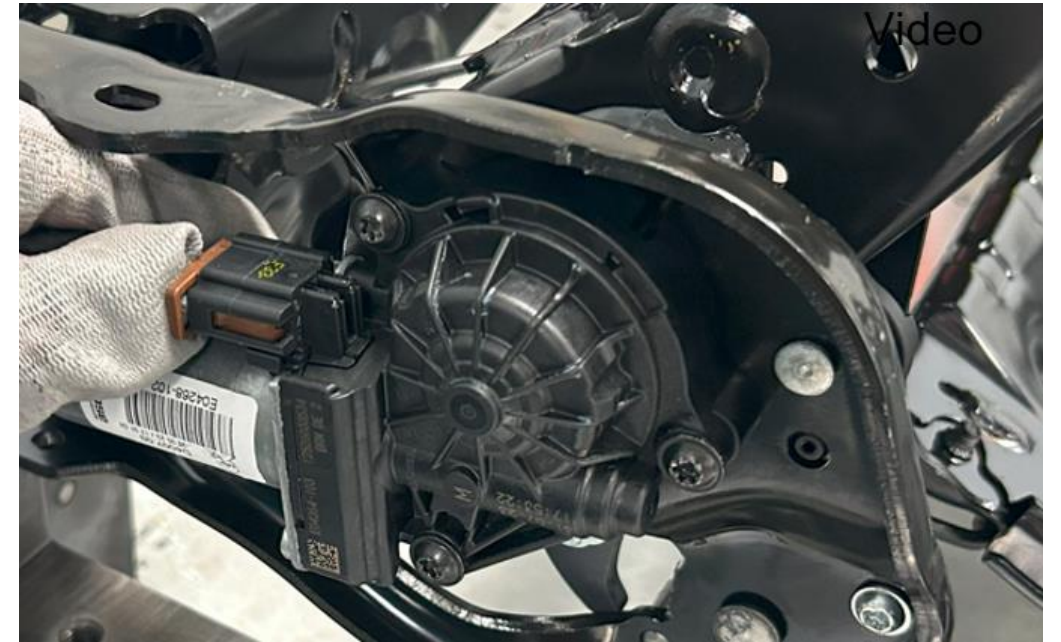
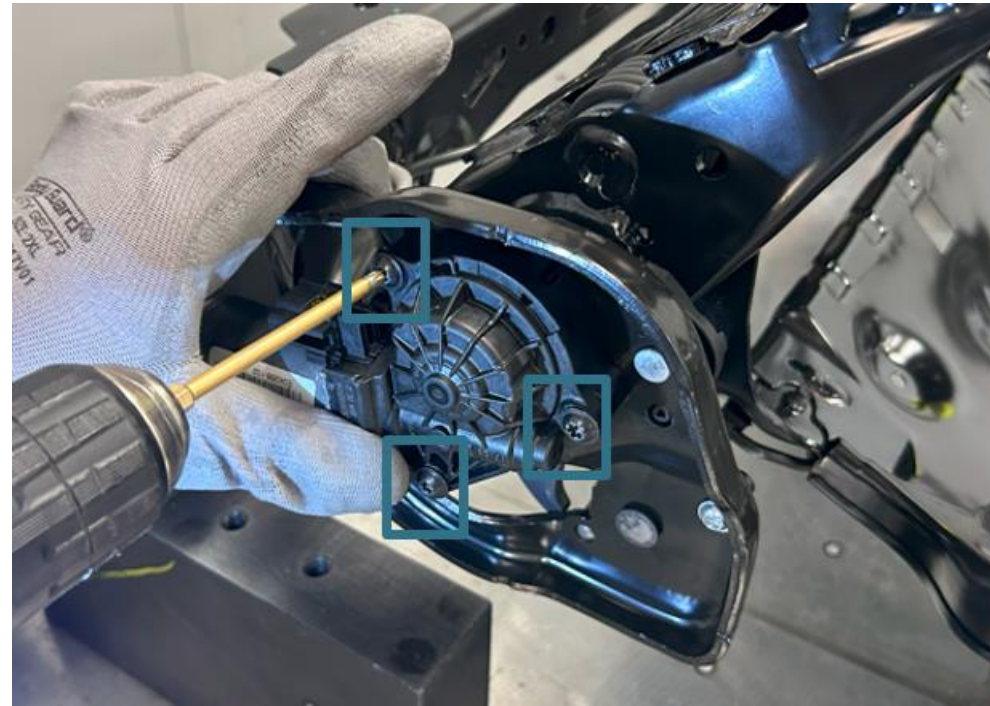
1. To remove the LNV Seat back rest folding motor first disconnect the brown electrical connector.
2. Remove the 3 T-20 screws from the motor.
3. Firmly grasp the LNV motor and begin to pull it out of the frame by gently rocking it up and down.
4. You can also move the back rest a little at the same time to get the gear teeth to disengage.

See Repair Instructions 'Removing and installing/replacing backrest adjustment motor, 3<sup>rd</sup> seat row' **REP 6731635**

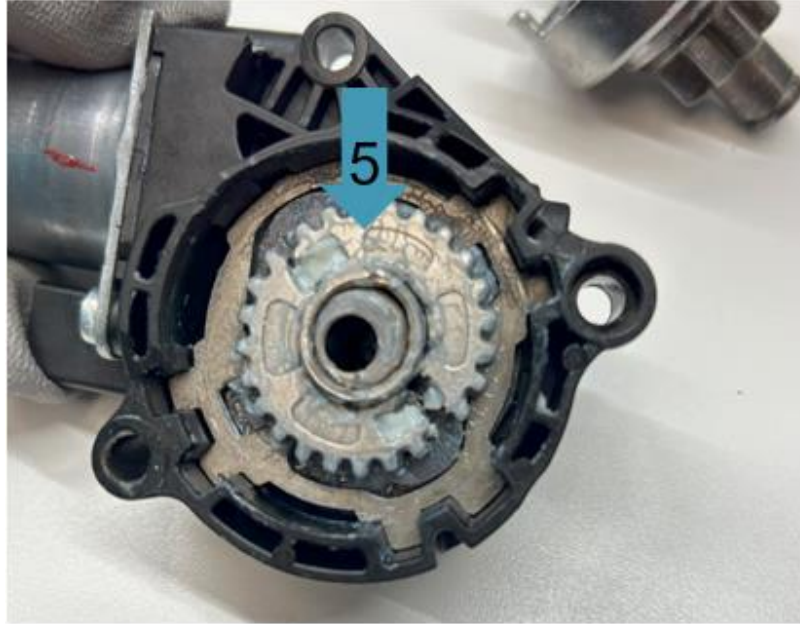
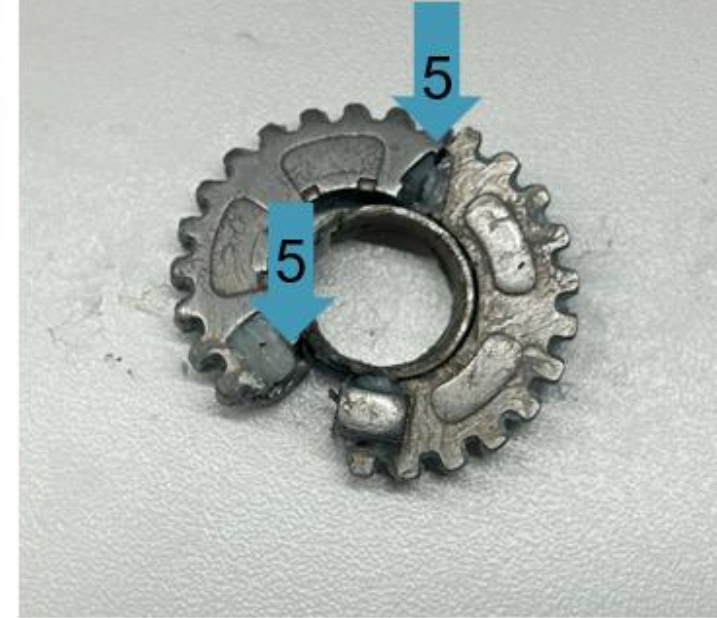
5. The gear tooth assembly may be damaged.

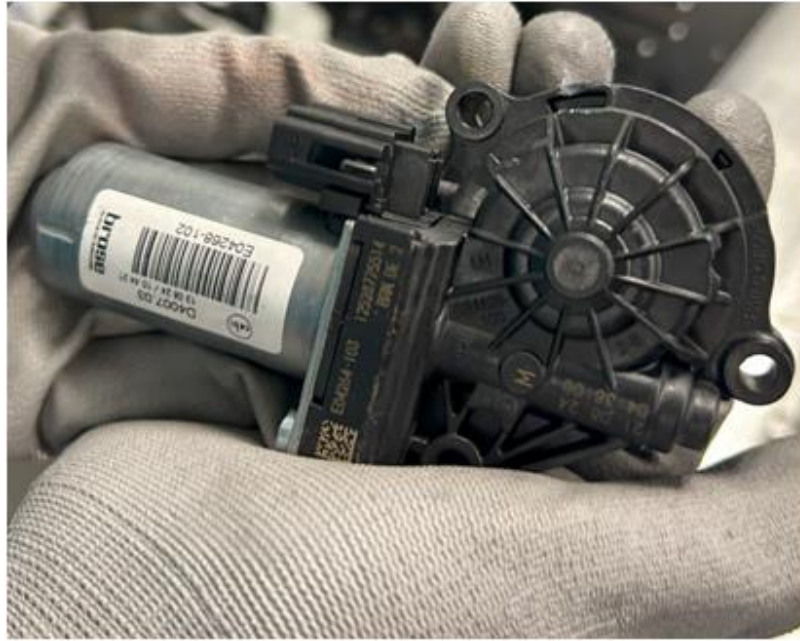
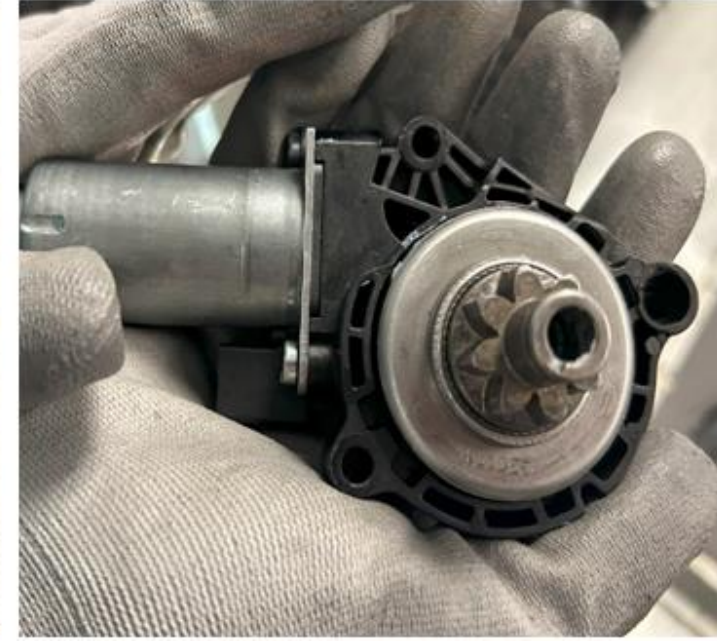
6. Check the new motor is a match and not damaged before installation.

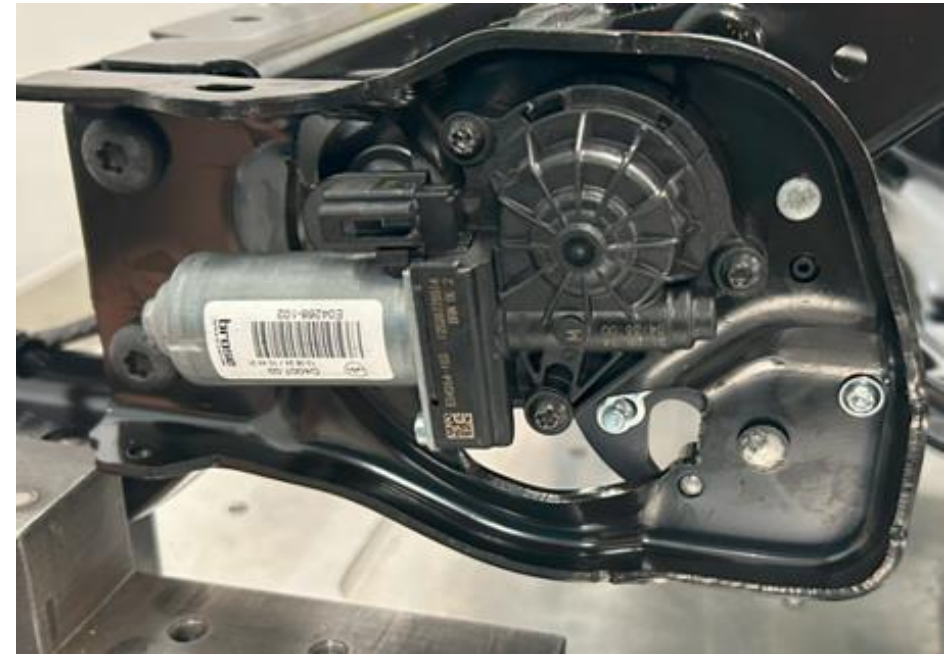
7. Fold seat back rest flat and then install LNV motor into seat frame assembly.

8. Install 3 T-20 mounting screws and **torque to 6 Nm.**

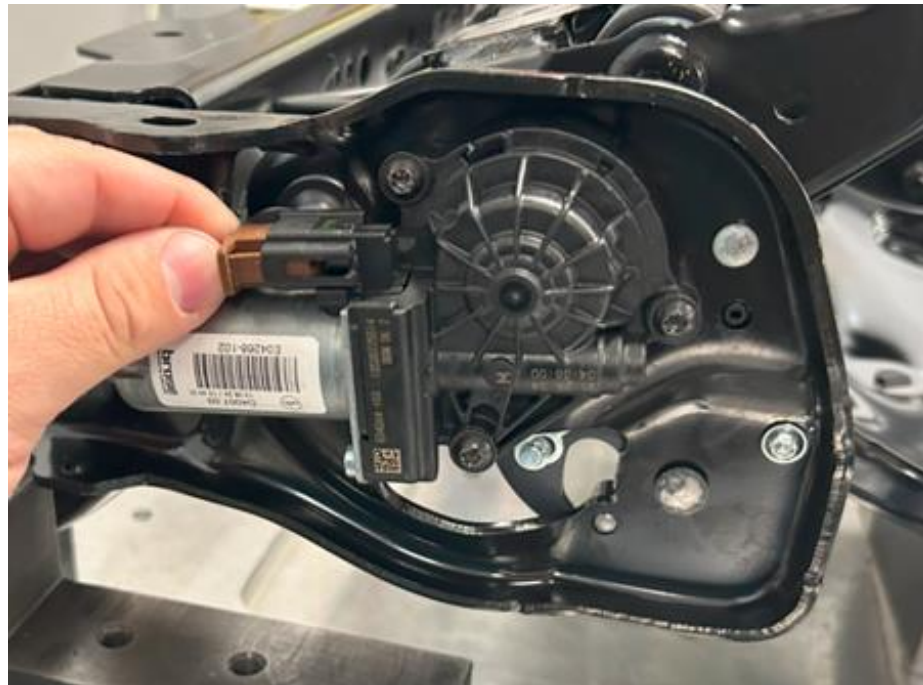
9. Reconnect brown electrical connector

10. Check functionality of seat.
