# Grecale, GranTurismo: Air Suspension System Diagnosis

DATE: December 17, 2024

This Technical bulletin serves as a guide and provides additional diagnostic info for possible Air suspension issues on GranTurismo and some Grecale equipped with Air Suspension System.

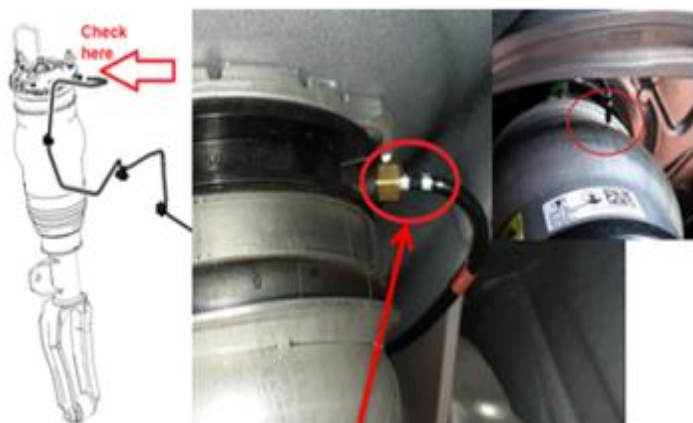
Sample of incorrect Air Suspension pipe installation on the front Air spring

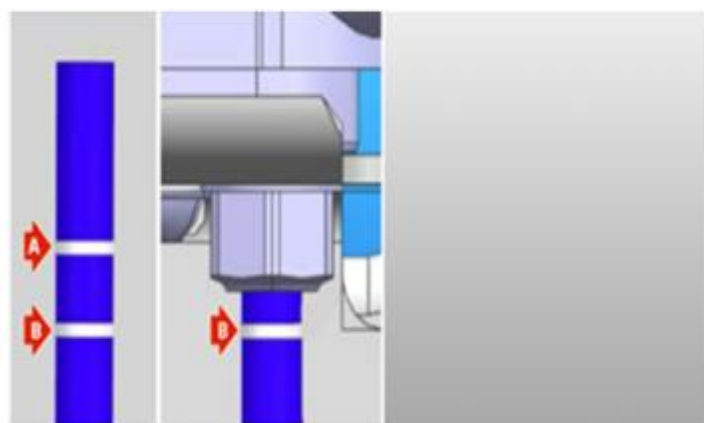
Correct layout to be ensured on the vehicle (points A and B)

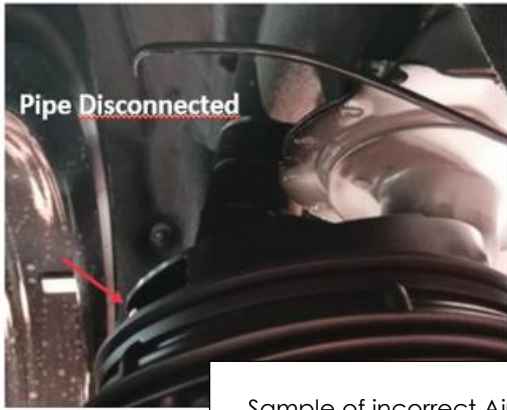
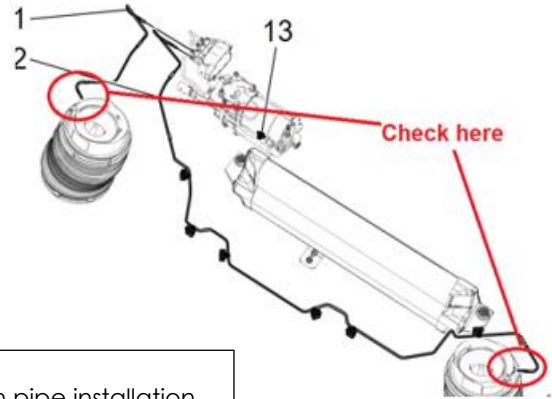
2 – Rear axle

Sample of incorrect Air Suspension pipe installation on the Rear Air Spring

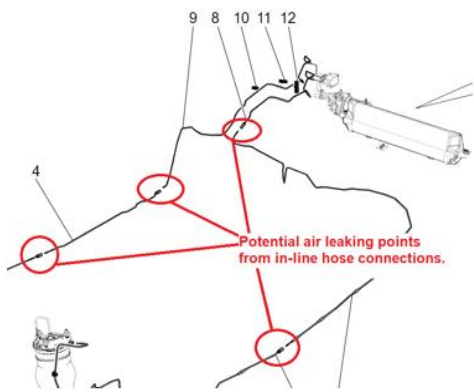
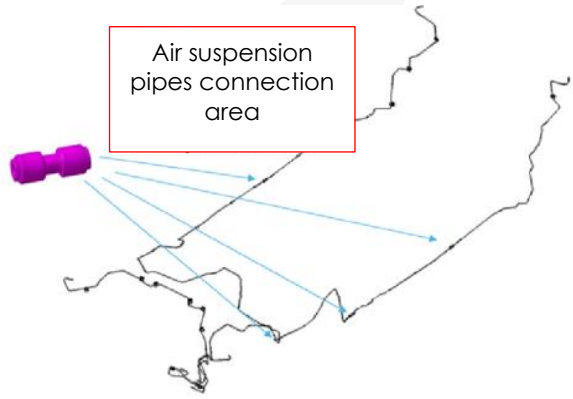
3a – Pipes connection area – Grecale (check the connections for at least 5-10 minutes with one of the products indicated at the end of this document)

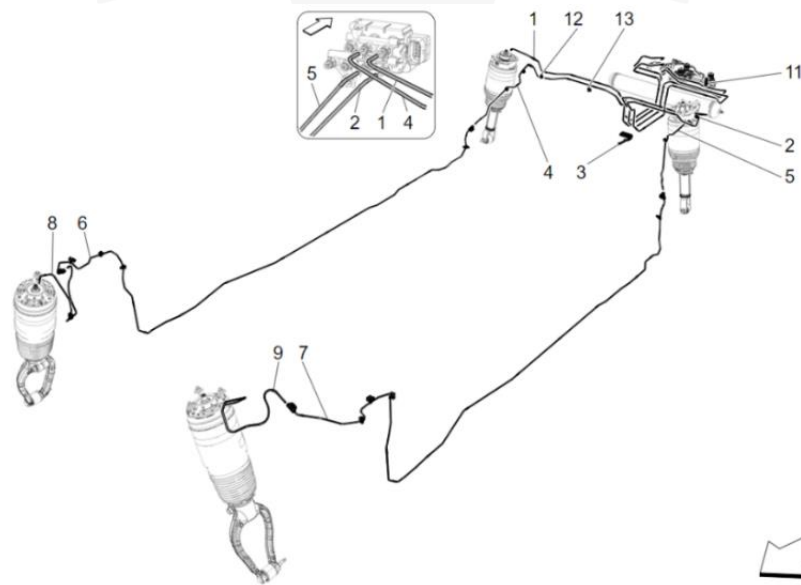
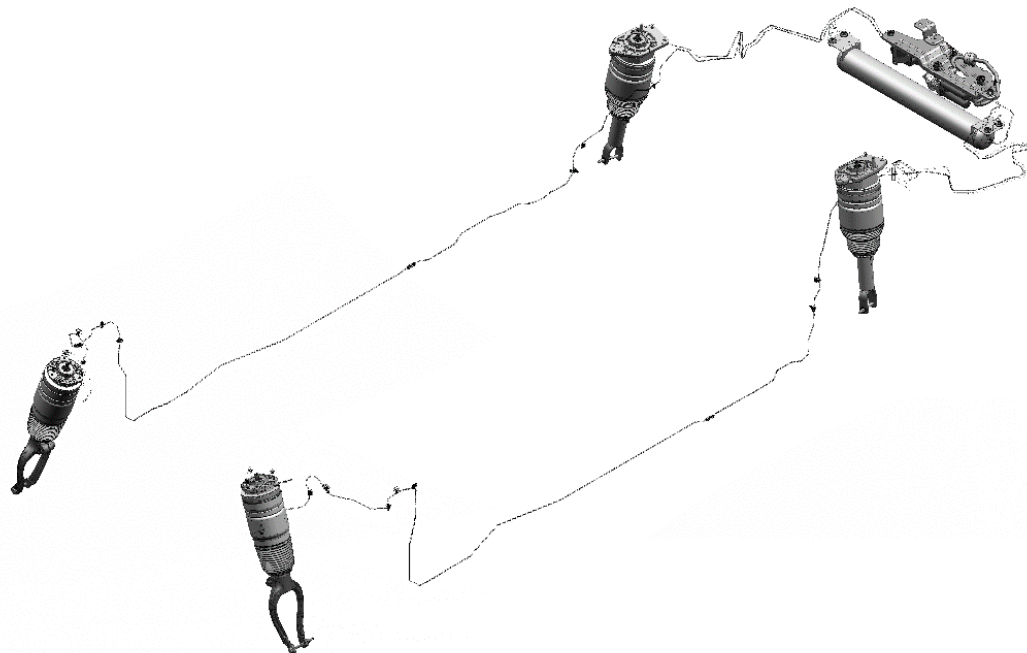
Old configuration

3b – Pipes connection area – New GranTurismo (check the connections for at least 5-10 minutes with one of the products indicated at the end of this document)

For the New GranTurismo, follow the instructions related to inspection points and fill in the specific checklist that you find in the final section of this document.

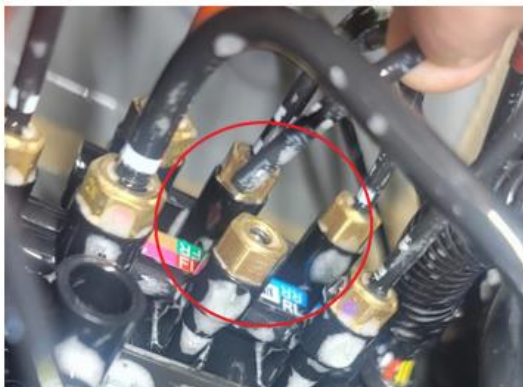
**4 – Air Valves Block pipes – disconnected or wrongly fitted (check the connections for at least 5-10 minutes with one of the products indicated at the end of this document)**

Check the air valves block pipes to ensure that there isn't any disconnected and/or wrongly installed line

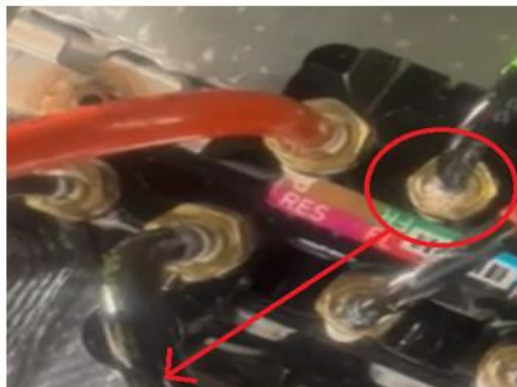
Use soapy water to detect potential air leak through the system

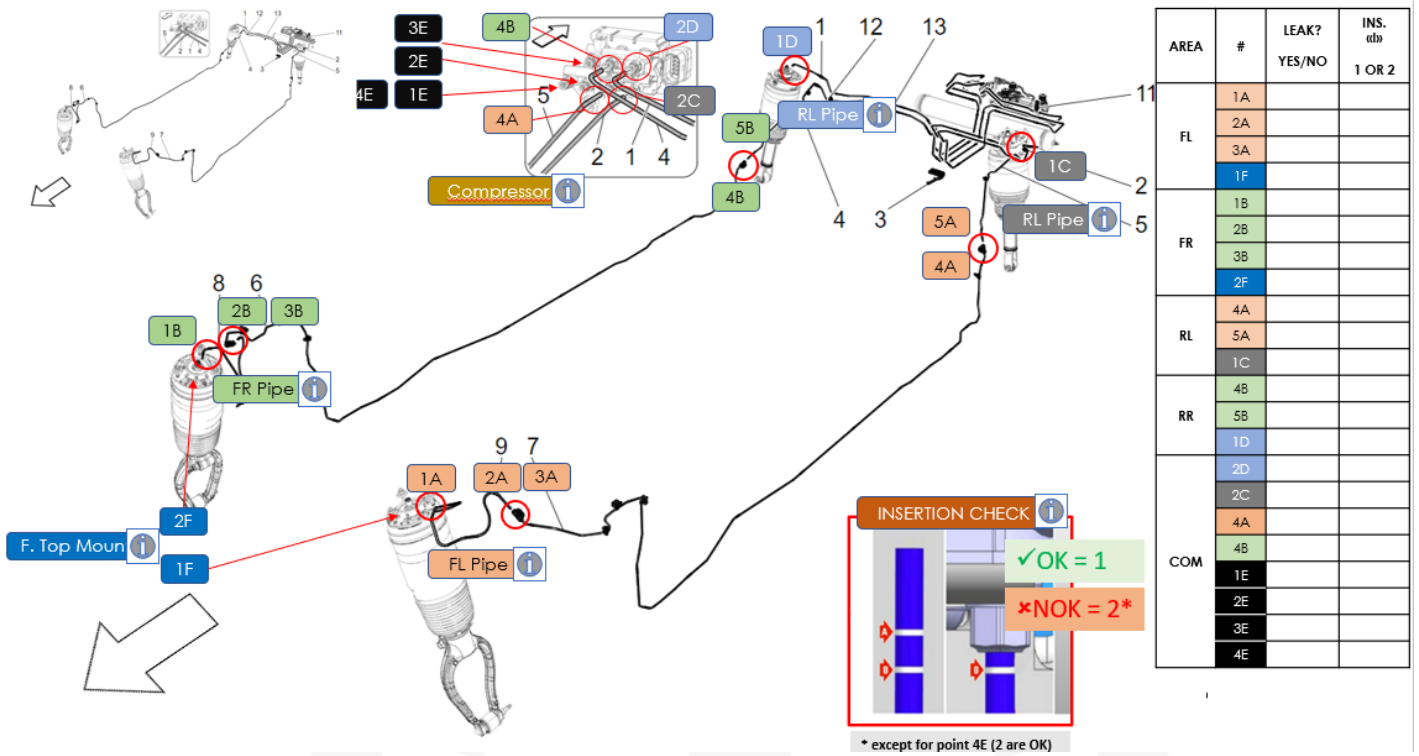
# GranTurismo Inspection points

AREA	#	LEAK? YES/NO	INS. db 1 OR 2
FL	1A		
	2A		
	3A		
FR	1B		
	2B		
	3B		
RL	4A		
	5A		
	1C		
RR	4B		
	5B		
	1D		
COM	2D		
	2C		
	4A		
	4B		
	1E		
	2E		
	3E		
	4E

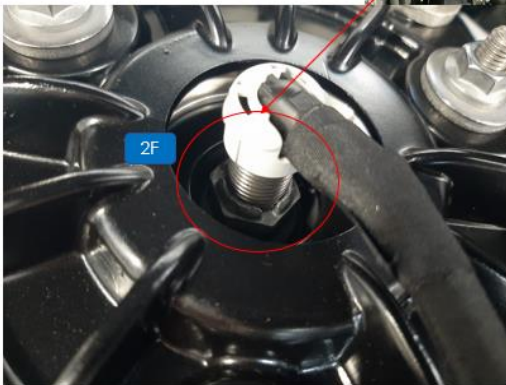
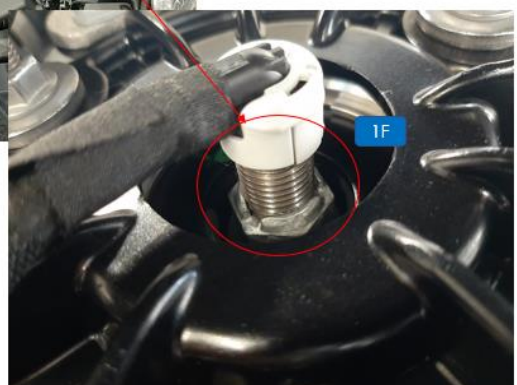
### M189 – Front Top Mount

When check on top mount with soapy water, be careful, don't put water on electric connector and don't disconnect the connector

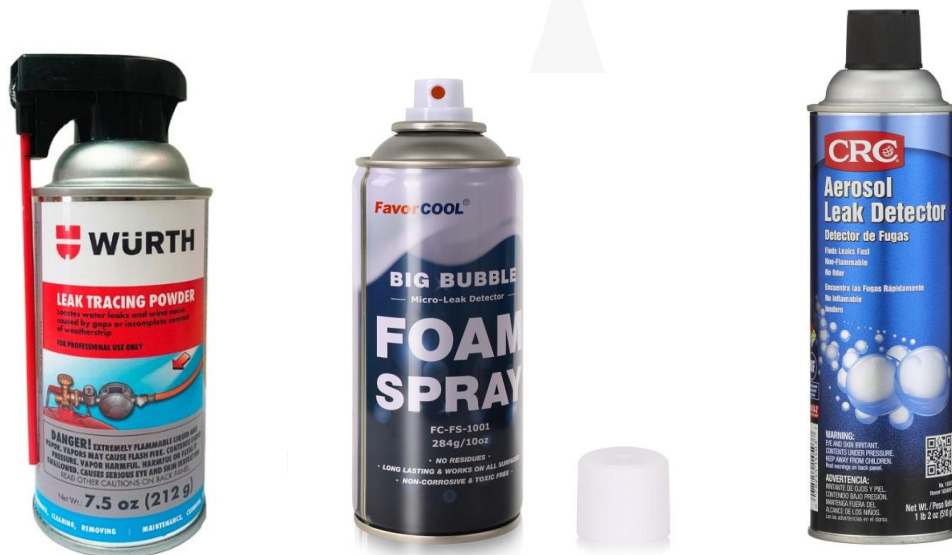
## Products to be used when inspecting for any leakage in the air suspension system.

- LEAK TRACING POWDER OR EQUIVALENT
