# Wishbone Bushes Serviceability Guide

**Location:** Chassis

**Topic:** Wish bone bush inspection guide.

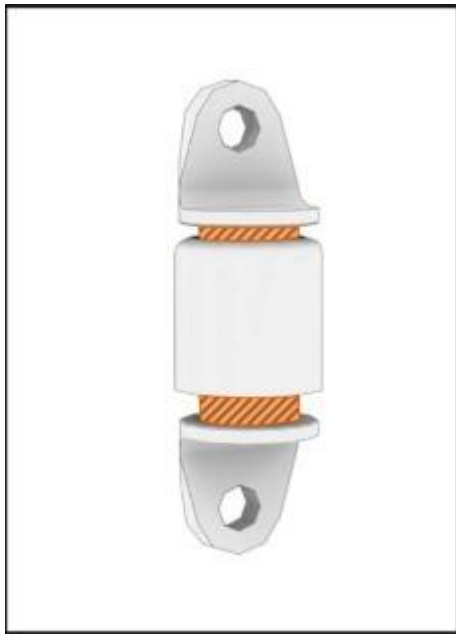
Image 1

1. If the cracks are located on the thin rubber that surrounds the bush inner metals (**see image 1**); •

The bushes **do not** need to be replaced.

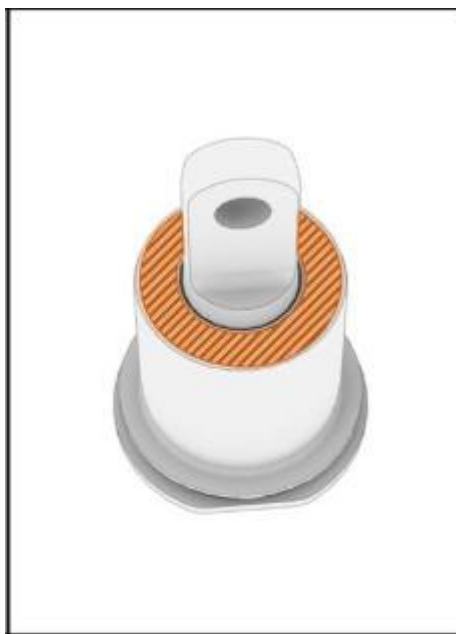
Image 2

2. If the cracks are located anywhere on the main rubber body of the bushes (**see image 2**);

- If the cracks are surface level only and less than 1mm in depth, the bushes **do not** need to be replaced.
- If the cracks are deeper than 1mm in depth, the bushes **must be** replaced.

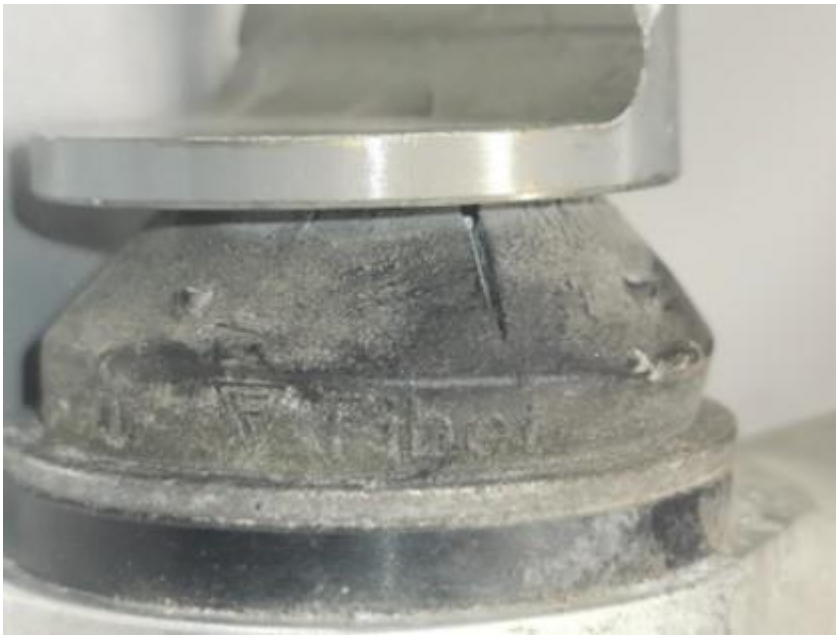
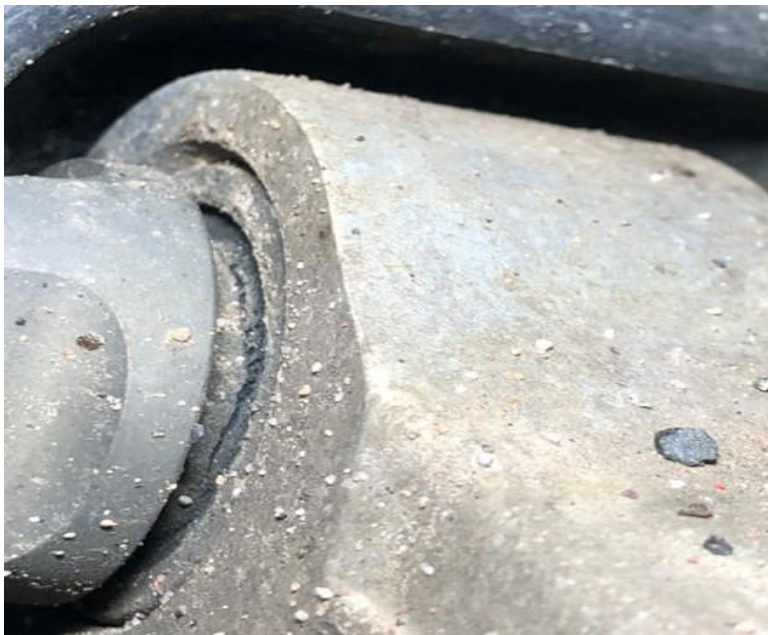
Examples of deep rubber cracks.

If cracks can't be measured due to their location, visual judgement can be used instead. Examples of deep cracks are shown below.

Bushes with deep cracks as shown **must be** replaced.

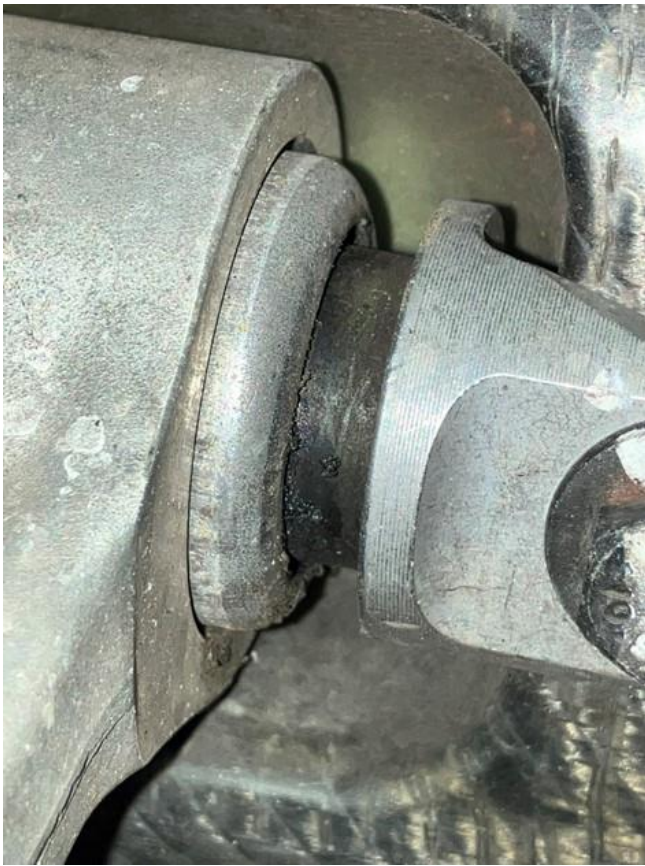
Light rubber debris is expected as the bushes progress through their useable life this is **not** a reason for replacement. See example below.

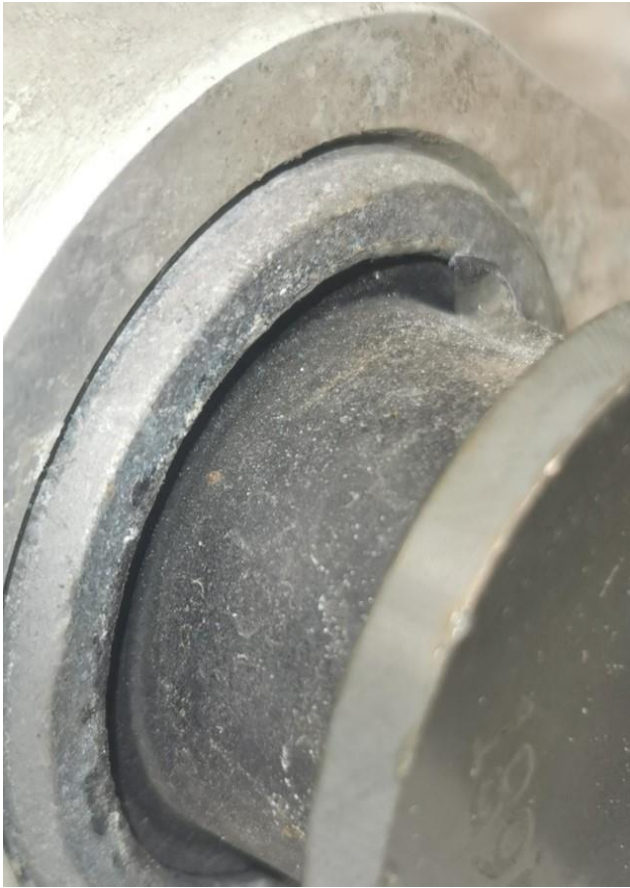
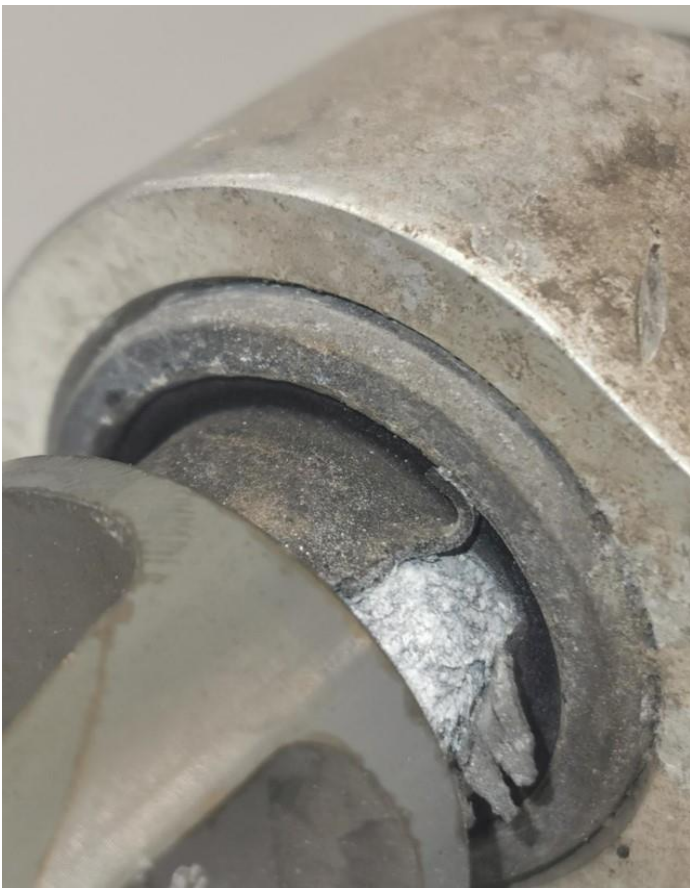
Examples of rubber peeling.

Depending on where and how the vehicle has been used, rubber peeling from the sides of the bush inner metals may occur.

Rubber peeling (as shown in the pictures below) does not impact the performance or the durability of the bushes, they **do not need** to be replaced.

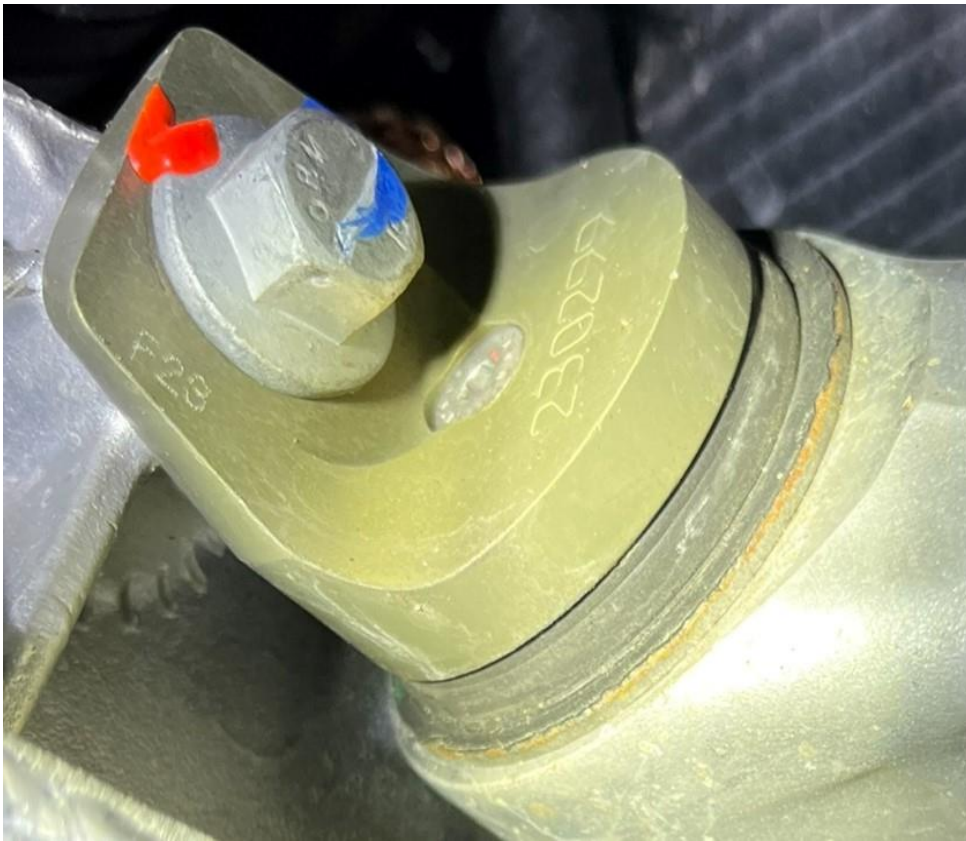
Dirt may accumulate on the front and rear faces of some wishbone bushes, as shown in the examples below.

(Example 1 - Bush outer metal dirt accumulation.)

This is **not corrosion** but rather dirt particles from the road that adhere to the exposed resin used during the rubber vulcanization process. This dirt does not impact the functionality of the bush and can be mostly removed with thorough cleaning if needed.

Bushes with dirt accumulation don't need to be replaced.

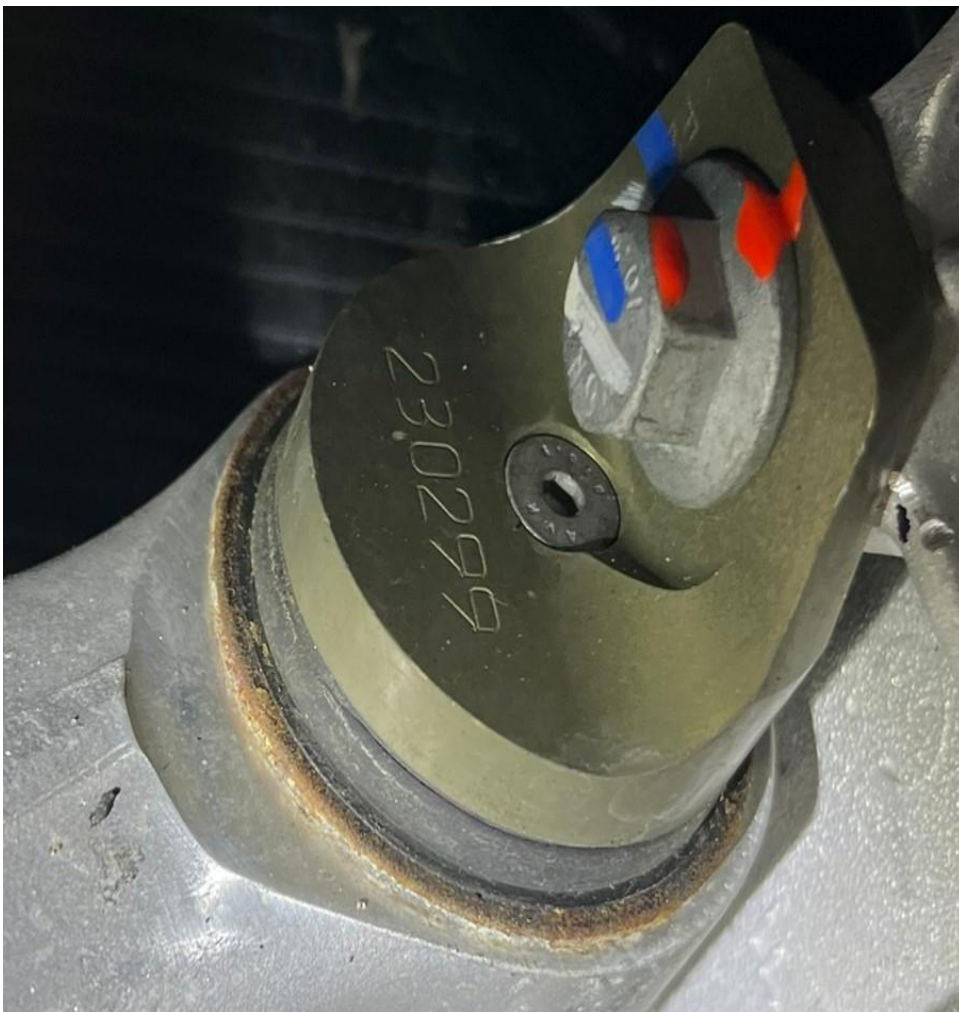
(Example 2 - Bush outer metal dirt accumulation.)
