# Technical Service Bulletin

## 60 Water entering through panoramic sliding sunroof

60 24 74 2075969/1 December 4, 2024.

Model(s)	Year	VIN Range	Vehicle-Specific Equipment
Q5, and SQ5	2018 – 2023	All	Panoramic Sunroof
Q5 e quattro	2020 – 2023		
Q5 Sportback, and SQ5 Sportback	2021 - 2023

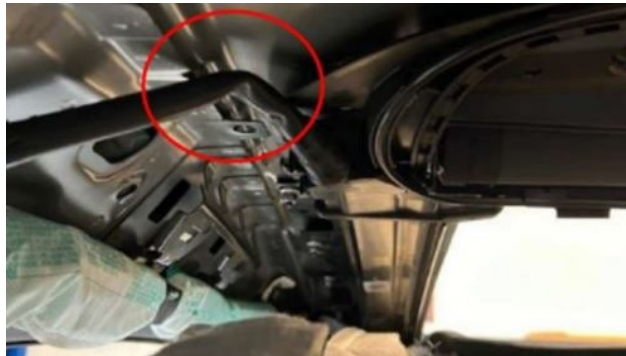
**Figure 2. Kinked hose.**

Water is drained from the sliding sunroof frame using hoses. These hoses may be kinked when the headliner is installed. The water drain can become blocked, particularly in combination with dirt, causing water to back up and then flow into the vehicle interior.

2. Pay particular attention to kinks in the hoses. Figures 2 and 3 show examples of kinked hoses. Figure 4 shows the correct routing between deformation elements. Kinked hoses must be replaced as per the Workshop Manual.
3. Figure 2 shows an example of a kinked hose.

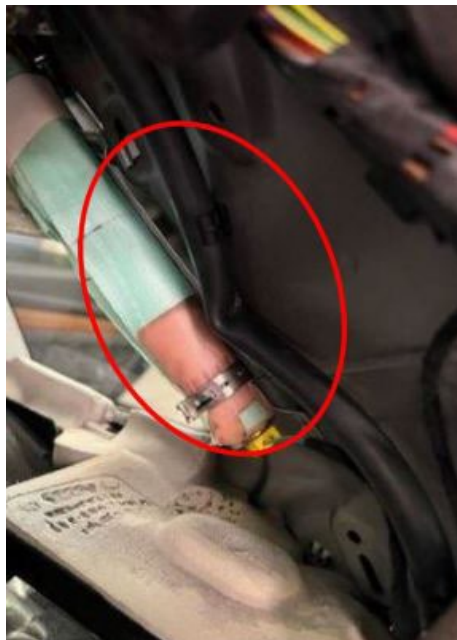
**Figure 3. Another example of a kinked hose.**

4. Figure 3 shows another example of a kinked hose.

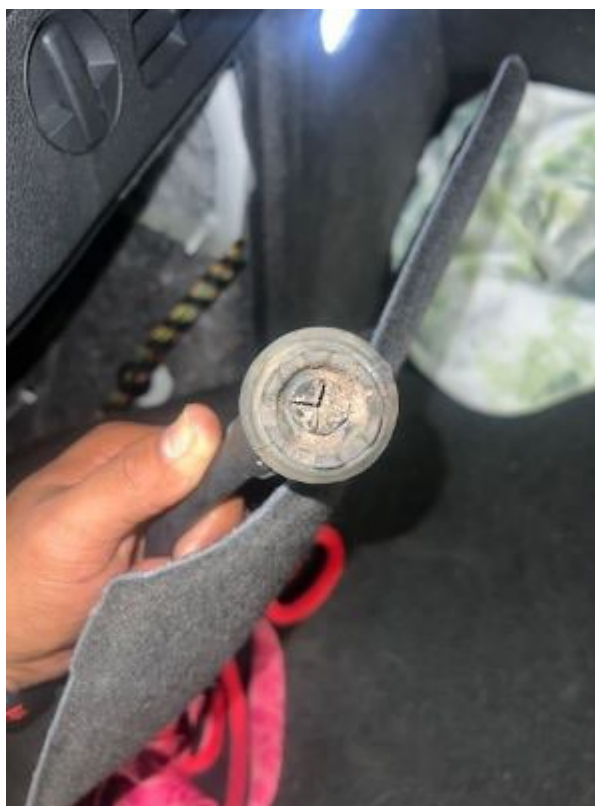
6. If the hoses are correctly routed, they must be checked for dirt (Figure 5).

**Figure 5.** Dirty water drain hose.

- 7. If large dirt residues are found, clean all 4 water drain hoses according to the Workshop Manual with tool SET6620 (formerly VAS6620) (Figure 6).

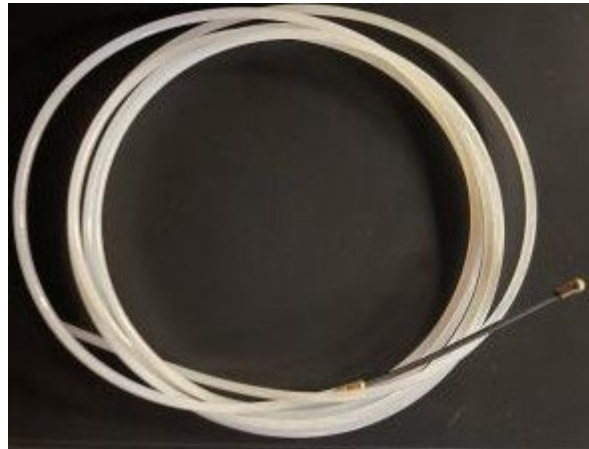
Figure 6. Cleaning tool SET6620 (formerly VAS6620).
