**WRV8 - Check Electric Machine on Front and Rear Axles and Replace if necessary (Workshop Campaign)**

Vehicle Type: **Macan 4 (XAB)/Macan Turbo (XAB)**

Model Year: **As of 2024**

Concerns: **Front electric machine or rear electric machine**

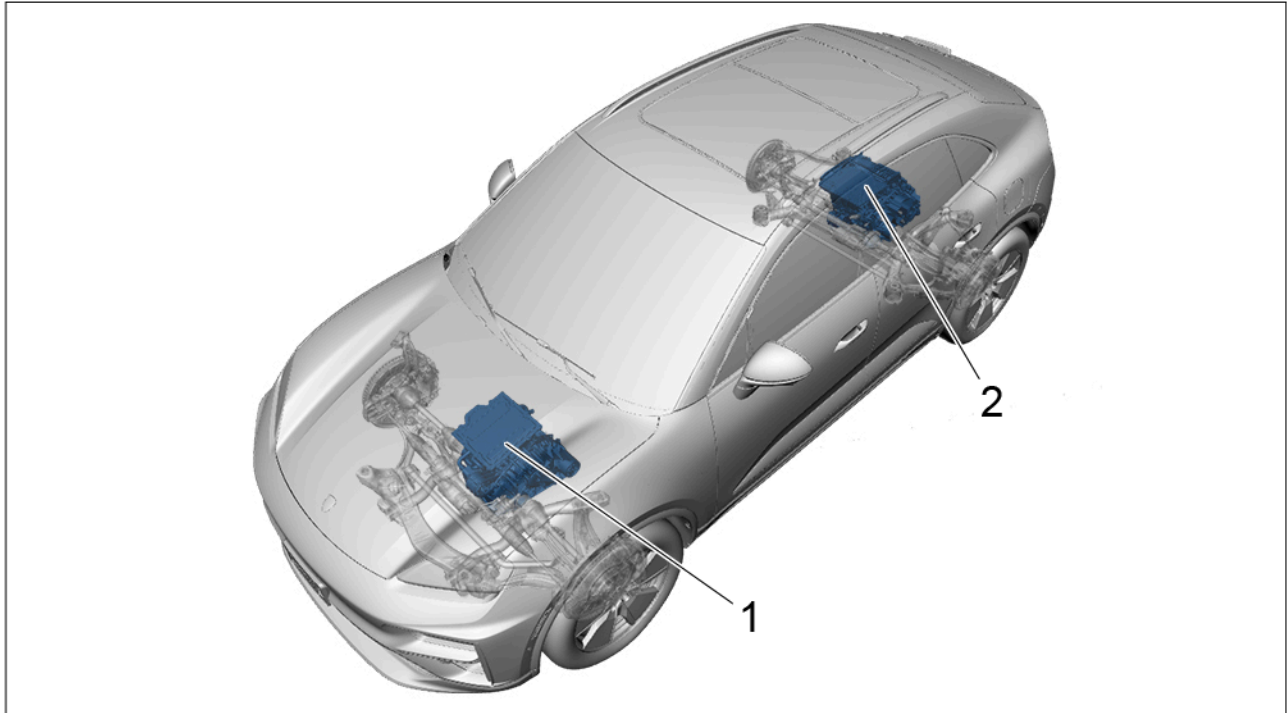
*Installation position front electric machine and rear electric machine*

- 1 – Front electric machine
- 2 – Rear electric machine

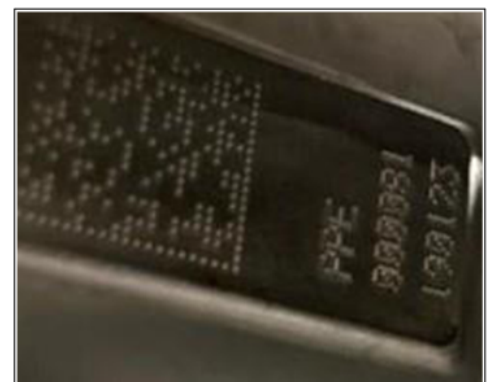
Rear electric motor

The welded marking is located on the rear housing of the electric machine. This consists of a QR code and a combination of letters and numbers. When creating the photo, it must be ensured that the combination of letters and numbers is easily recognizable.

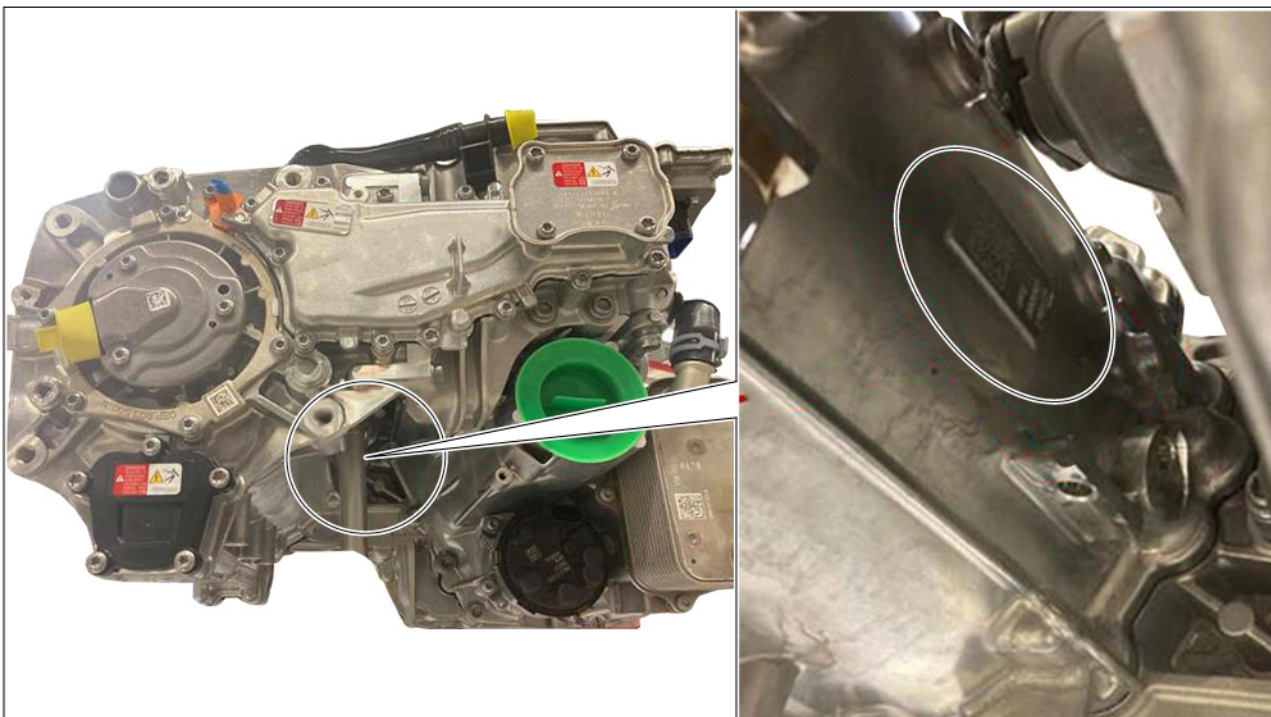
- 2 Locate welded marking ⇒ *Check welded marking on rear electric machine housing -Circle-* on rear electric machine housing and use **VAS 6748B - endoscope inspection camera** to create a photo of the welded marking, making sure that the numbers and characters are easily recognisable.

Check welded marking on rear electric machine housing

- Then send the photo together with the **VIN** of the **affected vehicle** and the following text via PRMS Warranty>Campaigns ticket to PCNA\_Warranty\_Support. Further procedure according to the PRMS ticket feedback.

Assessment		Action
(✓)	The rear electric machine <b>meets</b> the required specifications.	<b>Check OK.</b> Continue with Step ⇒ 5 Invoicing: Scope 3.
(x)	The rear electric machine does <b>not</b> meet the required specifications.	<b>Inspection not OK.</b> Replace rear electric machine. Continue with ⇒ <i>Technical Information</i> '519419 Replace rear electric machine

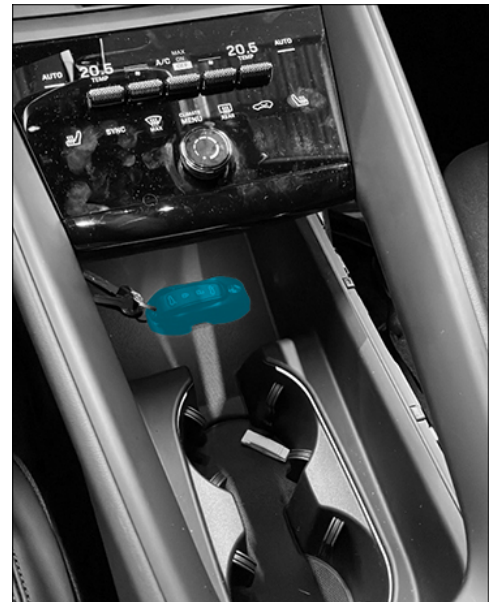
- 2.2 Position the original remote control in the emergency start tray.
  - 2.3 Select the vehicle type if necessary.
  - 2.4 In the **overview**.
  - 2.5 The **P90999 - PIWIS tester 4** starts the vehicle composite test. A new electric spare part/control unit is detected.
  - 2.6 The **P90999 - PIWIS Tester 4** specifies the further procedure.
  - 2.7 Follow the **P90999 - PIWIS Tester 4** instructions in menu.
  - 2.8 Back to the **Overview**.
  - 2.9 Read out all **fault memories** process and delete existing faults if necessary.
  - 2.10 End the diagnostic application.
- 3 Reset rotor position.  
⇒ *Technical Information '933155 Replacing front high-voltage pulse inverter'*
  - 4 End readiness for operation and remove **P90999 - PIWIS Tester 4**.

*Original handheld transmitter in emergency start tray*

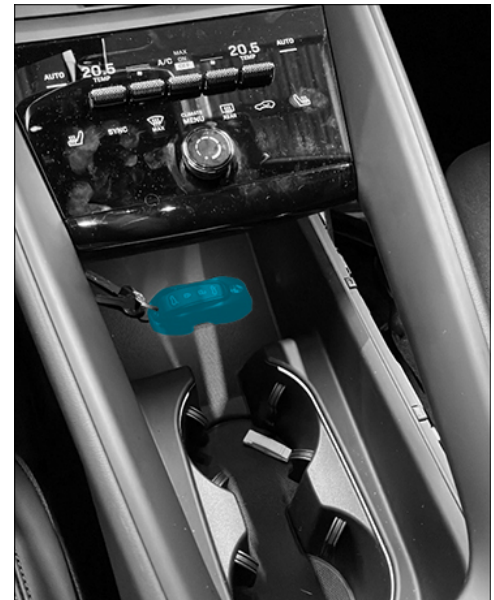
- 4.2 Position the original remote control in the emergency start tray.
  - 4.3 Select the vehicle type if necessary.
  - 4.4 In the **overview**.
  - 4.5 The **P90999 - PIWIS tester 4** starts the vehicle composite test. A new electric spare part/control unit is detected.

*Original handheld transmitter in emergency start tray*
