UPDATE PRIOR TO SALE NOTICE

Global Service Action
Number: N956 UPS5725-1

Subject: Vacuum Hose Blanking Plug - Inspection	Publication No.: N956 UPS5725-1
	Model: Range Rover Velar (LY)
	Model Year: 2025
	Date of Issue: 12 December 2024
	Expiry Date: 12 December 2025

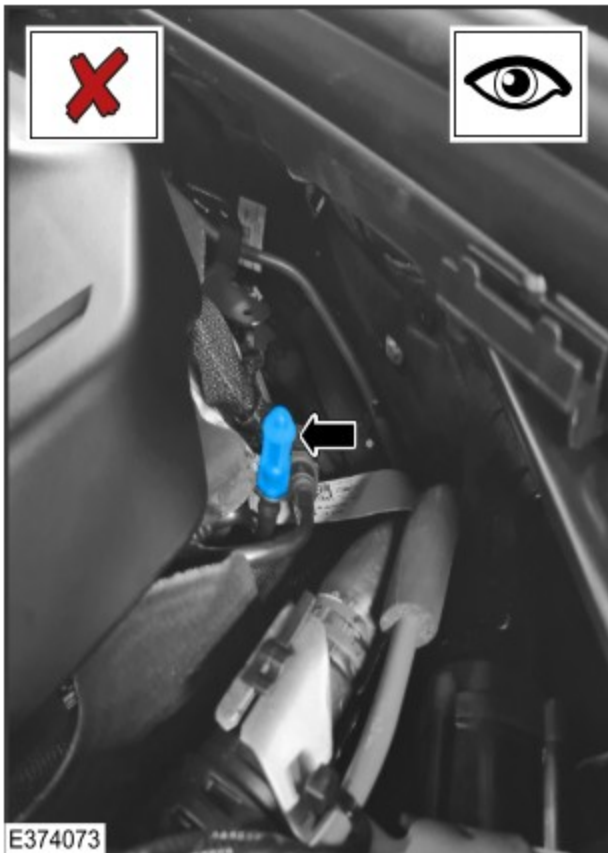
2. Inspect the vacuum pipe.

- If the vacuum pipe blanking plug **is** installed as shown in the illustration with the **GREEN** ✓, continue to step 4.
- If the vacuum pipe blanking plug **is not** installed as shown in the illustrations with the **RED X**, continue to step 3.

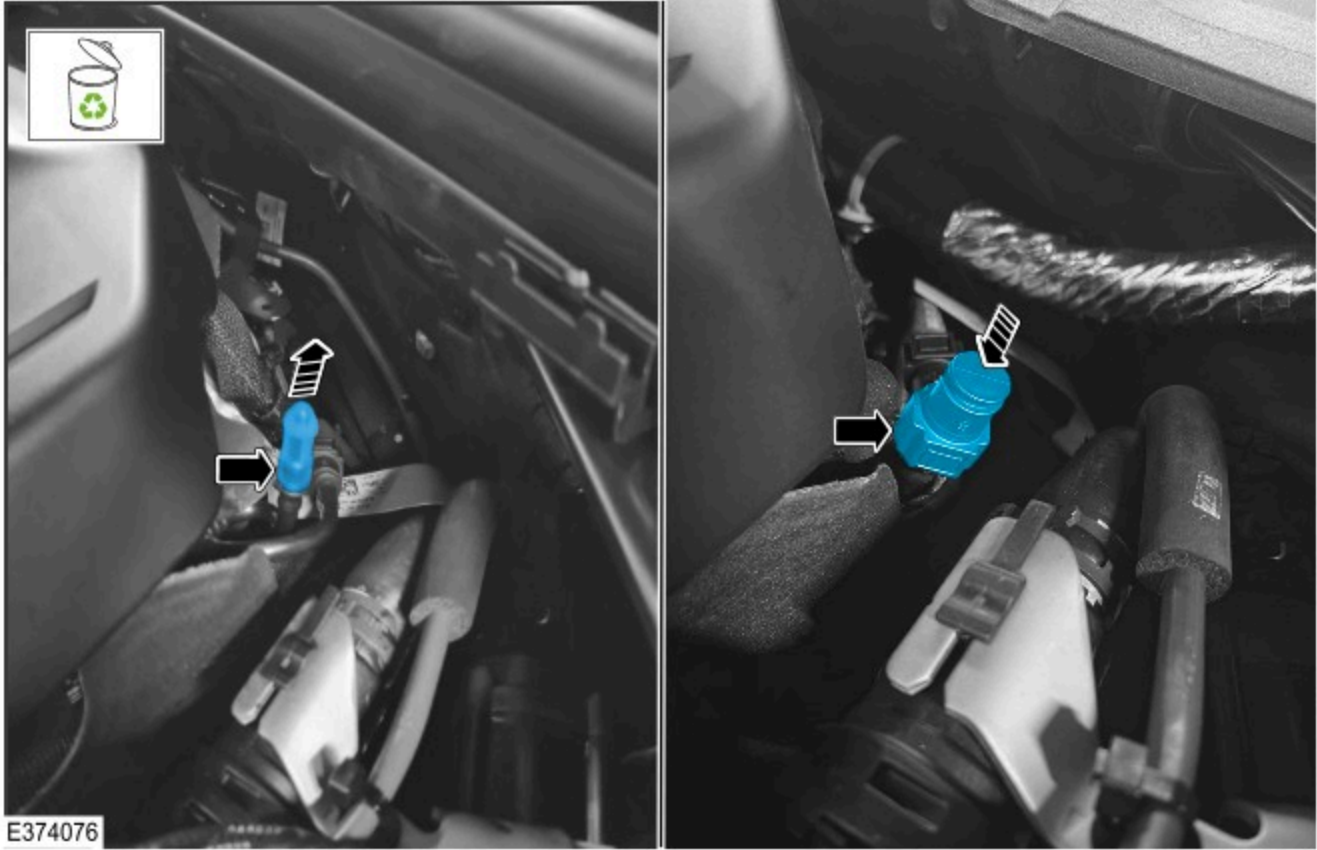
3. Install a new vacuum pipe blanking plug.

- Remove and discard the vacuum pipe transport plug.
- Install the vacuum pipe blanking plug.
