# UPDATE PRIOR TO SALE NOTICE

Global Service Action  
Number: H524 UPS5825-1

<b>Subject:</b>  <b>Vacuum Hose Blanking Plug - Inspection</b>	Publication No.: H524 UPS5825-1
	Model: F-PACE (X761)
	Model Year: 2025
	Date of Issue: 12 December 2024
	Expiry Date: 12 December 2025

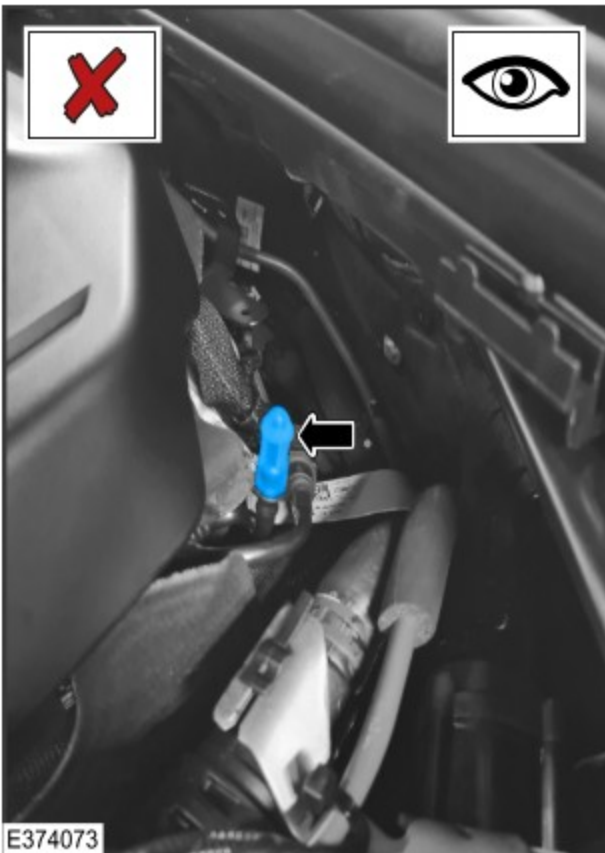
2. Inspect the vacuum pipe.

- If the vacuum pipe blanking plug **is** installed as shown in the illustration with the **GREEN** ✓, continue to step 4.
- If the vacuum pipe blanking plug **is not** installed as shown in the illustrations with the **RED X**, continue to step 3.

3. Install a new vacuum pipe blanking plug.

- Remove and discard the vacuum pipe transport plug.
- Install the vacuum pipe blanking plug.
