**Additional Coolant Pump Fault (POC4700) Causes MIL**

Models	Model Year	Model Type	VIN Range	Vehicle-Specific Equipment
Cayenne	2015 - 2017	92A	n/a	PHEV

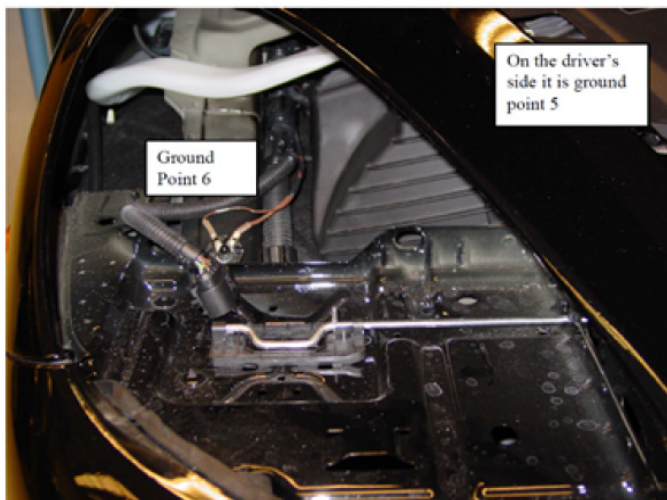
Figure 1 - Ground PIN 6B

- a) Corrosion on Ground Pin 6B (See figures 1 and 2.)
- b) Corrosion on the connector to the secondary low temperature coolant pump.
- c) A bad ground or otherwise unsound wiring.

Looking into right front wheel well through the headlamp area (Driver side similar)

The service recommendation is to check the ground, connector, and wiring for corrosion and circuit continuity. Repair the ground, connector, or wiring as needed. Sometimes, the ground bolt is painted and not adequately conductive. In this case, clean the ground bolt and eyelet using a wire brush and sandpaper. If the ground, connector, and wiring are acceptable, replace the electric water pump (958.606.567.00 - auxiliary coolant pump) and the electric water pump relay (958.615.008.01 - coolant pump relay).

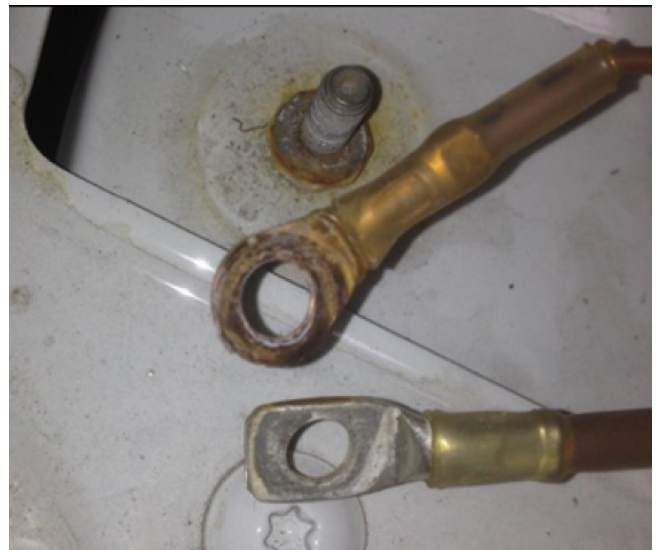
Figure 2 – Example of corrosion on ground point
