TECHNICAL INSTRUCTIONS
FOR
SPECIAL SERVICE CAMPAIGN 24TC06
Active Grille Shutter
Engine Warning Light May Illuminate
CERTAIN 2024 TACOMA

The subject vehicles were manufactured with a grill shutter wire harness connector that contained an incorrectly sized waterproof seal. The incorrect seal can cause water to enter the connector, potentially causing the engine warning light to illuminate.

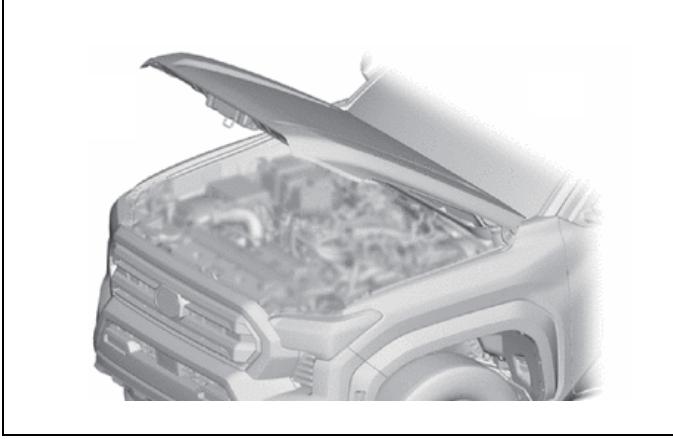
1. OPEN THE HOOD AND PROP IT OPEN WITH THE HOLDER STAY LEVER

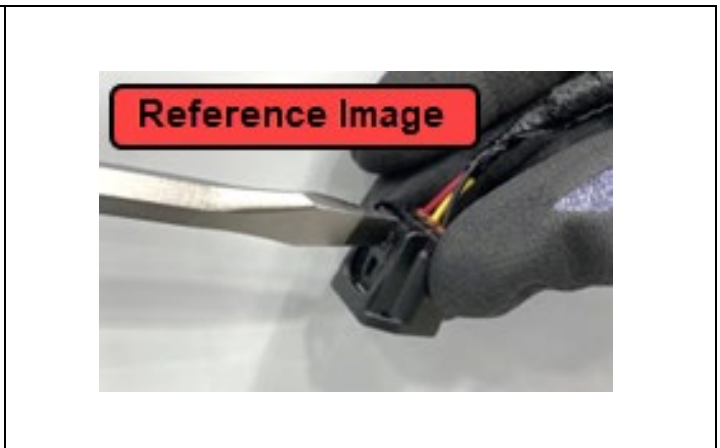
9. INSERT A FLATHEAD SCREWDRIVER THROUGH THE SIDE OPENING OF THE CENTRAL RIB, THEN RELEASE THE CONNECTOR AND REMOVE THE HARNESS
