## Warranty Extension: Popping/Crackling from the Speakers; Display Blank

Supersedes 23-025 dated July 26, 2024, to revise the information in **yellow**.

Year	Model	Trim Level	VIN Range
2019–21	RDX	ALL	Check iN for VIN eligibility

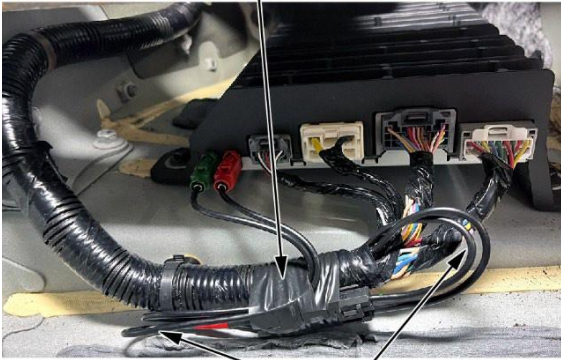
Attach the FAKRA service cables and splice boxes to the appropriate component harness with tape to prevent any rattles.

Keep smooth curves with a radius bend greater than 25 mm.

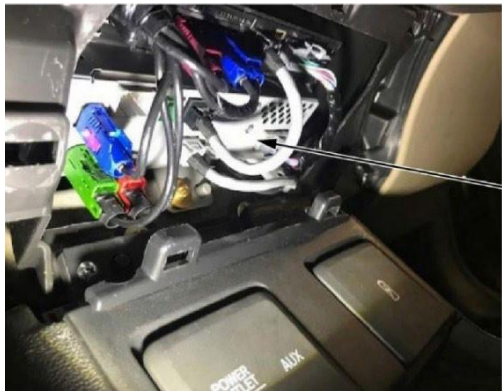
INFOTAINMENT  
CONTROL UNIT

1. Disconnect the red and green FAKRA connectors and any other related connectors at the infotainment control unit.

NOTE: Disassemble the connectors one at a time to avoid swapping the green and red wires.

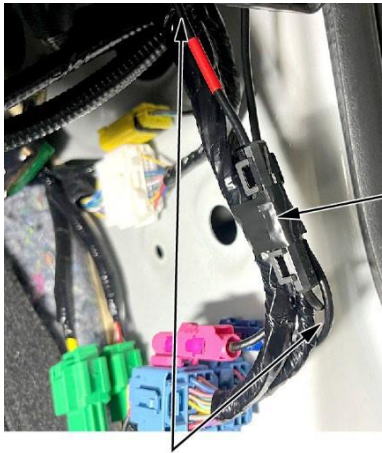
Attach the FAKRA service cable  
and splice box to the appropriate  
component harness with tape to  
prevent any rattles.

Keep smooth curves with a  
radius bend greater than 25 mm.

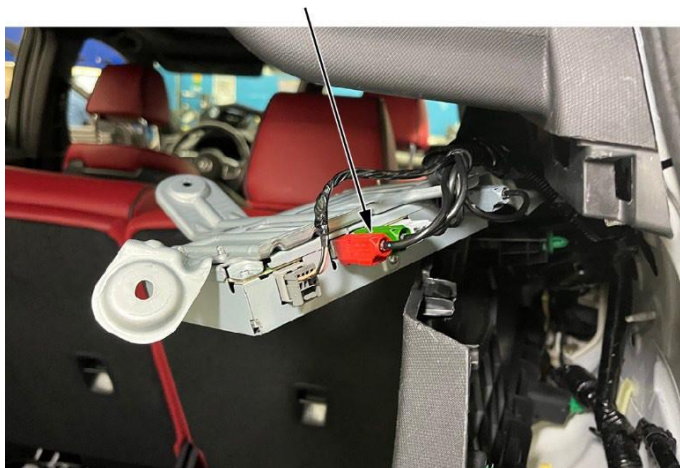
### FAKRA CONNECTORS

1. Disconnect the red and green FAKRA connectors at the tuner unit and then remove.

NOTE: Disassemble the connectors one at a time to avoid swapping green and red wires.

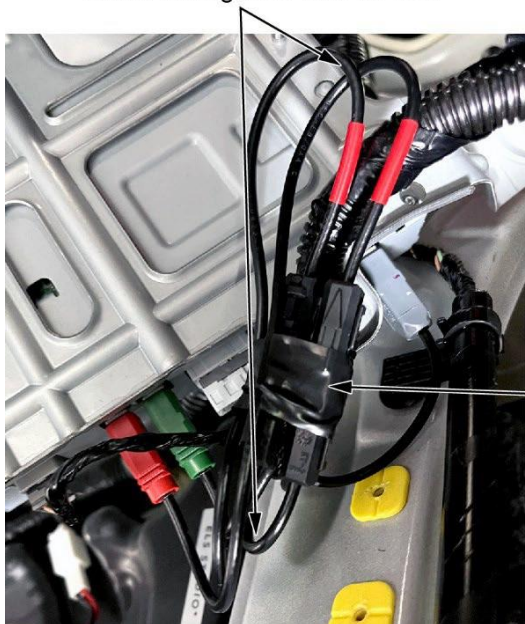
Keep smooth curves with a radius bend greater than 25 mm.

Attach the FAKRA service cables and splice boxes to the appropriate component harness with tape to prevent any rattles.

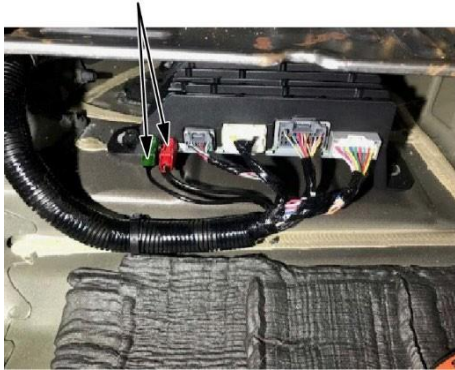
### FAKRA CONNECTORS

1. Disconnect the red and green FAKRA connectors at the stereo amplifier and then remove.

NOTE: Disassemble the connectors one at a time to avoid swapping the green and red wires.
