December 18, 2024

Version 2

Warranty Extension: 2022–24 RDX Popping/Crackling from the Speakers; Display Blank

Supersedes 24-045, dated July 30, 2024, to the revise the information highlighted in yellow.

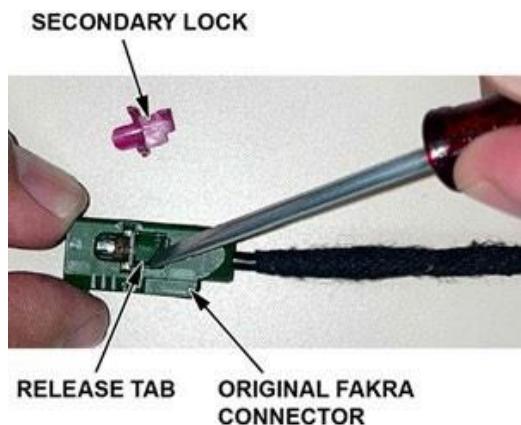
1. Use a small screwdriver, remove the secondary lock, then release the tab as shown.

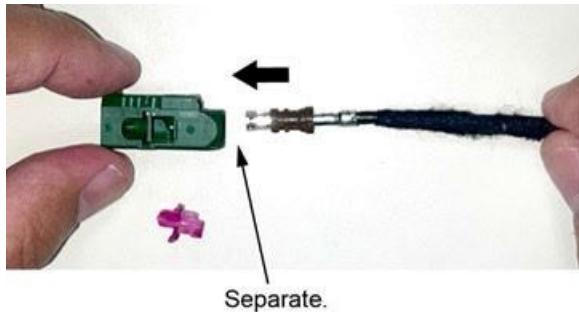
2. Pull to remove the housing from the vehicle harness. Then, **discard** the housing and lock.

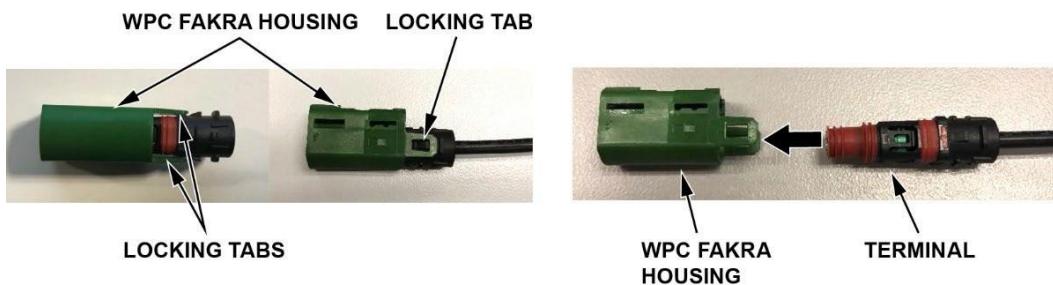
1. Release the two locking tabs on the WPC FAKRA service housing and remove the housing from the terminal.

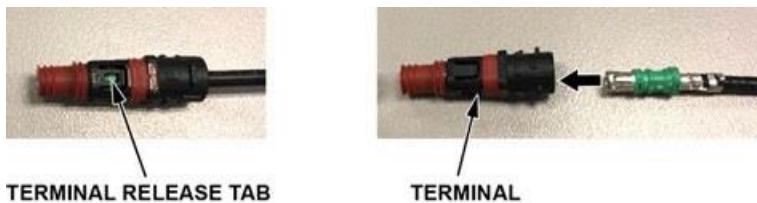
2. Release the lock tab and remove the terminal from the vehicle harness.

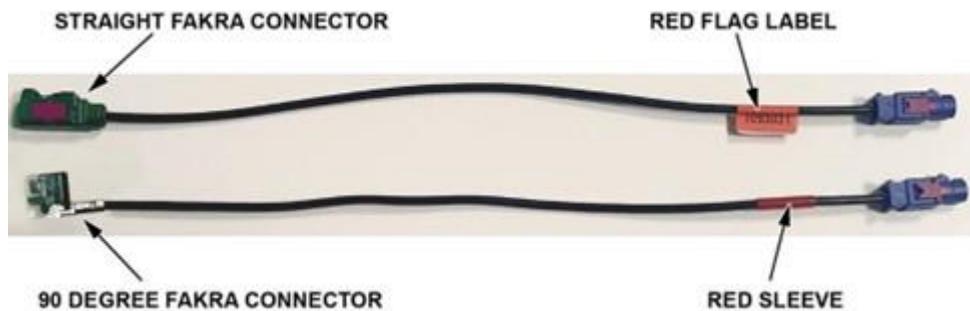
1. Install the appropriate FAKRA splice repair service cables and splice boxes as shown in the steps that follow:

- **The splice box arrow must always point in the direction of either the red flag label or red sleeve on the FAKRA splice repair service cable.**
- If the splice box is installed **incorrectly**, the repair will fail; MOST ring failure conditions will still occur.
- Some vehicles may not use the 90° FAKRA splice repair service cables.

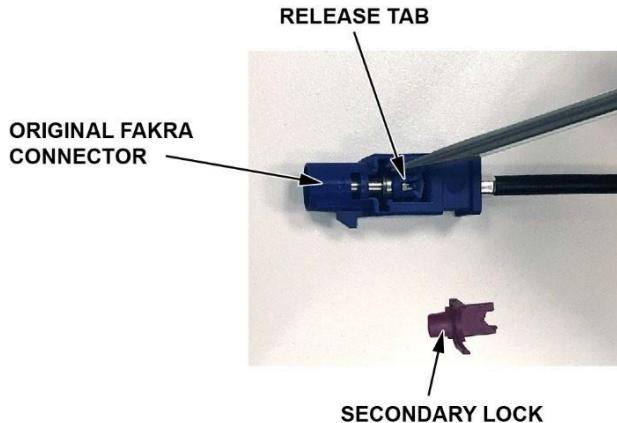
2. Use a small screwdriver to remove the secondary lock and then, release the tab.

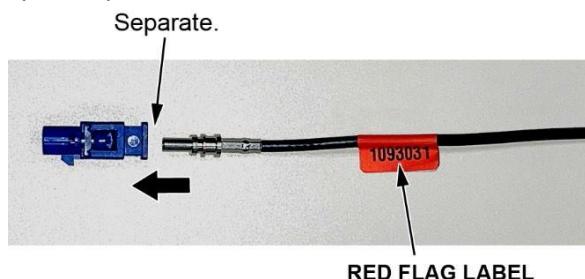
3. Pull to remove the housing from the cable and then discard the housing and secondary lock tab from the FAKRA splice repair service cable.

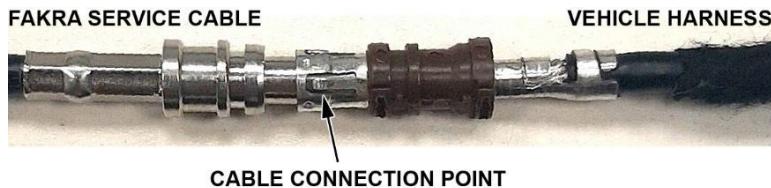
4. Connect the appropriate color FAKRA splice repair service cable to the vehicle harness.

- Make sure the FAKRA service cable is inserted straight into the vehicle harness terminal to avoid damage at the cable connection point.
- Always disassemble the connectors one at a time to avoid swapping the green and red wires.

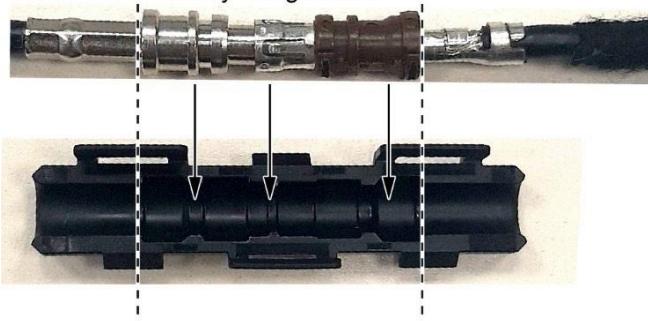
5. Attach the splice box halves to the cable connection.

Seat the connectors exactly into grooves.

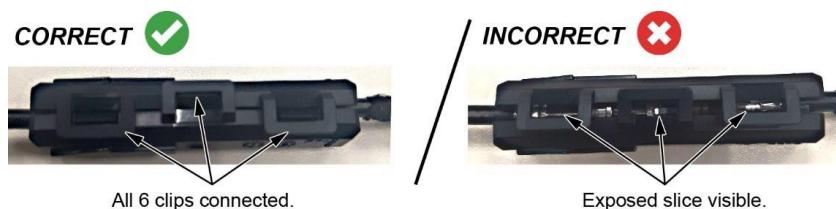
6. When mating the two splice box halves, **make sure** that all **6 lock tabs** are fully engaged. You may hear a click when installing the two halves.

- **The splice box arrow must always point in the direction of the red flag label or red sleeve on the FAKRA splice repair service cable.**
- The splice box is a **one-time** use part; Never reuse the splice box after it has been installed.
- If any of the lock tabs break during installation, the splice box halve(s) must be replaced.
- If the splice box is installed **incorrectly**, the repair **will fail**; MOST Ring failure conditions will still occur.

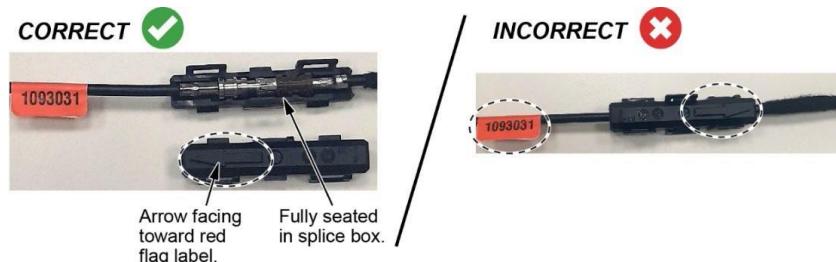
7. Make sure the arrow on the splice box **faces** towards the red flag label or red sleeve.

NOTE: Do not spin the splice box or the cables as this can cause damage to the connection point.

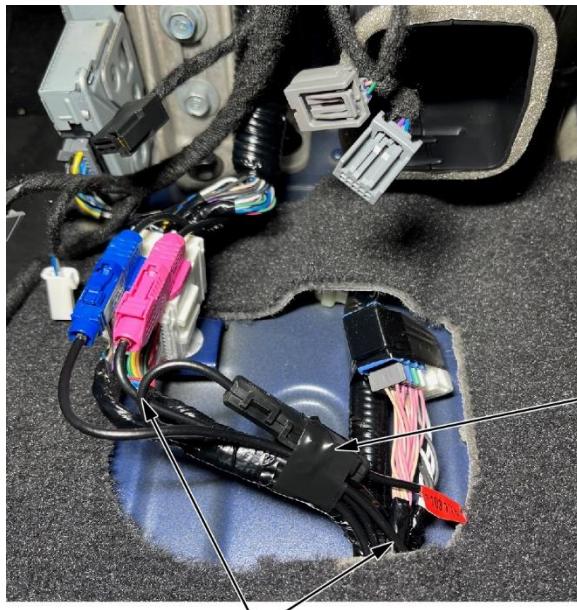
8. Once the FAKRA splice repair service cables and splice boxes have been attached to the cable connection, tape the splice boxes and FAKRA service cables to the appropriate component harness.

NOTE: Reference below for a correct example of the cable connection routing.

Attach the FAKRA service cable and splice box to the appropriate component harness with tape to prevent any rattles.

Keep smooth curves with a radius bend greater than 25 mm.

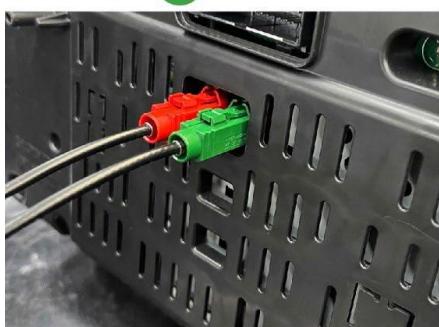
CORRECT

NOTE: Make sure the FAKRA splice repair service cables are not bent at connector(s), as shown below.

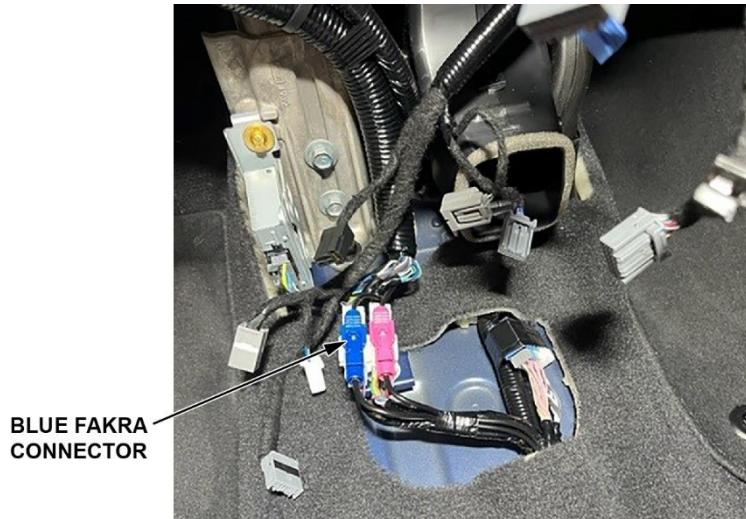
1. Disconnect the blue FAKRA connector at the center console.

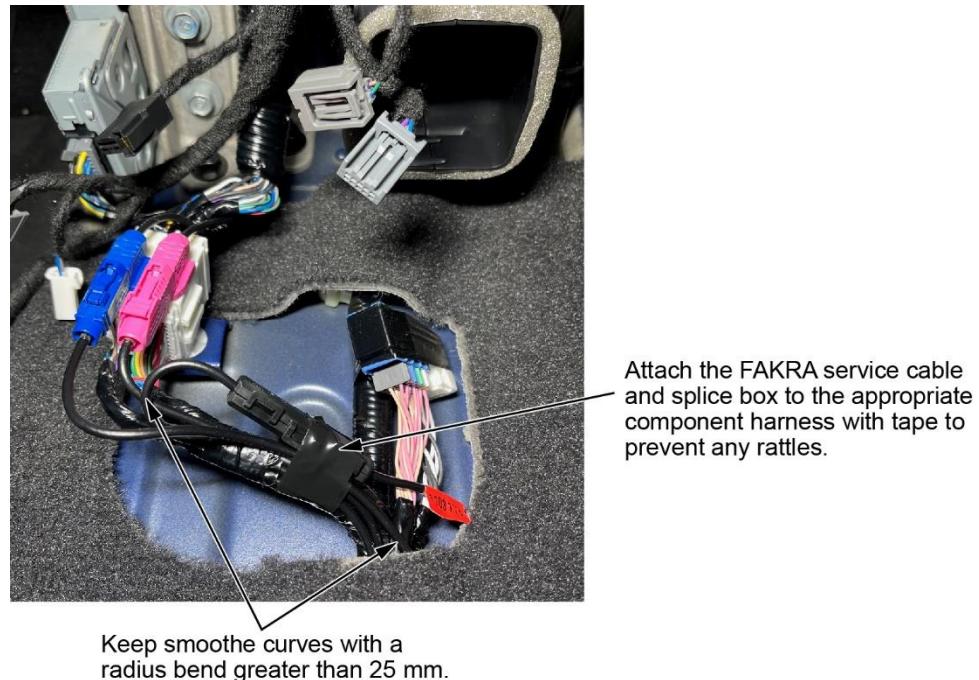
3. Tape the FAKRA splice repair cable and splice box to the in-line harness.

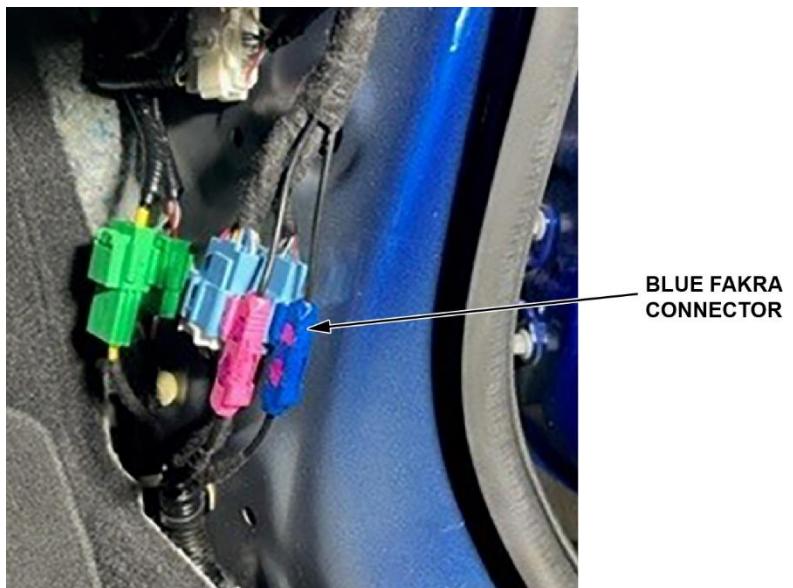
1. Disconnect the blue FAKRA connector at the passenger side kick panel.

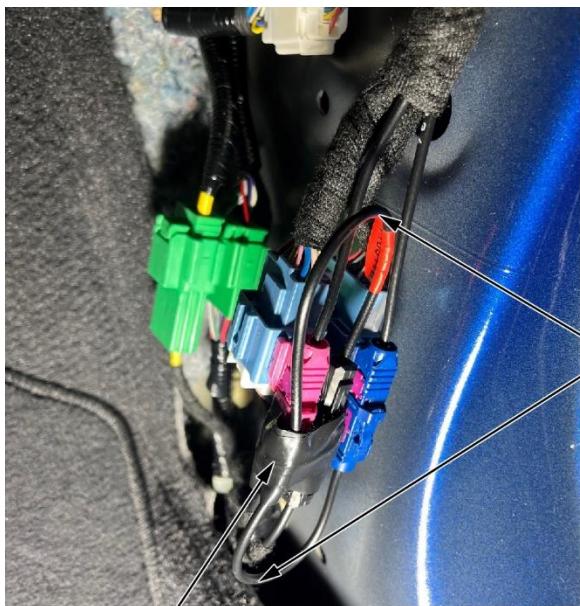
3. Tape the FAKRA splice repair cable and splice box to the in-line harness.

Keep smooth curves with a radius bend greater than 25 mm.

Attach the FAKRA service cable and splice box to the appropriate component harness with tape to prevent any rattles.
