Warranty Extension 2021–23 TLX Popping/Crackling from the Speakers; Display Blank

Supersedes 24-046, dated July 30, 2024, to the revise the information highlighted in **yellow**.

A coaxial cable terminal was not manufactured to proper specifications. An improperly manufactured terminal may lead to poor communication in the media-oriented system transport (MOST) bus network which can potentially affect the audio sound quality.

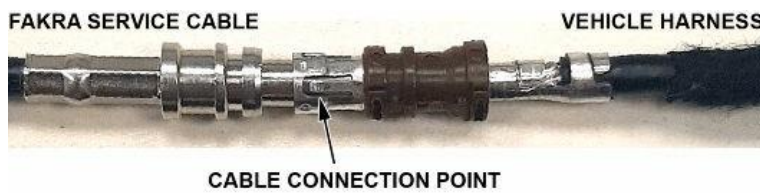
4. Connect the appropriate color FAKRA splice repair service cable to the vehicle harness.

- Make sure the FAKRA service cable is inserted straight into the vehicle harness terminal to avoid damage at the cable connection point.
- Always disassemble the connectors one at a time to avoid swapping the green and red wires.

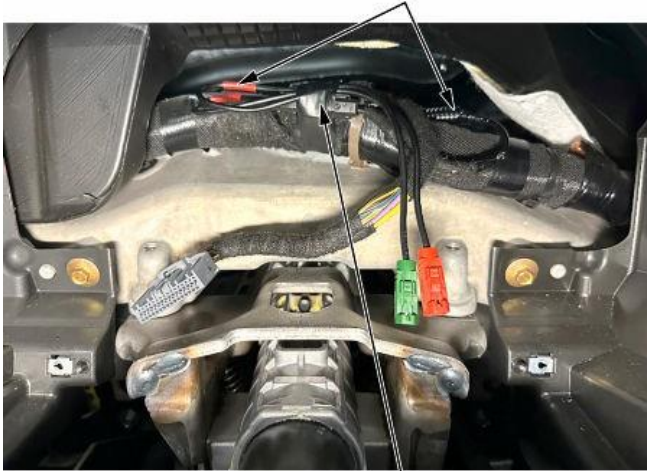
- Once the FAKRA splice repair service cables and splice boxes have been attached to the cable connection, tape the splice boxes and FAKRA service cables to the appropriate component harness.

Keep smooth curves with a radius bend greater than 25 mm.

Attach the FAKRA service cables and splice boxes to the appropriate component harness with tape to prevent any rattles.

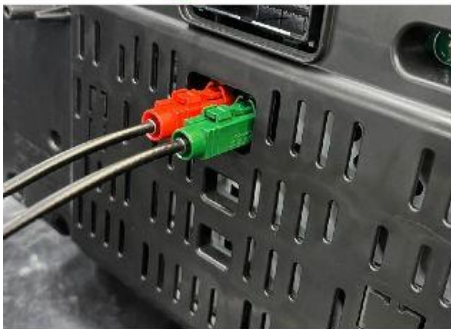
CORRECT ✓

NOTE: Make sure the FAKRA splice repair service cables are not bent at the connector(s), as shown below.

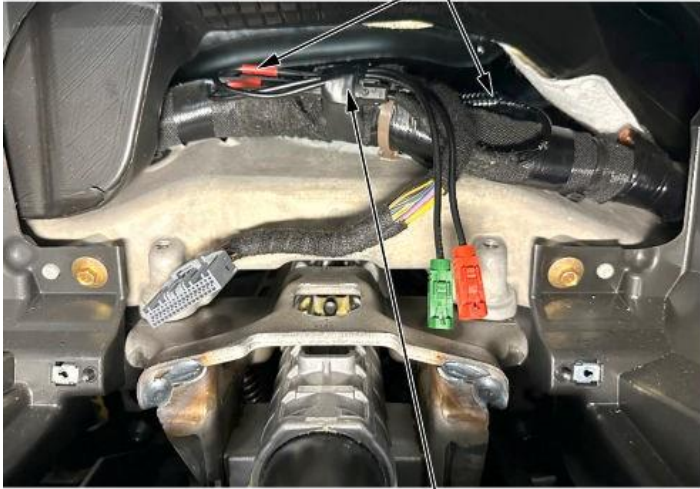
4. Tape both FAKRA splice repair cables and splice boxes to the gauge control module harness.

NOTE: Make sure the FAKRA service cables are routed on top of the 32-pin gray connector harness to prevent improper cable routing.

Keep smooth curves with a radius bend greater than 25 mm.

Attach the FAKRA service cables and splice boxes to the appropriate component harness with tape to prevent any rattles.

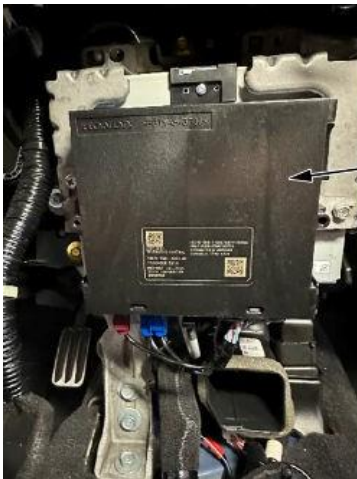
TELEMATICS
CONTROL UNIT

1. Remove the telematics control unit.

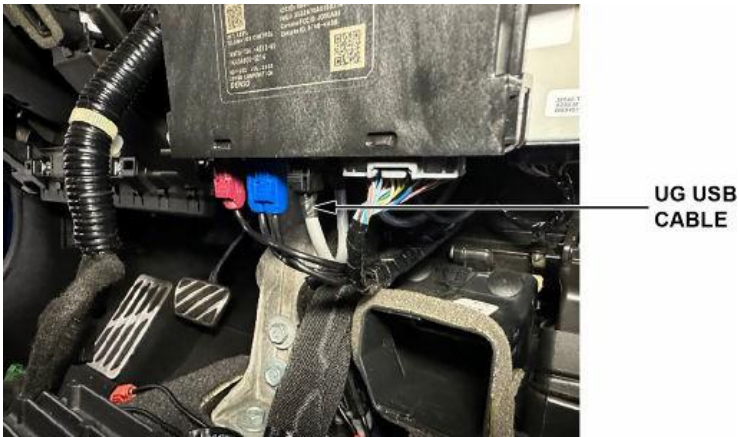
2. Disconnect the gray UG USB cable from the telematics control unit and set the unit off to the side.

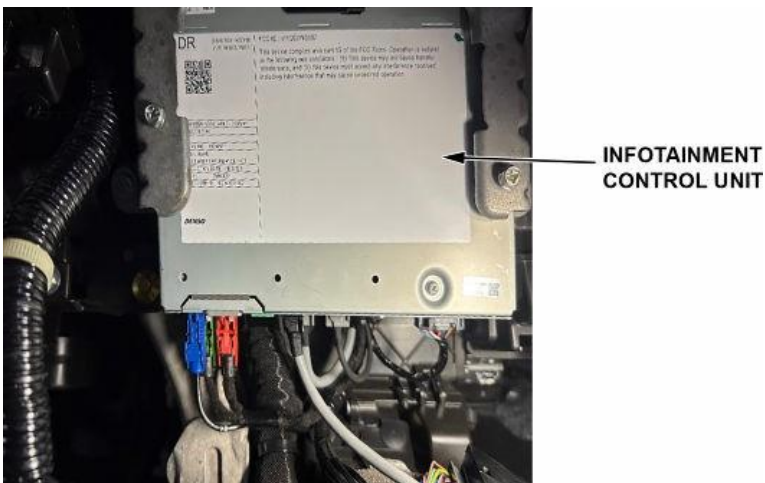
3. Disconnect the red and green FAKRA connectors and any other related connectors at the infotainment control unit.
NOTE: Disassemble the connectors one at a time to avoid swapping the green and red wires.

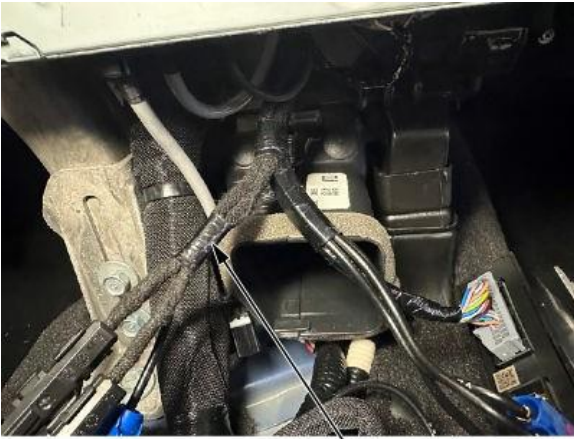
5. Carefully cut and remove the harness tape.

Cut and remove tape.

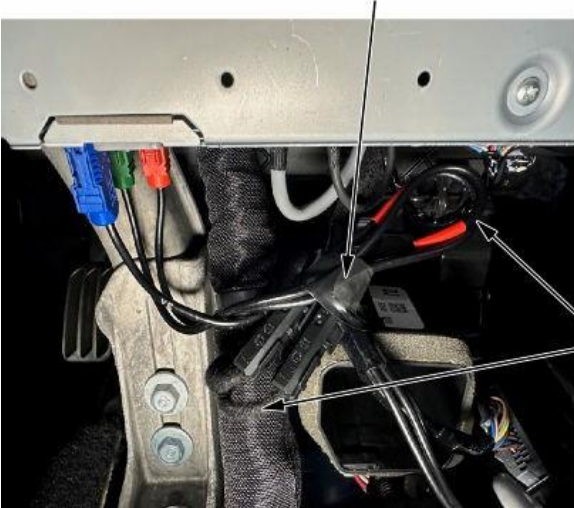
6. Tape both FAKRA splice repair cables and splice boxes to the infotainment control unit harness.

Attach the FAKRA service cables and splice boxes to the appropriate component harness with tape to prevent any rattles.

Keep smooth curves with a radius bend greater than 25 mm.

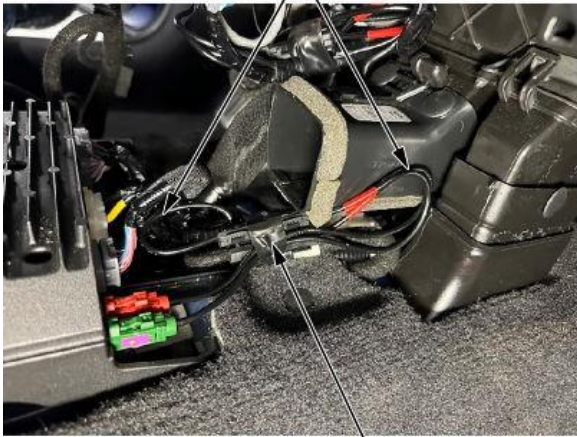
3. Tape both FAKRA splice repair cables and splice boxes to the stereo amplifier harness.

Keep smooth curves with a radius bend greater than 25 mm.

Attach the FAKRA service cables and splice boxes to the appropriate component harness with tape to prevent any rattles.

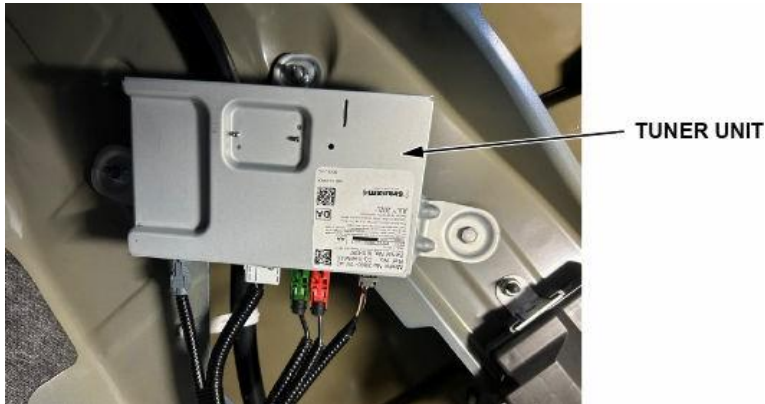
1. Disconnect the red and green FAKRA connectors at the tuner unit.

Disassemble the connectors one at a time to avoid swapping the green and red wires.

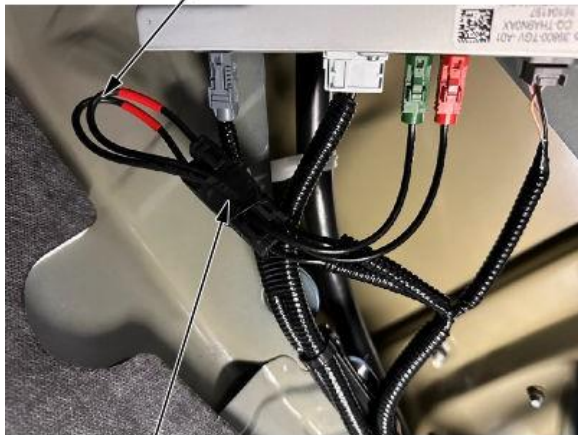
Keep smooth curves with a radius bend greater than 25 mm.

Attach the FAKRA service cables and splice boxes to the appropriate component harness with tape to prevent any rattles.
