December 18, 2024

Version 2

Warranty Extension: 2022–24 MDX Popping/Crackling from the Speakers; Display Blank

Year	Model	Trim Level	VIN Range
2022–24	MDX	ALL	ALL

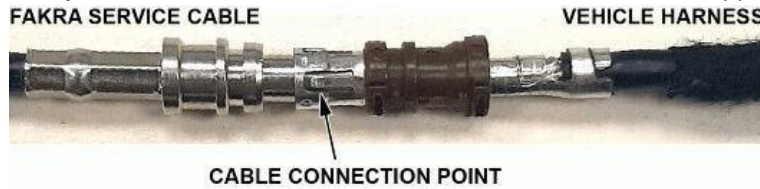
- Connect the appropriate color FAKRA splice repair service cable to the vehicle harness.

- Make sure the FAKRA service cable is inserted straight into the vehicle harness terminal to avoid damage at the cable connection point.
- Always disassemble the connectors one at a time to avoid swapping the green and red wires.

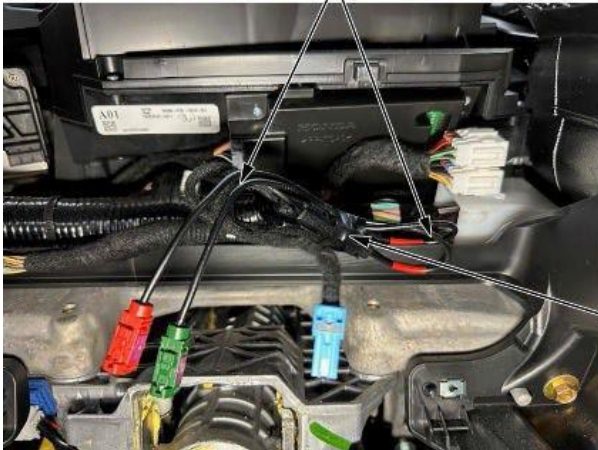
- Once the FAKRA splice repair service cables and splice boxes have been attached to the cable connection, tape the splice boxes and FAKRA service cables to the appropriate component harness.

Keep smooth curves with a radius bend greater than 25 mm.

Attach the FAKRA service cables and splice boxes to the appropriate component harness with tape to prevent any rattles.

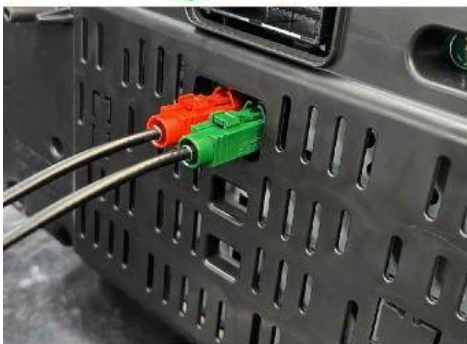
CORRECT ✓

NOTE: Make sure the FAKRA splice repair service cables are not bent at the connector(s), as shown below.

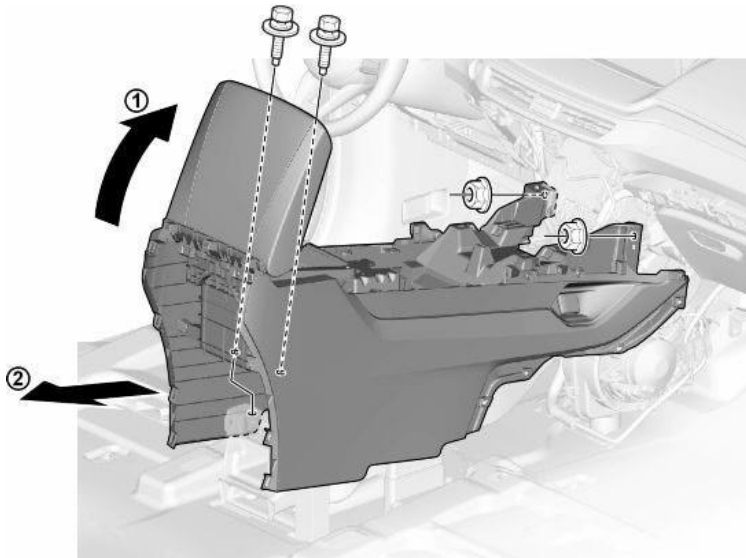
NOTE: Before removing the center console make sure the following is disconnected:

1. Passenger side 12-volt power supply
2. Console storage compartment 12-volt power supply, USB port, and the storage compartment light
3. Storage compartment harness fasteners that ran up the dash located on the driver's side of the console

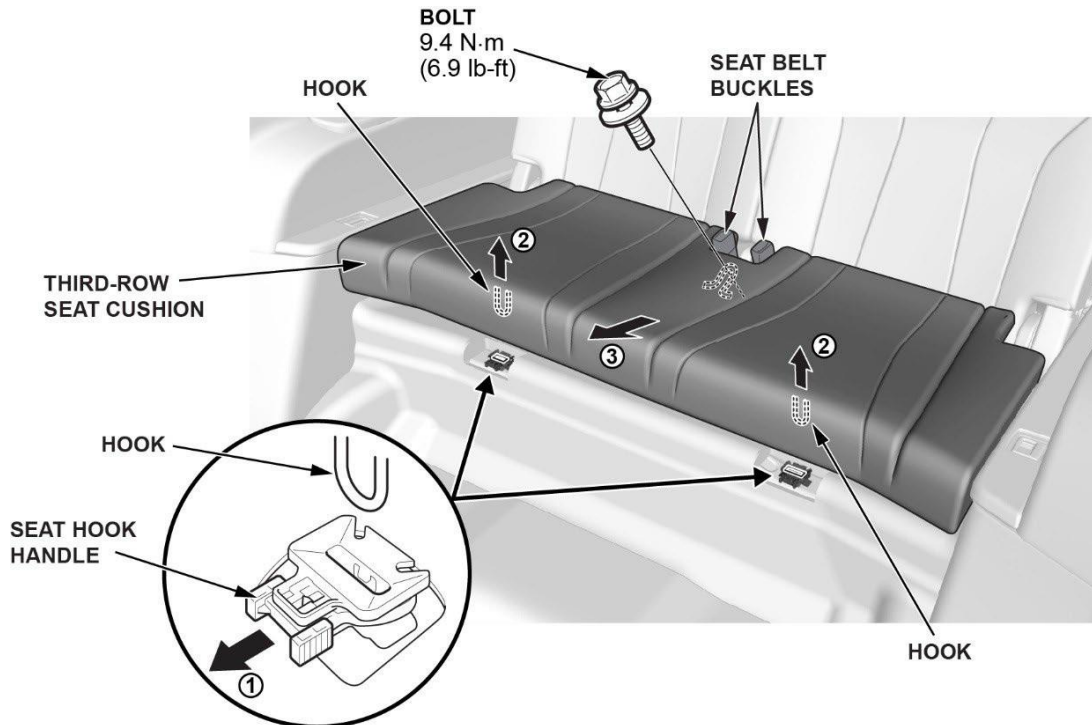
6. Do the following steps to remove seat cushion:

1. Remove the bolt.
2. While pushing down on the third-row seat cushion, pull the seat hook handles to release the hooks.
3. Pull the third-row cushion forward to remove.

7. Pull back the third-row seat cushion to pull off the seat belt buckles from the slits in the third-row seat cushion, then pull it forward (#3 in above image).

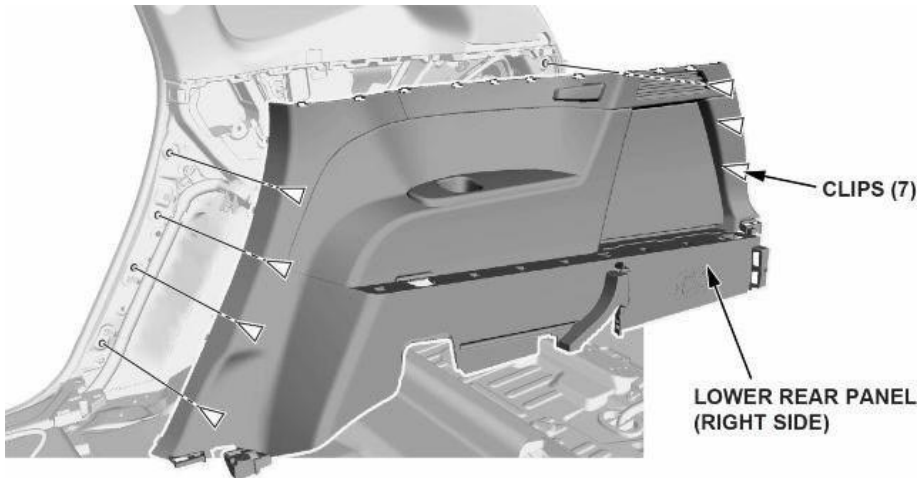
9. Remove the right side lower rear panel.

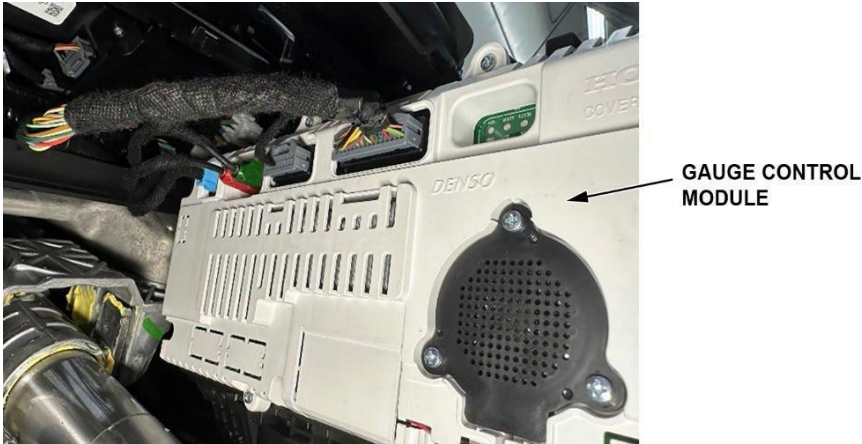
1. Locate and turn the gauge control module to access the rear connectors.

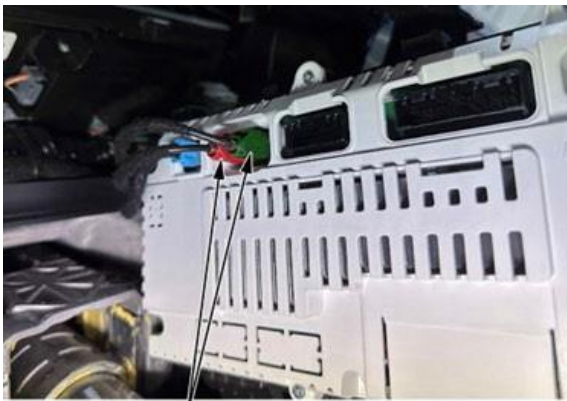
FAKRA CONNECTORS

2. Disconnect the red and green FAKRA connectors and any other related connectors from the gauge control module.

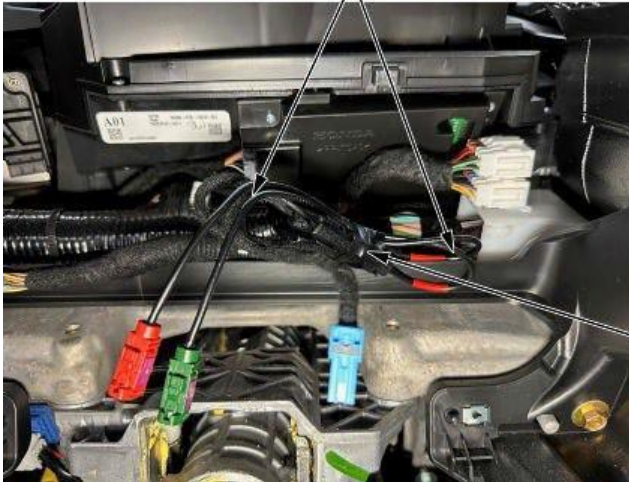
4. Tape both FAKRA splice repair cables and splice boxes to the gauge control module harness.

Keep smooth curves with a radius bend greater than 25 mm.

Attach the FAKRA service cables and splice boxes to the appropriate component harness with tape to prevent any rattles.

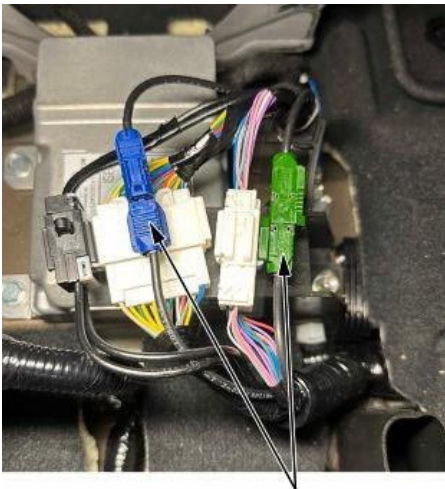
IN-LINE CONNECTORS

1. Disconnect the blue and green FAKRA connectors at the center console.

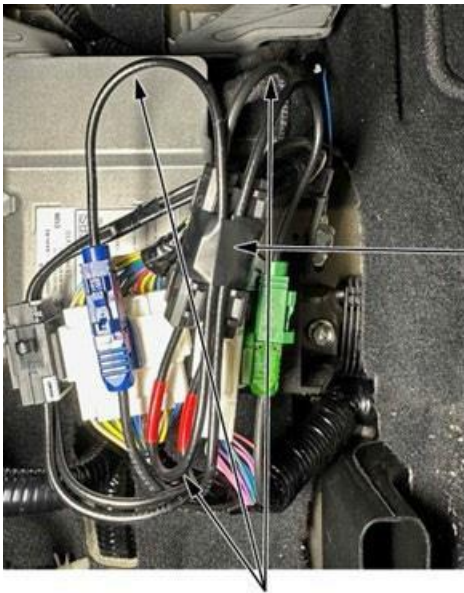
3. Tape the blue and green FAKRA splice cables and splice boxes to the in-line harness.

Attach the FAKRA service cables and splice boxes to the appropriate component harness with tape to prevent any rattles.

Keep smooth curves with a radius bend greater than 25 mm.

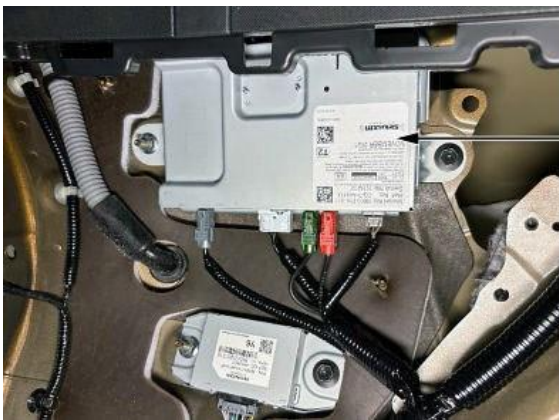
TUNER UNIT

1. Disconnect the red and green FAKRA connectors at the tuner unit.

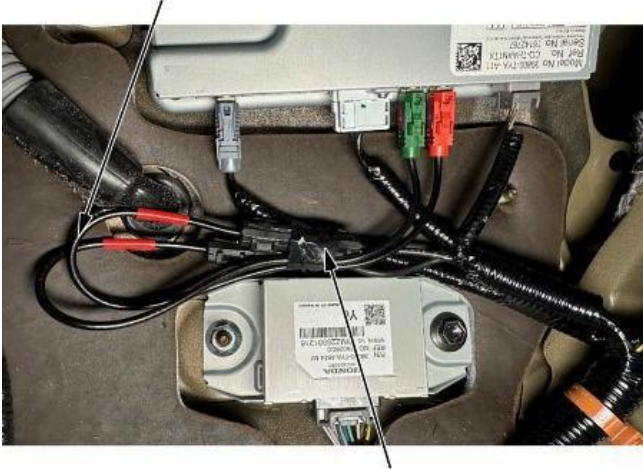
3. Tape both FAKRA splice repair cable and splice boxes to the in-line harness.

Keep smooth curves with a radius bend greater than 25 mm.

Attach the FAKRA service cables and splice boxes to the appropriate component harness with tape to prevent any rattles.

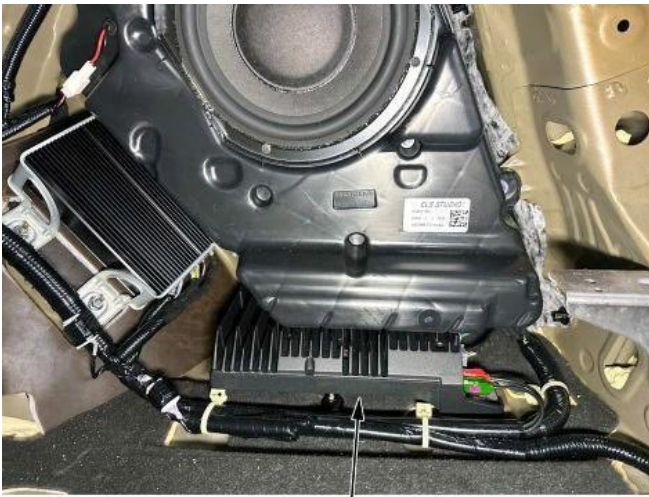
STEREO AMPLIFIER

1. Disconnect the red and green FAKRA connectors at the stereo amplifier.

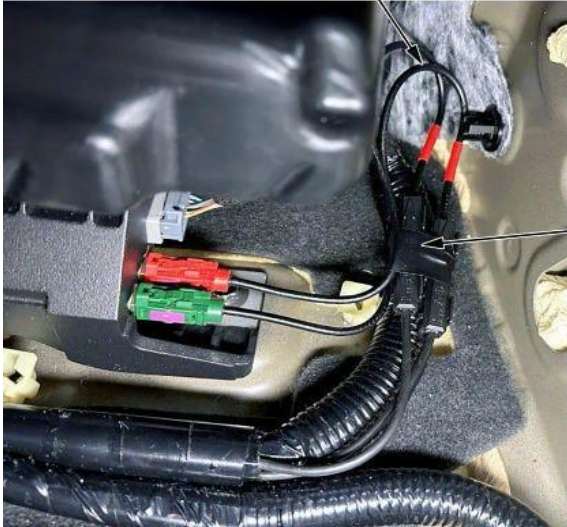
Keep smooth curves with a radius bend greater than 25 mm.

Attach the FAKRA service cables and splice boxes to the appropriate component harness with tape to prevent any rattles.
