# Service Bulletin

Bulletin No.: 24-NA-257

**Subject: Rear Seat Belt Bezel Falls Off**

Brand:	Model:	Model Year:		VIN:		Engine:	Transmission:
		from	to	from	to		
GMC	HUMMER EV Pickup	2024	2025	-	-	All	All
	HUMMER EV SUV

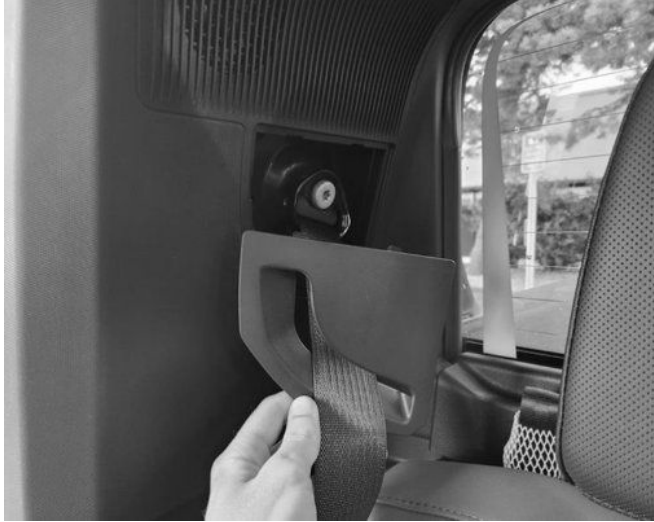
<p style="text-align: right; font-size: small;">6764570</p> <p>A customer may notice that the rear seat belt bezel may pop off while pulling on the seat belt to strap in.</p>
<b>Cause</b>	The seat belt bezel may not be properly retained to the trim.
<b>Correction</b>	Dealers will be directed to add felt tape to both C-pillar trim panels to ensure the seat belt bezel stays attached.
