FLEET CHECK

ISSUE DATE:	12/8/2022
SERVICE BULLETIN SUBJECT:	Grayson Hinge Fleet Check
VINs or MODELS AFFECTED:	Service Specified Buses
COMPLETE BY:	Next Service Opportunity
SERVICE BULLETIN #:	SC-22-167
LABOR OPERATION CODE:	CB45Z

GRAYSON HINGE FLEET CHECK

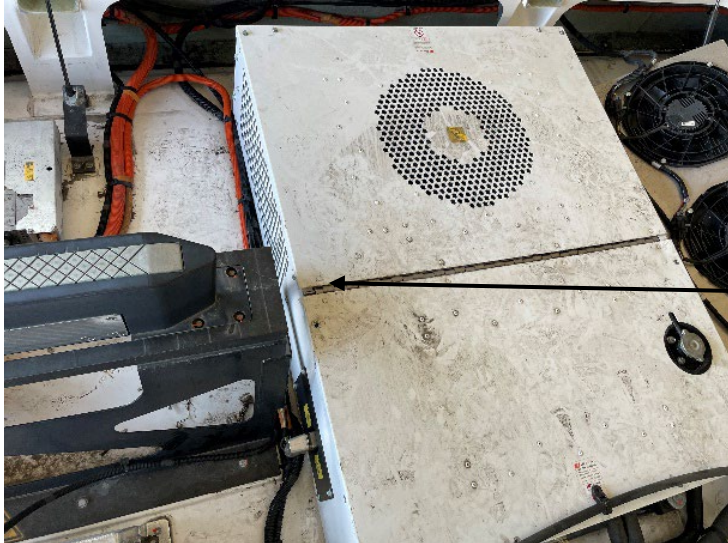
Hinge Pin

1. Use the Proterra approved Lockout/Tagout procedure to make the bus safe for work.
2. Using the Proterra and Transit Agency specific procedures, safely access the rooftop of the bus to inspect the Grayson unit.

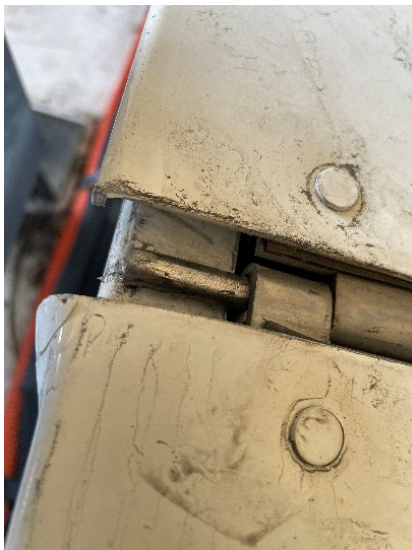
3. Inspect the Hinge Pin on the Grayson Hinge. If the hinge pin appears as shown in the following photograph, it must be modified. This photograph shows the end of the hinge pin nearest the charge blade.

4. If the hinge pin is not bent as shown in the previous photograph, using Lineman's Pliers, pull the hinge pin outward and bend the last half inch of the pin to a 90-degree angle. The bend should be made on the end of the pin farthest from the charge blade.

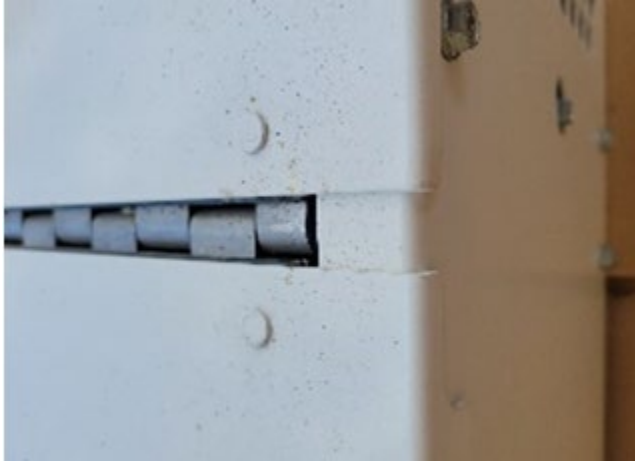
- Using Lineman's Pliers, push the hinge pin back in until the 90-degree bend is flush with the Grayson unit. Remove and reinstall the side panels as necessary to ensure the hinge pin is fully contained inside the enclosure as shown in the following photograph.

- Close the Grayson Unit doors.
- Safely exit the rooftop of the bus.
- Remove the Lockout/Tagout devices and return the bus to service.
