<b>HYUNDAI</b> <b>Technical Service Bulletin</b>	<b>GROUP</b> <b>ENGINE MECHANICAL</b>	<b>NUMBER</b> <b>25-EM-001H</b>
	<b>DATE</b> <b>JANUARY 2025</b>	<b>MODEL(S)</b> <b>TUCSON (LM)</b>
<b>SUBJECT:</b> CENTER MUFFLER ASSEMBLY REPLACEMENT (WARRANTY EXTENSION TXXZ)

**Description:** Certain Tucson (LM) vehicles may have a weakened weld at the zone where the center muffler is attached to the exhaust pipe. This condition may cause the center muffler to detach from the exhaust pipe.

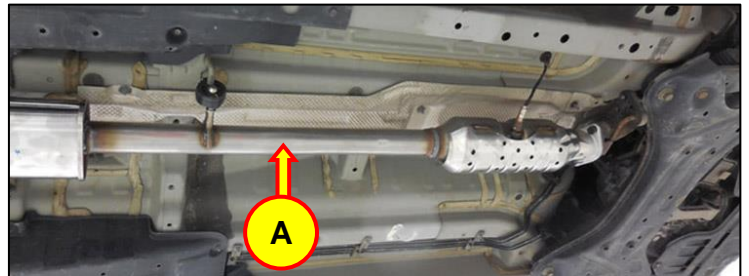
1. Lift the vehicle on a hoist and refer to the Shop Manual to remove the center muffler (A) from the vehicle.
  - **Engine Mechanical System > Intake and Exhaust System > Muffler > Repair Procedures**

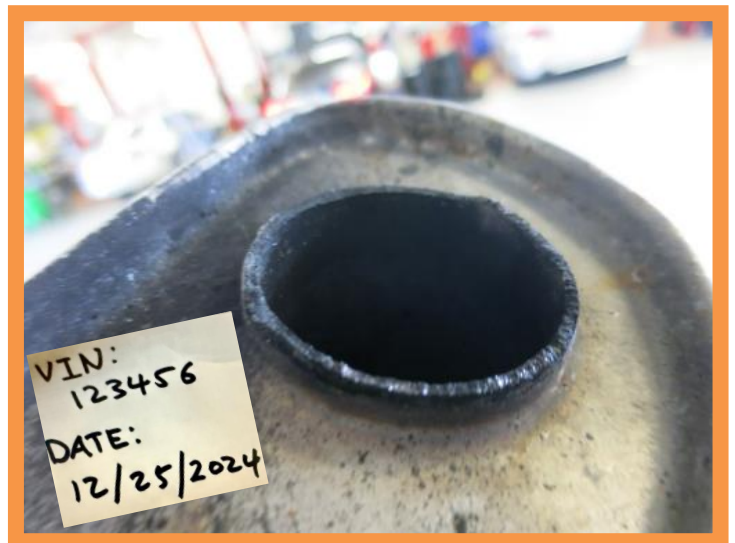
- Take a STUI photo of the detached or weakened muffler section of the assembly.

Using STUI, take a photo of the weakened welding area where the center muffler is attached to the exhaust pipe along with the last 6 digits of the VIN and date of repair on a piece of paper. Upload the photo to STUI.

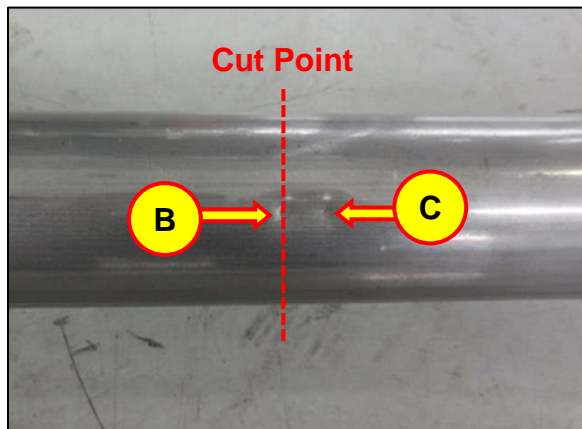
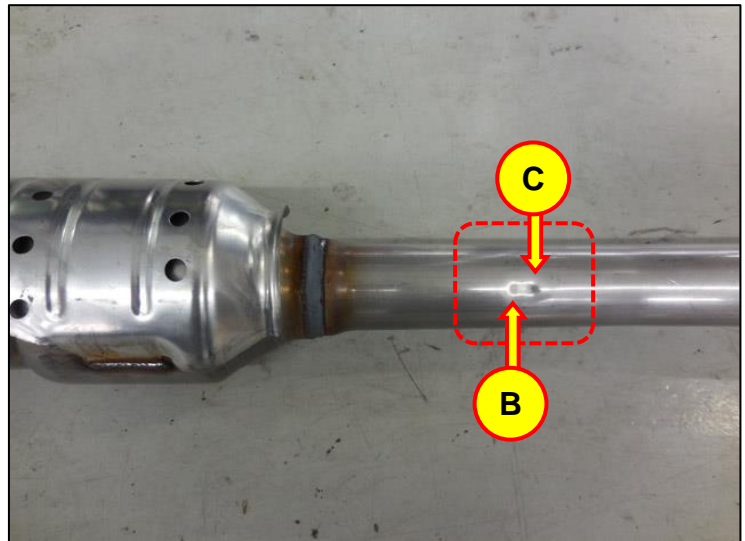
2. Locate the front dent (B) and rear dent (C) of the center muffler pipe for cutting at point (B).

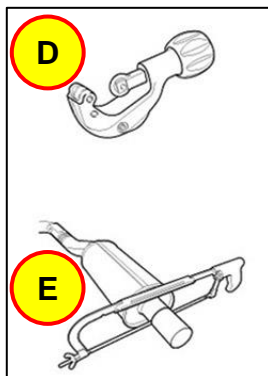
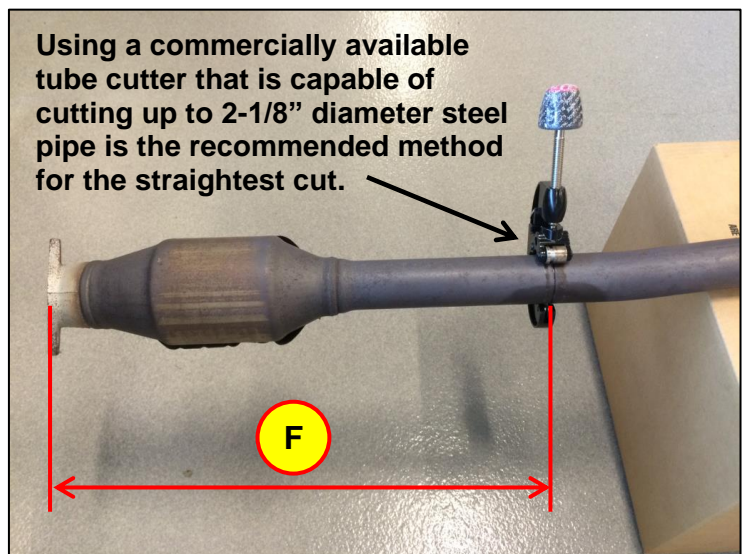
3. Cut the center muffler pipe perpendicular to the front dent (B) cutting point.
- Retain the cut portion with the catalyst (F) to be reused with the new center muffler.

Mark the circumference of the pipe and cut the pipe by using a pipe cutter (D), a hack saw (E), or equivalent.

Using a commercially available tube cutter that is capable of cutting up to 2-1/8" diameter steel pipe is the recommended method for the straightest cut.

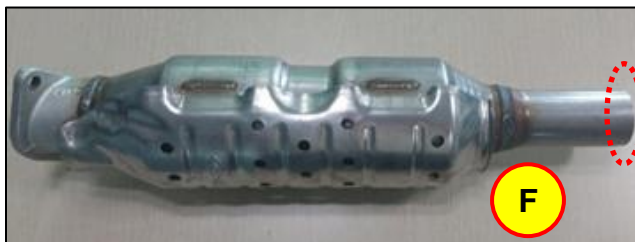
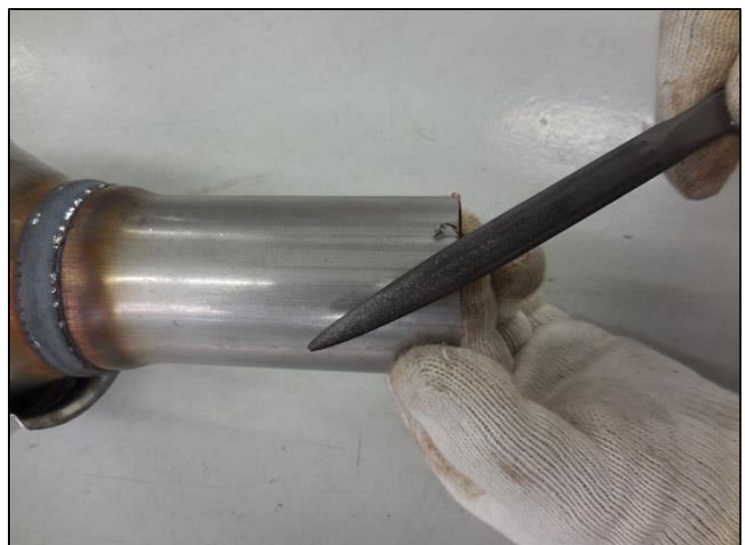
4. Deburr the cut edge of the pipe at the rear portion of the catalyst (F) using a metal file.

Do not allow any foreign material to enter inside the catalyst pipe.

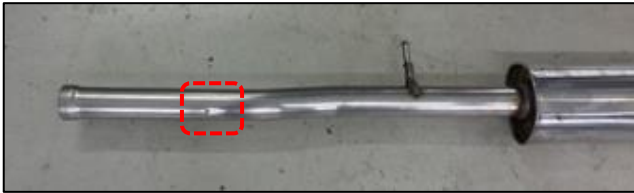
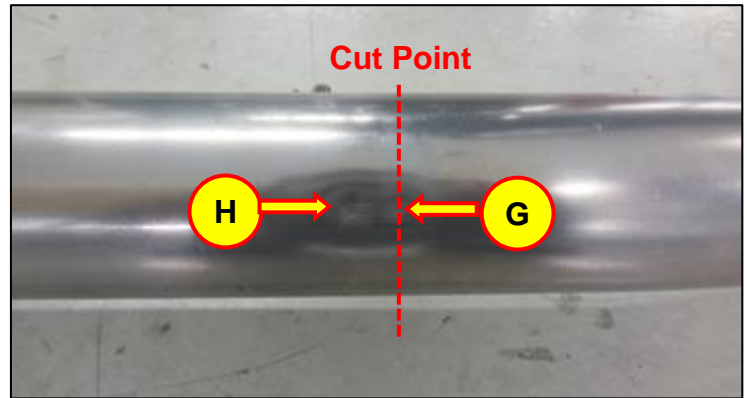
5. Locate the front dent (H) and rear dent (G) of the new replacement campaign center muffler pipe for cutting at rear dent point (G).

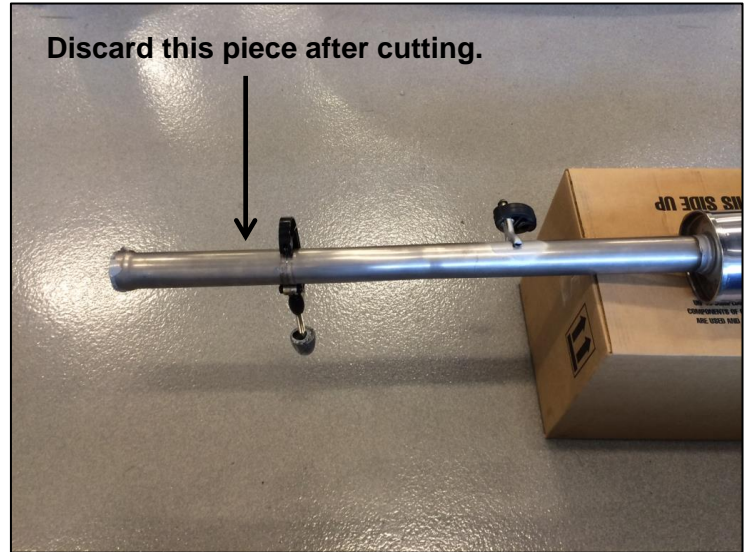
6. Cut the new replacement center muffler pipe perpendicular to the rear dent (G) cutting point.
- Discard the short cut off portion of the new center muffler.
  - Deburr the cut edge of the pipe at the front portion of the replacement center muffler pipe.

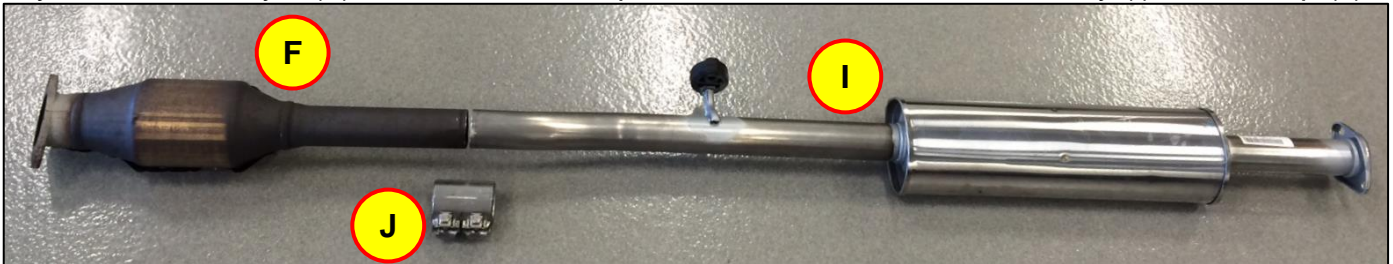
Layout of the catalyst (F), shortened new replacement center muffler assembly (I), and clamp (J).

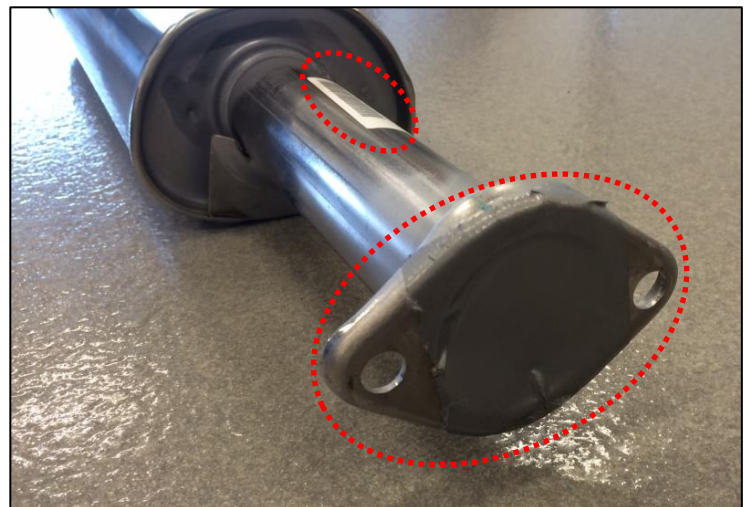
Remove any sticker labels and protective covering tape from the new replacement center muffler assembly prior to installation.

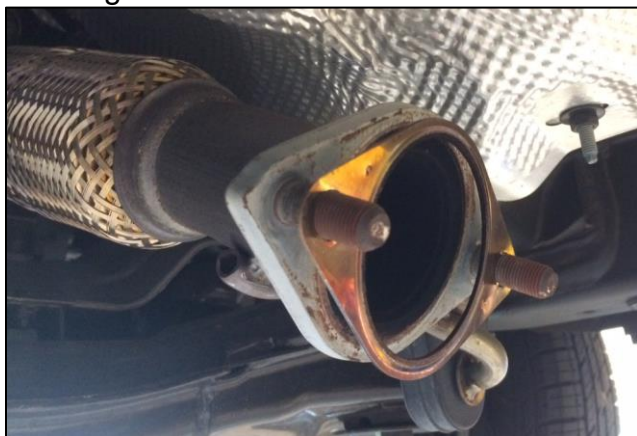
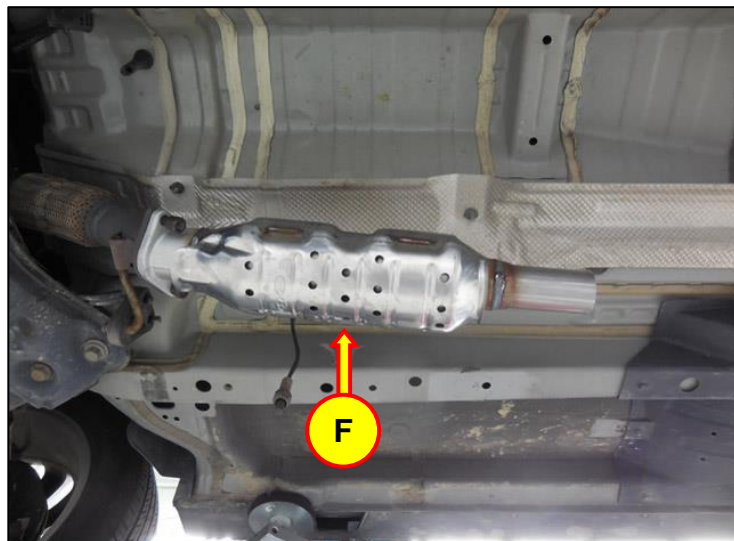
7. Replace the front flange gasket and install the catalyst (F), then temporarily hand tighten the flange nuts.

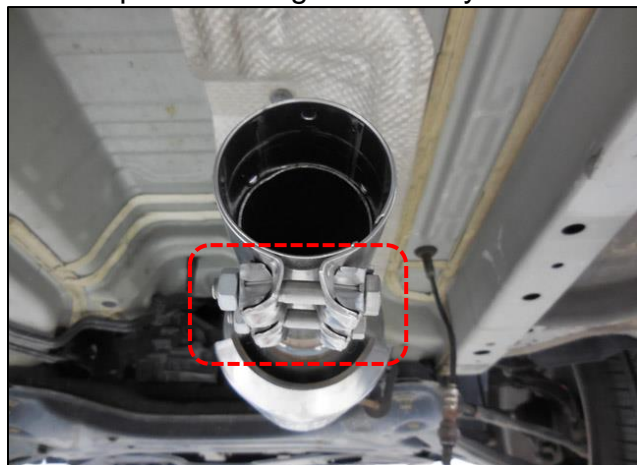
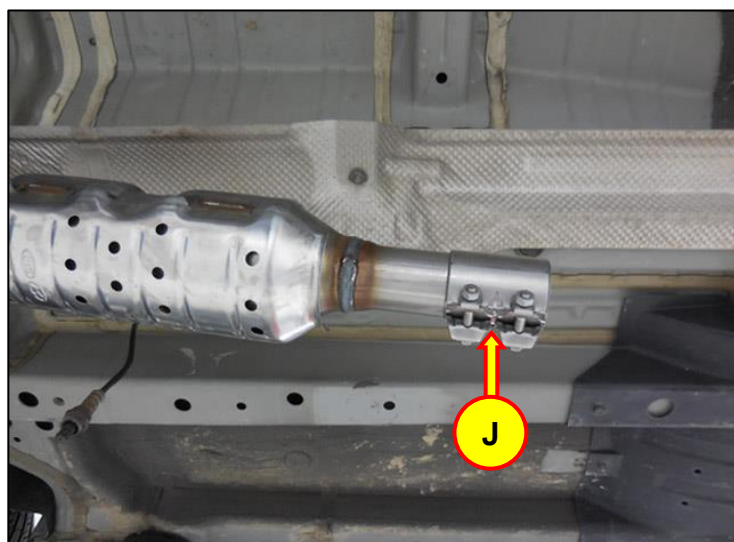
8. Install the clamp (J) to the catalyst pipe with the clamp bolts facing horizontally.

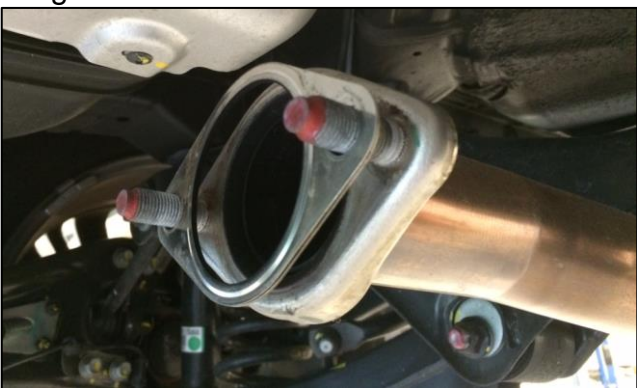
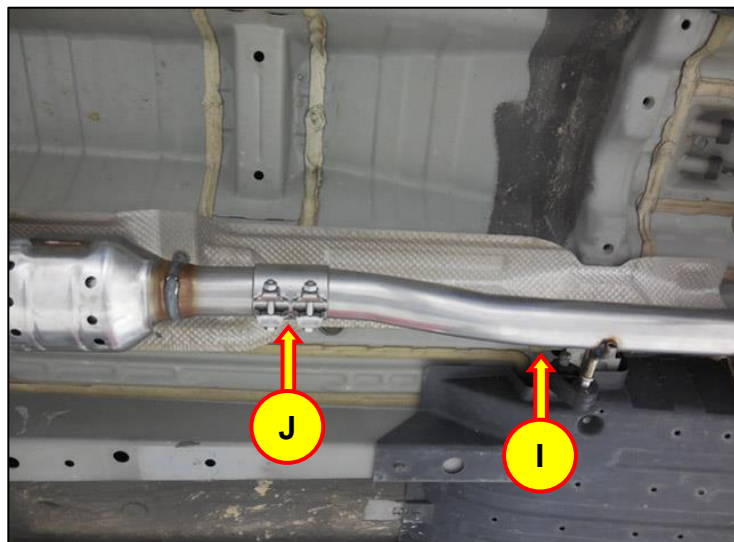
9. Replace the rear flange gasket and install the new replacement center muffler (I) to the clamp (J), then temporarily hand tighten the flange nuts.

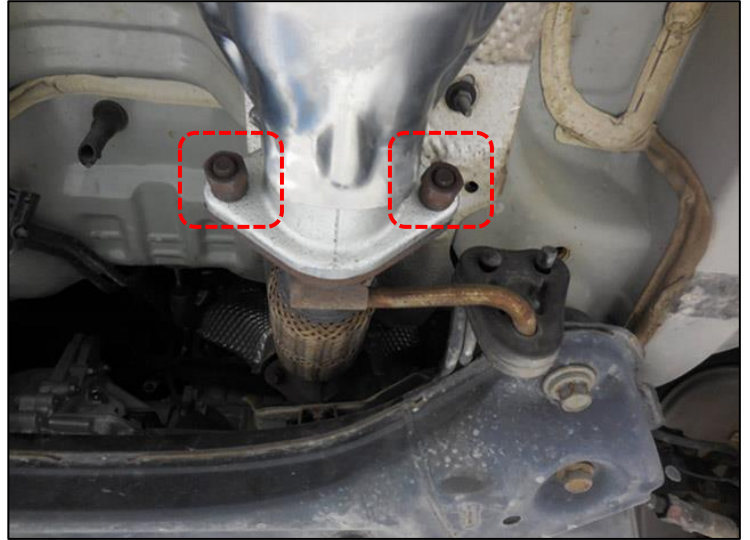
10. Tighten the front flange mounting fasteners of the center muffler catalyst.

- **Tightening torque: 49 Nm (36 lb-ft)**

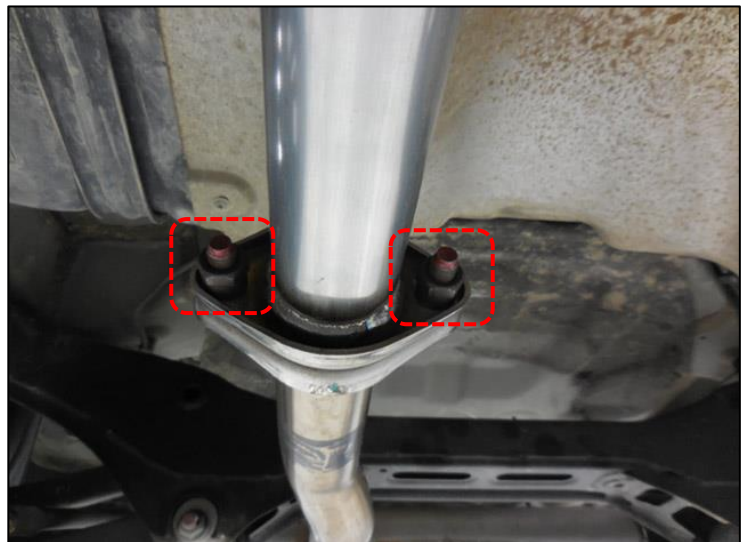
11. Tighten the rear flange mounting fasteners of the center muffler pipe.

- **Tightening torque: 49 Nm (36 lb-ft)**

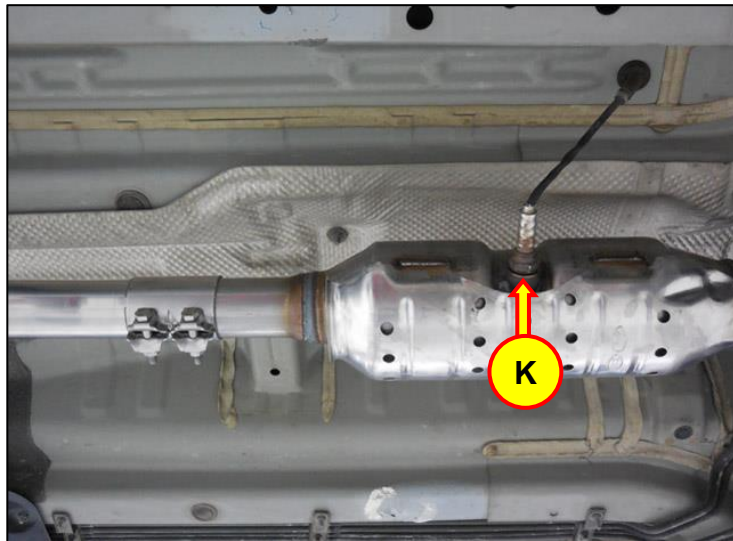
13. Reinstall the rear O2 sensor (K) to the catalyst (if applicable depending on engine and emission type).

- **Tightening torque: 22 Nm (16 lb-ft)**

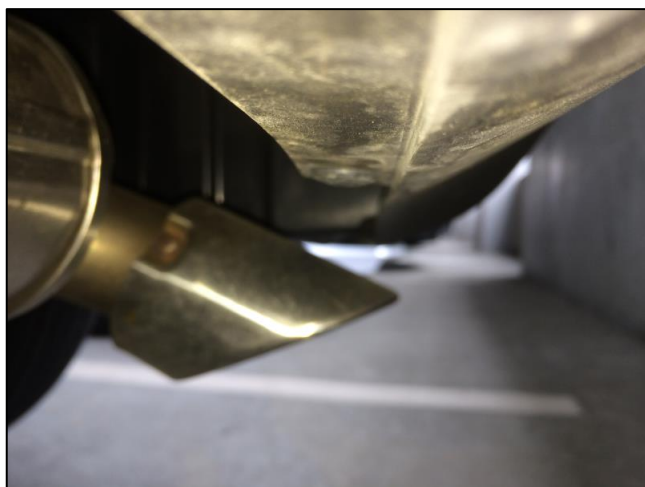
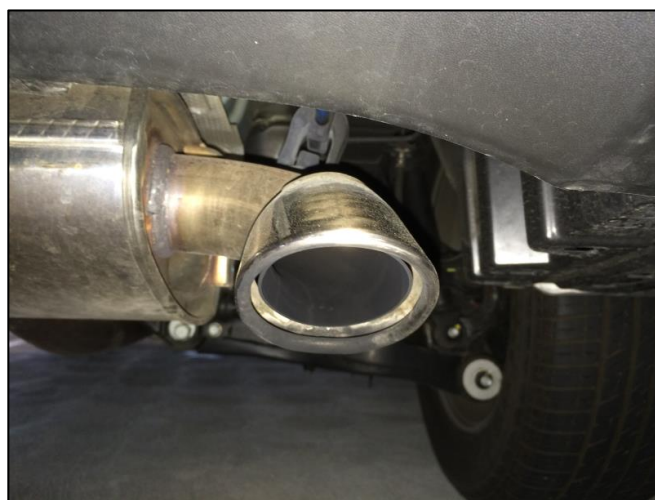
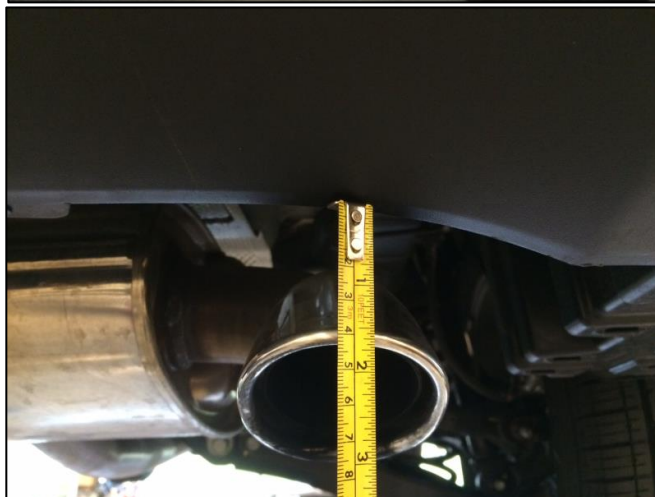
14. Verify repair.

- Check that there are at least 30mm of clearance between the rear bumper cover and the exhaust tip finisher.
- Operate the engine briefly to confirm that there is no exhaust leak and noise from the clamped pipe areas.
