SIB 51 19 24

EXTERIOR MIRROR GLASS STAINED/CLOUDY

E-Series	Model Description
G60	5 Series Sedan
G70	7 Series Sedan
G90	M5 Sedan

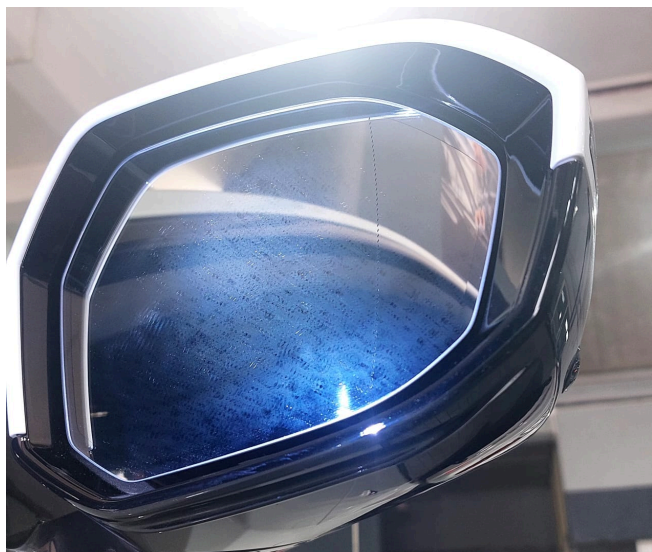
There is a matte “veil” or milky stain on the exterior mirror glass.

Passenger side mirror shown; situation can occur on either or both exterior mirrors.

Contamination from dirt and/or water calcium build up.

Clean and polish the mirror glass using a suitable glass cleaner/polish and a clean sponge.

1. Verify that the customer's concern is the issue stated above.
2. Clean and polish the glass using glass polish and a clean sponge.

Note: The glass can be polished without removal of exterior mirror assembly or glass.
