PROTERRA

FLEET CHECK

ISSUE DATE:	6/23/2022
SERVICE BULLETIN SUBJECT:	VROD Bracket Securement Inspection
VINs or MODELS AFFECTED:	Service Specified Buses
COMPLETE BY:	Next Service Opportunity
SERVICE BULLETIN #:	FC-22-75
LABOR OPERATION CODE:	SR42Z

VROD BRACKET SECUREMENT RETROFIT

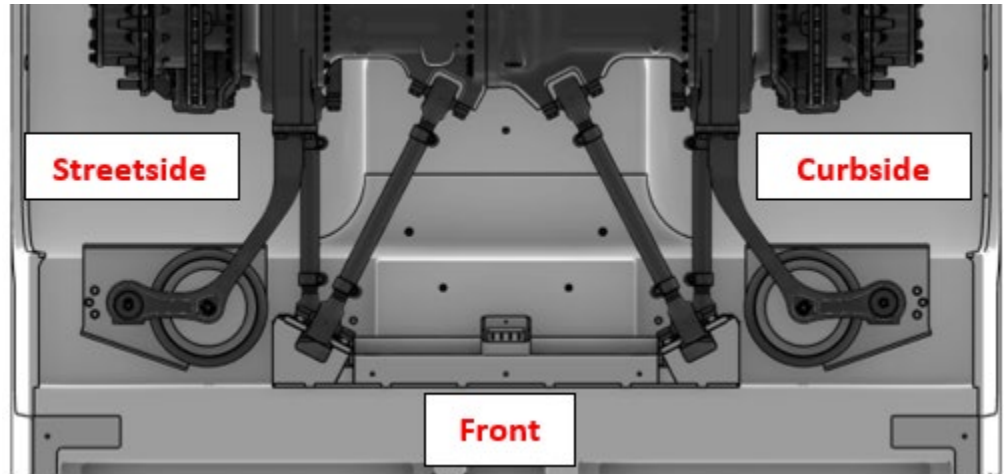
4. Using the following illustrations as a guide, take a photograph of each area of the bus.

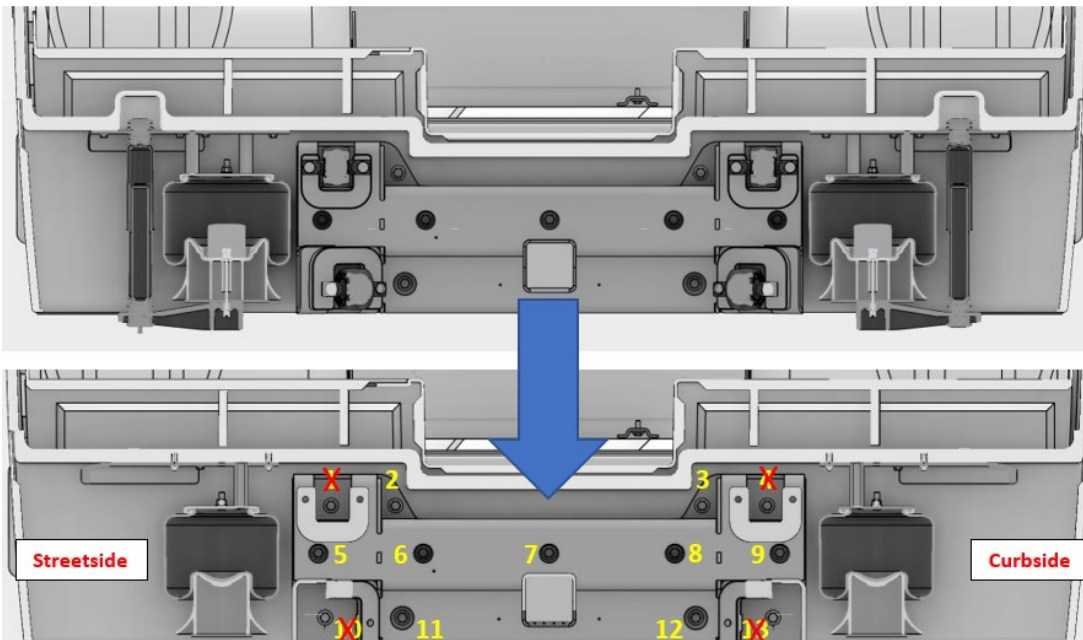
5. Using the following illustration as a guide, inspect the torque stripes on the suspension link bracket bolts.
