Paint Damage On Door Paneling In Area Of Door Handle

| Topic number | LI72.00-P-071544 |
| Function group | 72.00 - General |

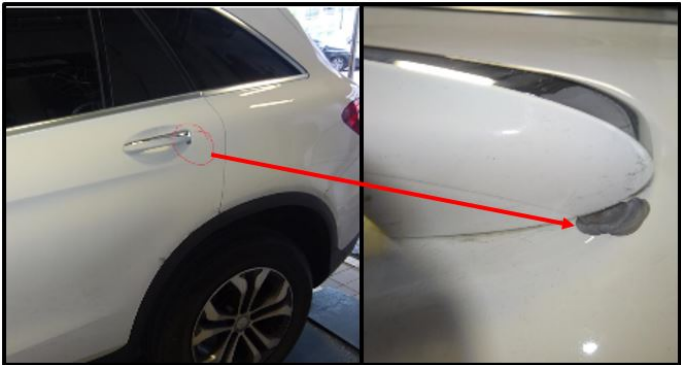
Paint damage on door paneling in area of door handle (see picture 1).

| Attachments | |
|---|---|
| Bild 1.JPG | Fault profile - rear door as example |

Alignment of door handle bearing bracket is not correct.

- 1. Paint the affected area of the door paneling using the spot repair procedure in accordance with the manufacturer's specifications.
- 2. Replace the door handle, ensuring that the door handle bearing bracket is installed correctly (see picture 2).

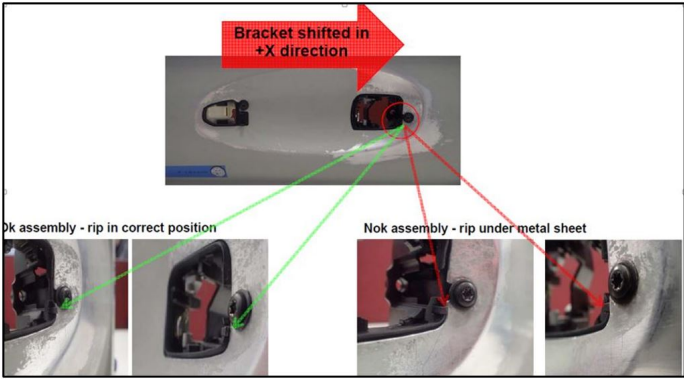
| Attachments | |
|---|---|
| <a href="#">Bild 2.JPG</a><br> | Installation of bearing bracket |

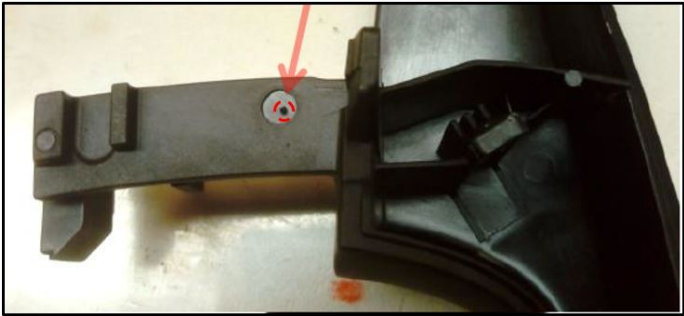
| Attachments | |
|---|---|
| <a href="#">Bild 3.JPG</a><br> | Marking - Optimized door handle |

Note: The optimized door handles are marked as shown in the illustration (see picture 3).
