<b>HYUNDAI</b> <b>Technical Service Bulletin</b>	GROUP <b>BODY</b>	NUMBER <b>25-BD-001HG</b>
	DATE <b>JANUARY 2025</b>	MODEL(S) <b>G80 (DH)</b>
<b>SUBJECT:                   DARK CHROME TRIM STAINED OR DISCOLORED</b>

**This TSB supersedes 19-BD-002HG to remove the cleaning procedure and revise the entire bulletin to instead replace the affected stained dark chrome trim.**

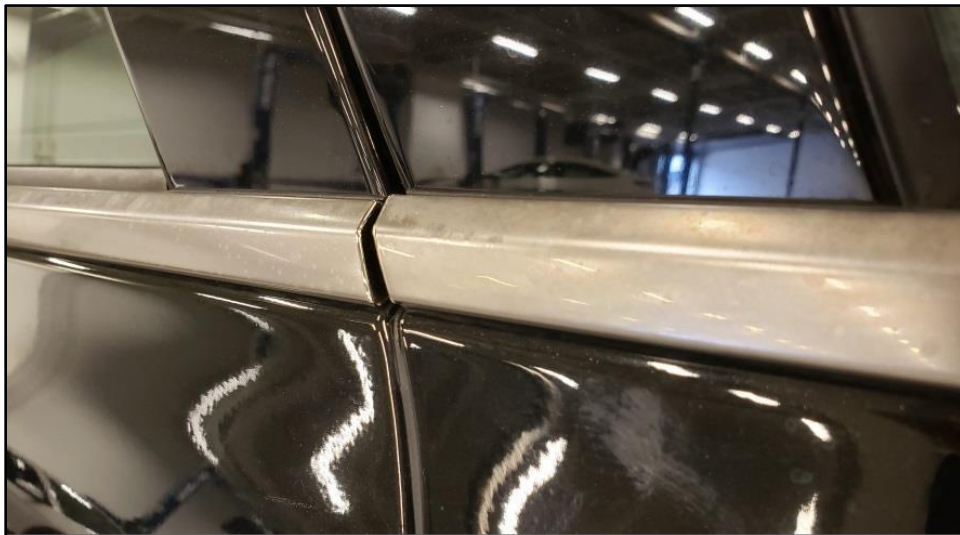
**Description:** This procedure provides repair information for the dark chrome trim when stains are present. Some stains may occur from hard water or cleaning chemicals used during a car wash. Follow the procedures below to replace the affected dark chrome moldings.

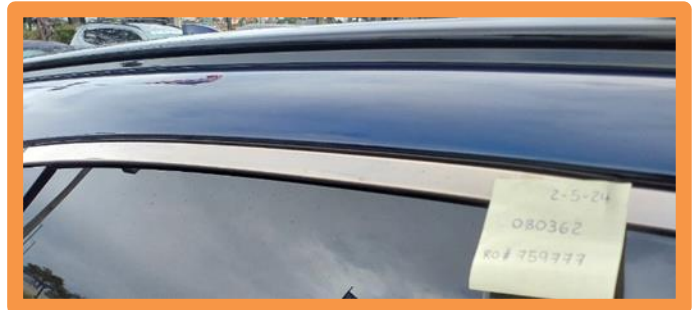
Using STUI, take photos of each stained/discolored dark chrome trim with the last 6 digits of the VIN and the date of repair on a piece of paper.

3. Replace each affected dark chrome trim.  
Refer to the applicable shop manual procedure for each part.
4. The service procedure is now complete.
