| <br><b>Technical Service Bulletin</b> | <b>GROUP</b><br><b>BODY</b> | <b>NUMBER</b><br><b>25-BD-001G</b> |
| <b>SUBJECT:</b> DARK CHROME TRIM STAINED OR DISCOLORED | | |

This TSB supersedes 22-BD-008G to remove the cleaning procedure and revise the entire bulletin to replace the affected stained dark chrome trim.

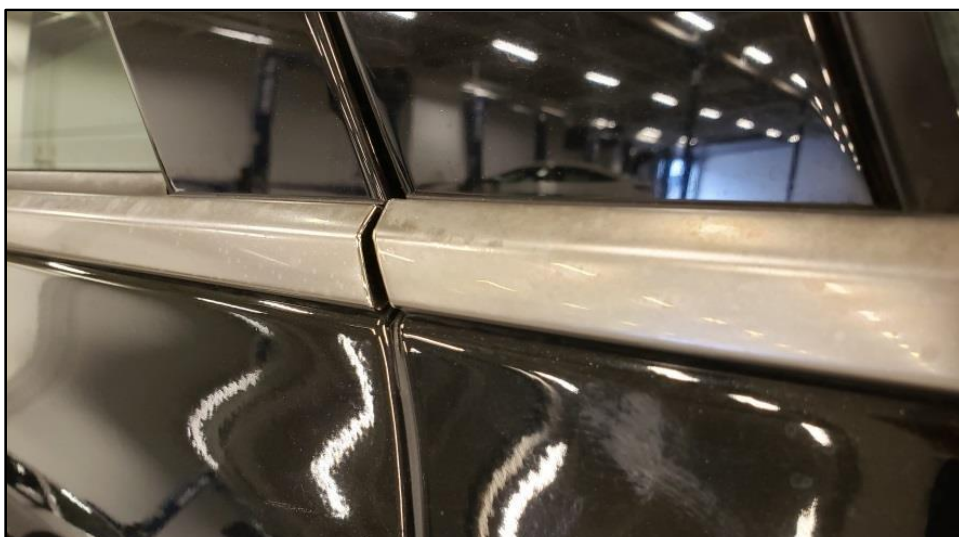
**Description:** This procedure provides repair information for the dark chrome trim when stains are present. Some stains may occur from hard water or cleaning chemicals used during a car wash. Follow the procedures below to replace the affected dark chrome moldings.

3. Replace each affected dark chrome trim.

Refer to the applicable shop manual procedure for each part.
4. The service procedure is now complete.

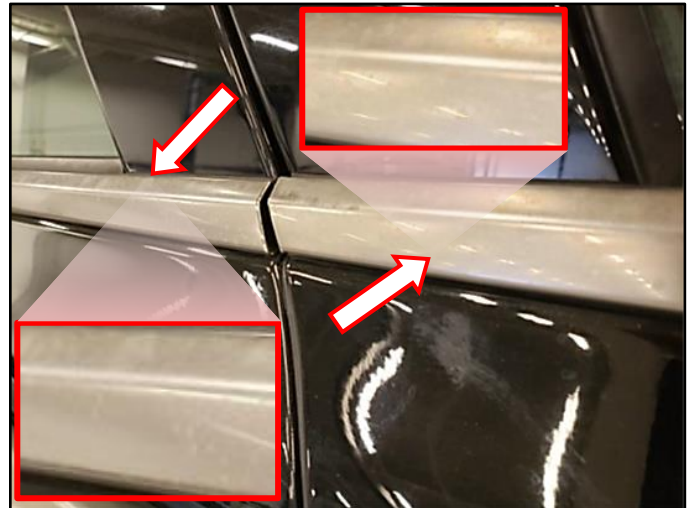
1. Inspect all exterior chrome surfaces on the vehicle to confirm which trim pieces have stains.

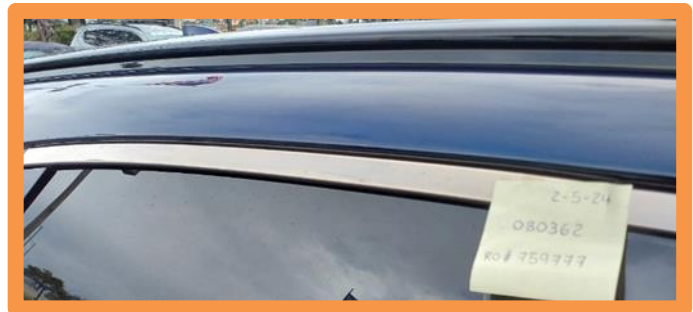
Using STUI, take photos of each stained/discolored dark chrome trim with the last 6 digits of the VIN and the date of repair on a piece of paper.

Upload the photos to STUI.
