# FLEET CHECK

<b>Subject</b>	DuoPower DC Link Fleet Check
<b>Issue Date</b>	12/05/2024
<b>Service Bulletin Number</b>	SC-24-020
<b>Models Affected</b>	Service Specified Vehicles
<b>Complete By</b>	Next Service Opportunity
<b>Labor Operation Code</b>	PE50
<b>Description</b>	Visual inspection of the DC Link cables located on top of the DP axle to ensure all split blocks and swivel bundle spacers are installed.

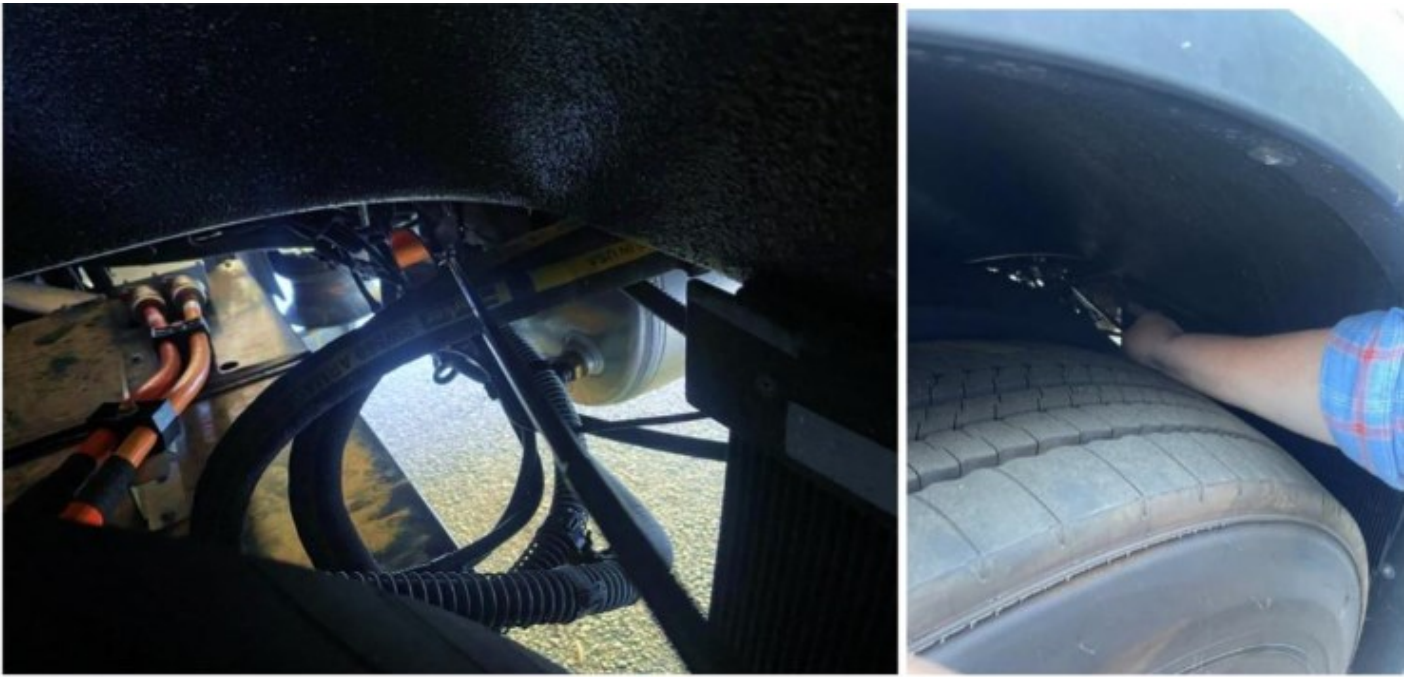
**Step 3:**

Over the top of the rear wheels using a inspection mirror or cell phone you will be able to see the top of the axle.

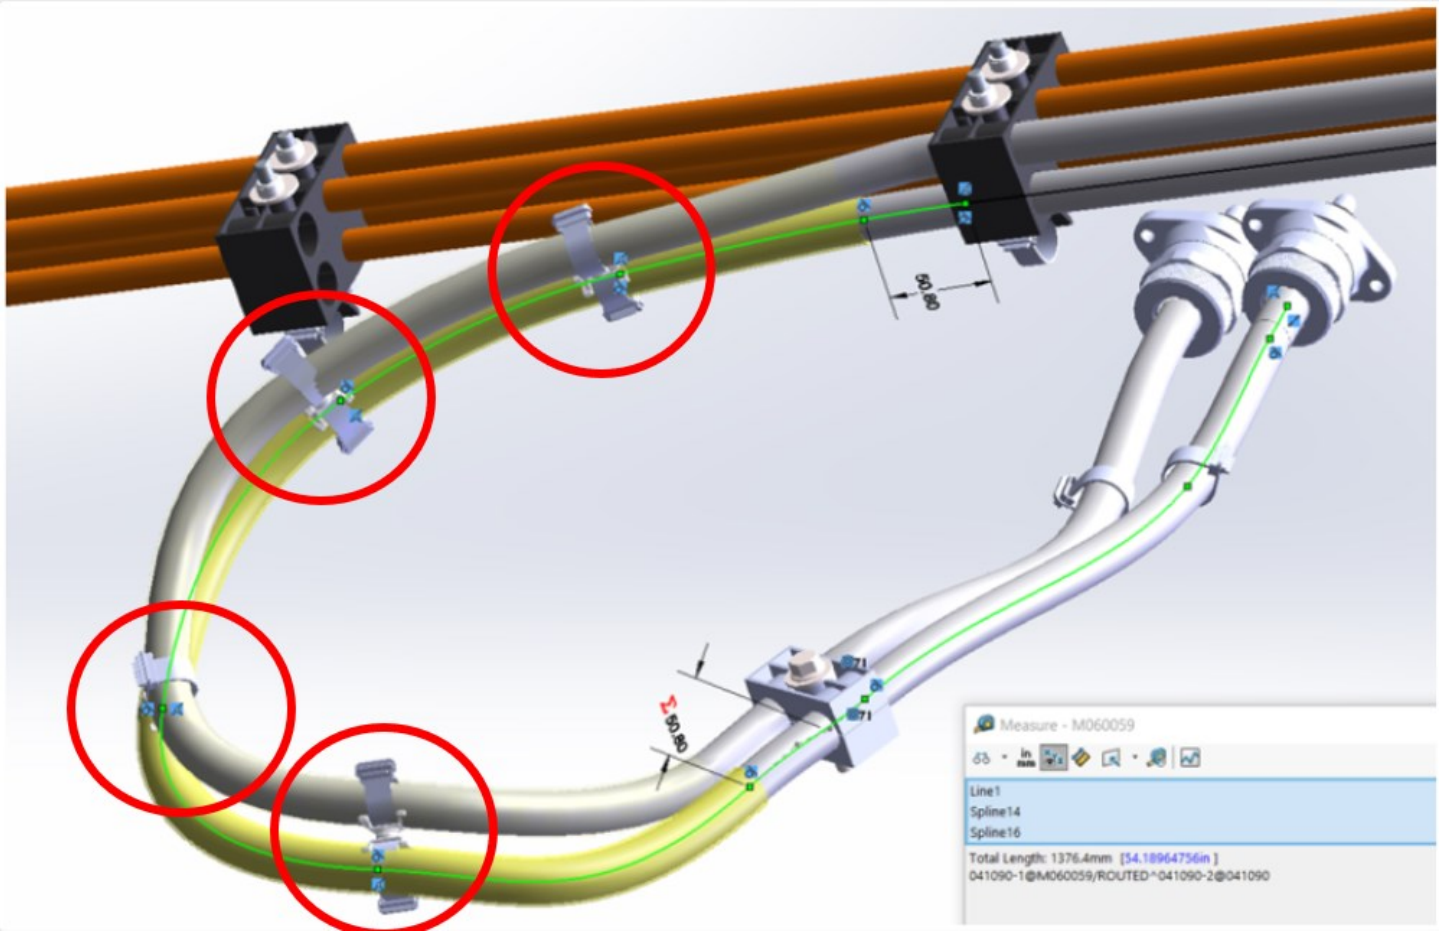
**Step 5:**

Inspect the 4 Swivel bundles to be installed circled below. The Swivel bundles should be holding both the positive and negative cables secured together.
