# TECHNICAL SERVICE BULLETIN

<b>ISSUE DATE:</b>	09/07/2023
<b>SERVICE BULLETIN SUBJECT:</b>	PP-1 Back Pressure Hadley Retrofit
<b>VINs or MODELS AFFECTED:</b>	Service Specified Buses
<b>COMPLETE BY:</b>	Next Service Opportunity
<b>SERVICE BULLETIN #:</b>	SC-23-158
<b>LABOR OPERATION CODE:</b>	BV47Z

## PP-1 Back Pressure Hadley Retrofit

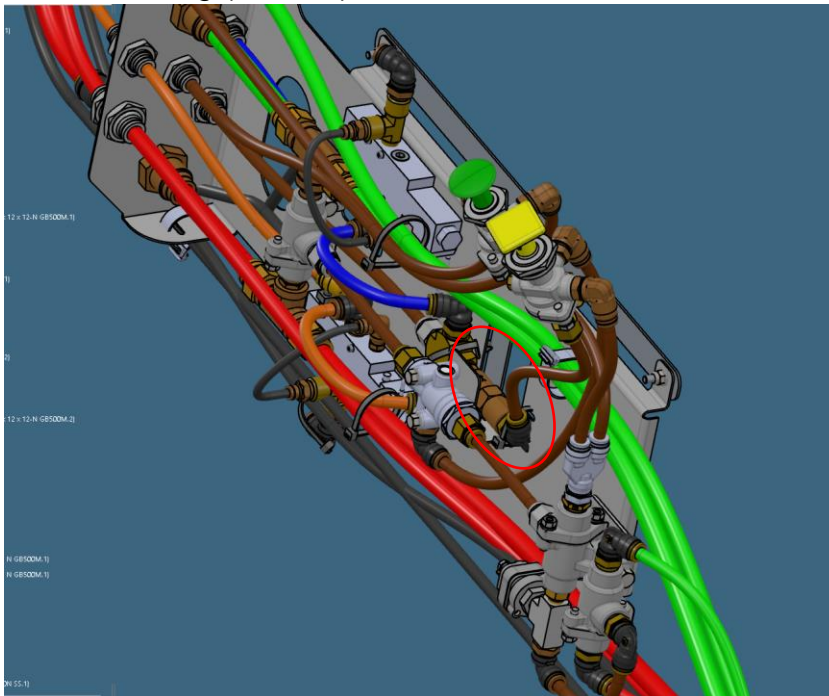
3. Disconnect the brown 3/8.-inch air line from the check valve shown in the following illustration. Install the Plug (003801) into the check valve as shown in the following illustration.

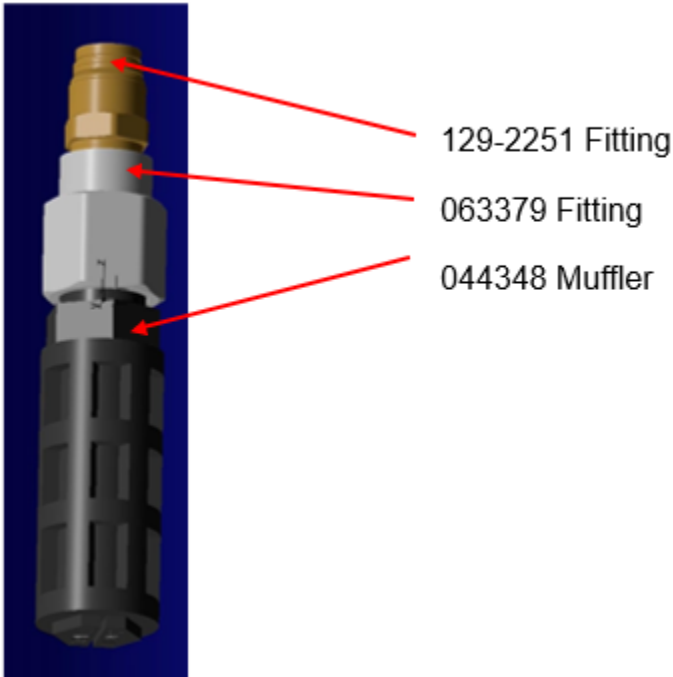
4. Assemble the parts as shown in the following illustration. Use Loctite 567 on the tapered threads.
