**PROTERRA**

| <b>SERVICE BULLETIN SUBJECT:</b> | Rooftop Cooling Fan Terminal Fleet Check |
| <b>SERVICE BULLETIN #:</b> | SC-21-103 |

### **ROOFTOP COOLING FAN TERMINAL RETROFIT**

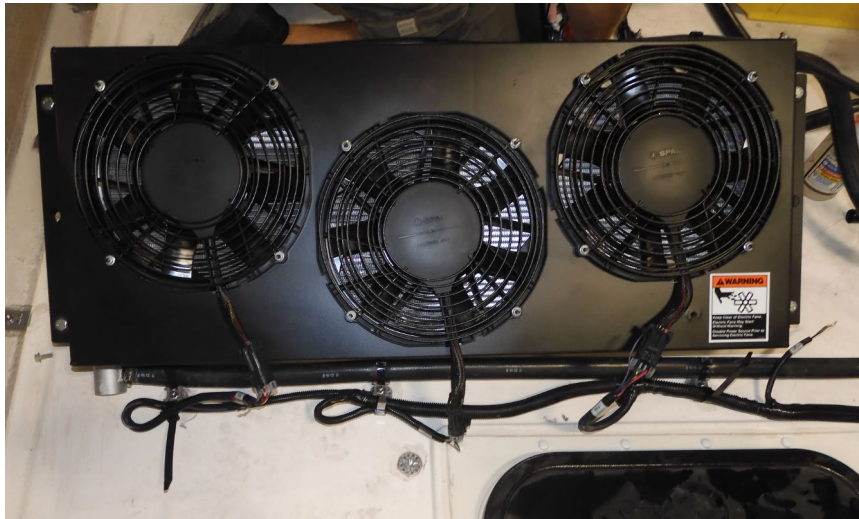
1. Complete the Proterra approved Lockout/Tagout procedure to make the bus safe for work.
2. Referencing the ServiceMax report for the bus that you are working on, determine the location of any damage to the Cooling Fan circuit.
3. Follow all the Proterra and Transit Agencies safety policies to safely access the rooftop of the bus if damage was found on the rooftop connectors. **If no rooftop repairs are required, proceed to Step 7.**
4. Working on the rooftop of the bus, locate the three-fan radiator shown in the following photograph.

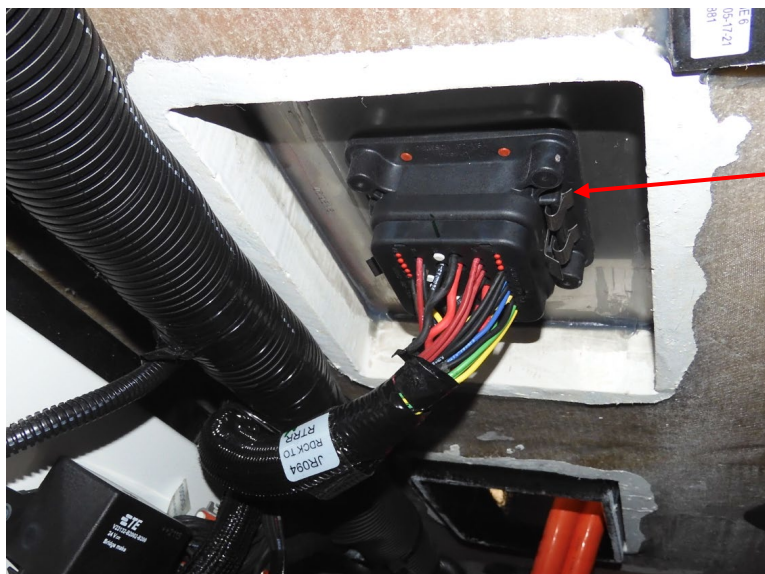
Metal Clip

7. If the ServiceMax report shows no damage to the Rear Deck connector and/or the Rear Deck VEC, proceed to Step 14.
8. Using a T-30 Torx Driver, remove any panels necessary to access the Rear Deck VEC and the Rooftop pass through at the rear of the bus.
9. Using a Small Flat Blade Screwdriver, retract the metal clips that secure the pass-through connector.
