All Vehicles Equipped with M139: CEL for P012800 - The coolant temperature is below the coolant thermostat specified temperature.

Topic number	LI20.10-P-076206
Version	22
Function group	20.10 - Coolant pump, coolant thermostat
Date	1/27/25
Validity	All vehicles with any version of M139 engine
Reason for change	Remedy change

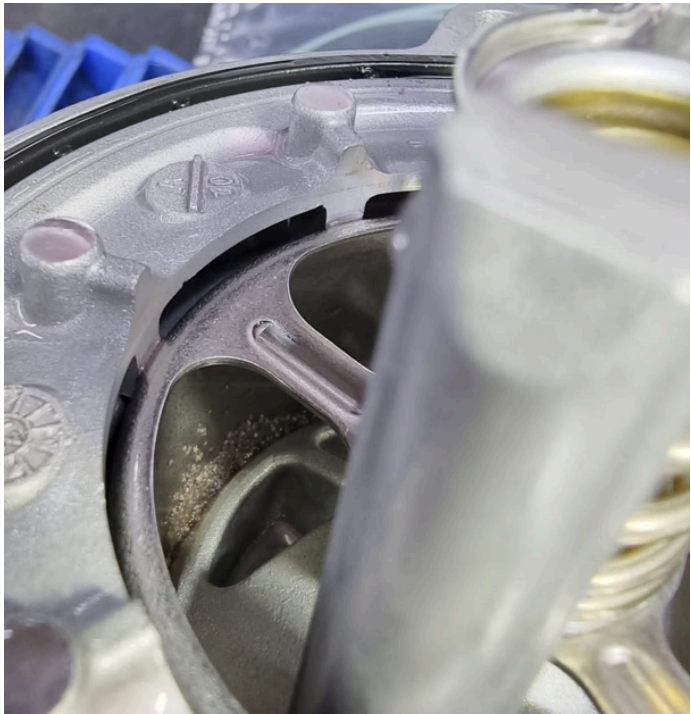
Attachments	
File	Description
<a href="#">Debris Aft of Sealing Surface of Thermostat.png</a>

Before beginning the flushing procedure, remove the thermostat and inspect it for debris. Pay close attention to the gap between the inner sleeve and the body of the thermostat.

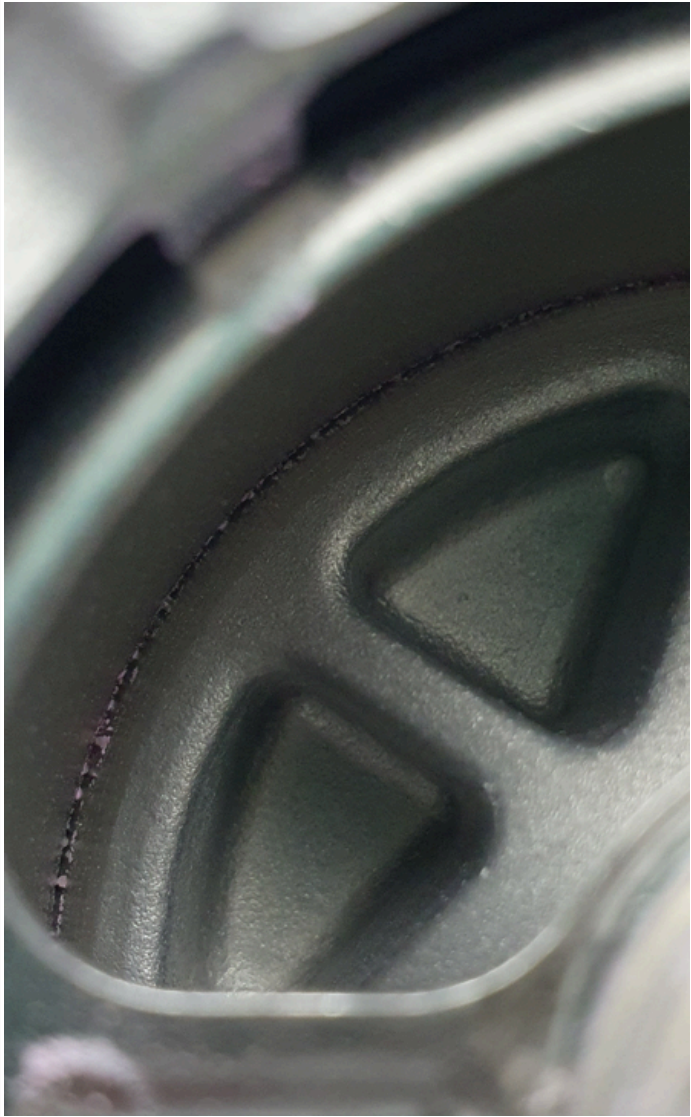
Debris at Interior Sealing Surface of Thermostat.png
