## Weatherstripping Loose or Not Set

Year	Model	Trim Level	VIN Range
2023–25	Accord	ALL	1HGCV1F***A000074–1HGCV2F***A023161

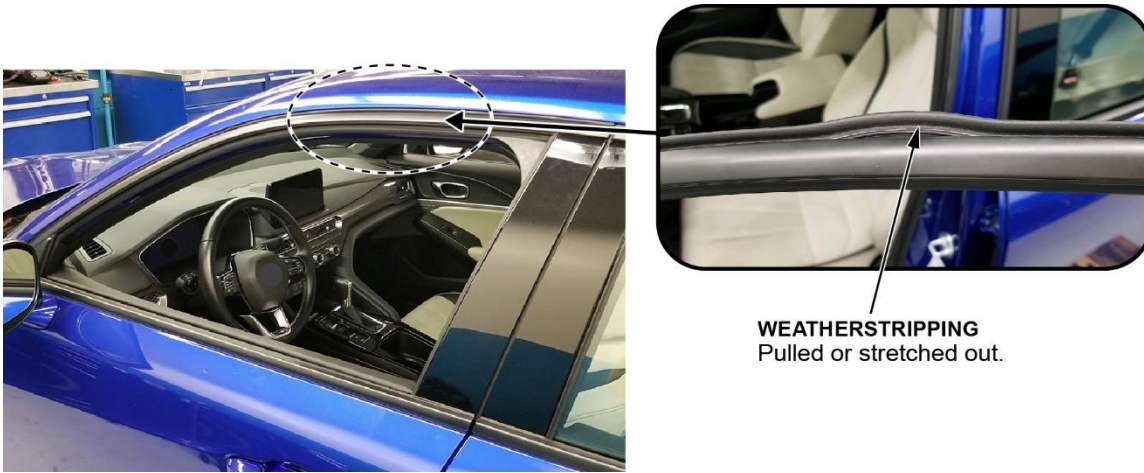
The door weatherstripping is loose or not set at the top of the door frame.

The customer may grab the top of the door sash (to assist while entering and exiting the vehicle) and dislodge the seal.

If the weatherstripping is pulled out of the sash and is undamaged, continue to the REPAIR PROCEDURE section in this bulletin to replace the weatherstripping on all doors.

NOTE: If the weatherstripping is damaged, this procedure does not apply.

If the weatherstripping is pulled out of the sash and is undamaged, replace the weatherstripping on all doors with the improved parts.

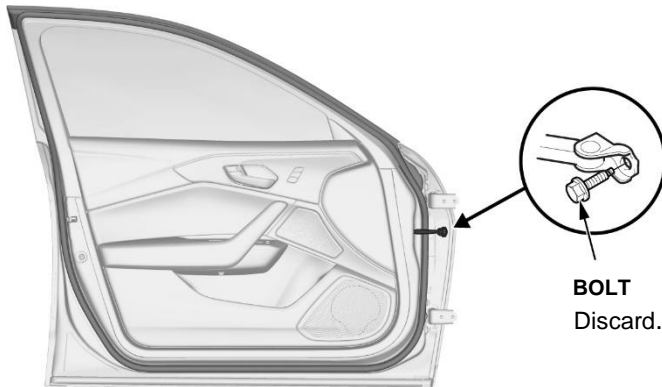
2. Remove the bolt from the door checker. Discard the bolt.

NOTICE: With the door-checker bolt removed, the door can overextend and cause damage to the door. Use care around the door until the new door-checker bolt is installed.

3. Complete the removal of the weatherstripping, then discard it.
4. Starting at the front of the door, install the new weatherstripping in the reverse order of removal.
5. Install the new door-checker bolt then tighten to the specification, **29 N·m (21 lb-ft)**.
6. Clear the weatherstripping contact areas around the door of any dirt or debris.

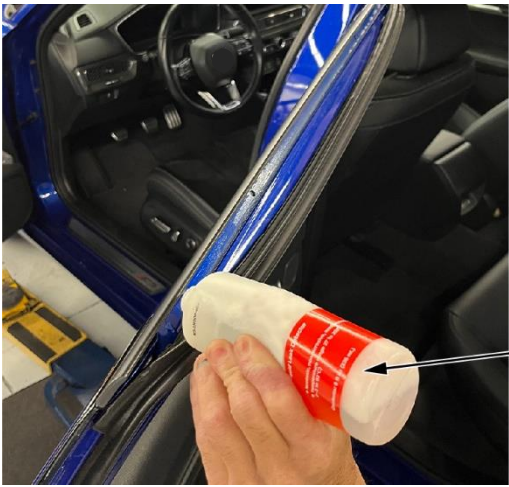
7. Apply a soap and water solution to the channel on top of the door frame and the weatherstripping to aid installation.

**SOAP AND WATER**  
Place solution in  
channel and on  
weatherstrip.

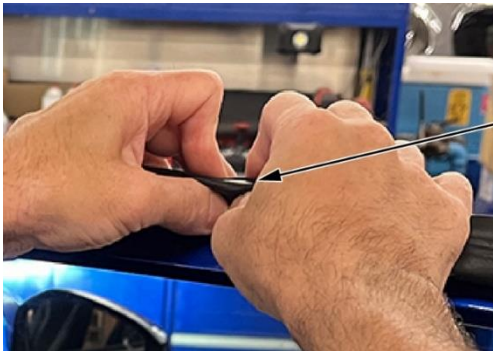
- If the door checker is in the way of installing the weatherstripping, remove the door checker bolt then continue the REPAIR PROCEDURE at step 4.
- Pinch the weatherstripping to aid in installing its upper and lower edges into the channel of the door frame.

Pinch to aid in placing  
edges into the channel.

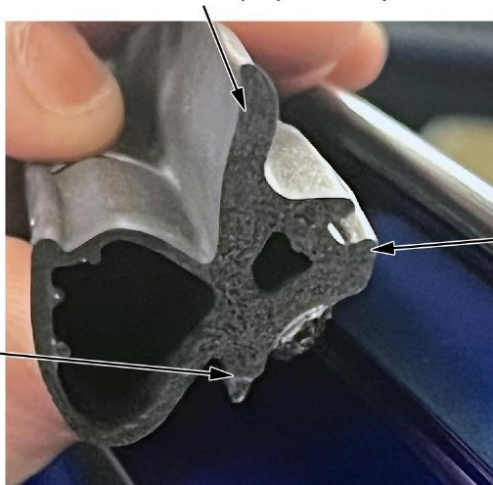
**CROSS-SECTION**  
For illustration purposes only.

**NOTE:** Ensure both edges of the weatherstripping are firmly installed into the channel of the door frame.

**LOWER EDGE**  
Ensure lower edge  
is inside channel.

**UPPER EDGE**  
Ensure upper edge  
is inside channel.

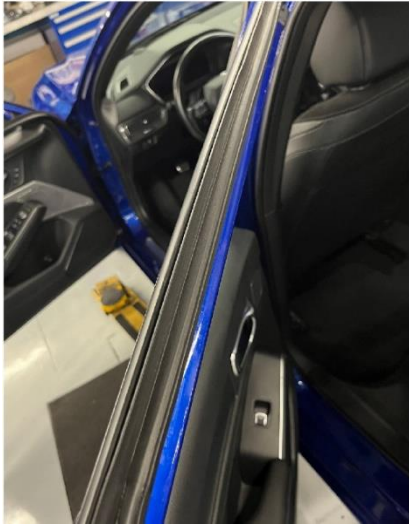
**CORRECT** ✓

NOTE: Be sure the weatherstripping is straight once installed.
