January 24, 2025

Version 1

Weatherstripping Loose or Not Set

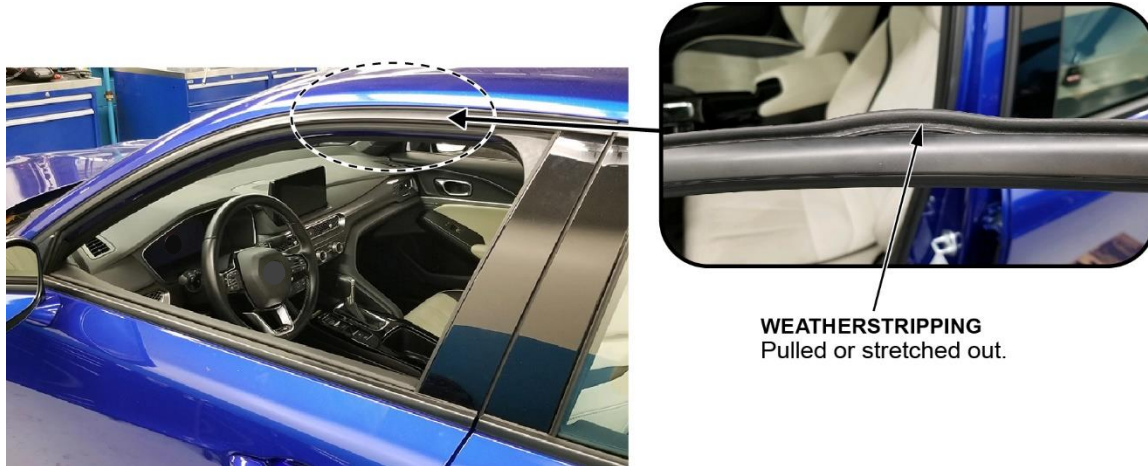
If the weatherstripping is pulled out of the sash and is undamaged, continue to the REPAIR PROCEDURE section in this bulletin to replace the weatherstripping on all doors.

NOTE: If the weatherstripping is damaged, this procedure does not apply.

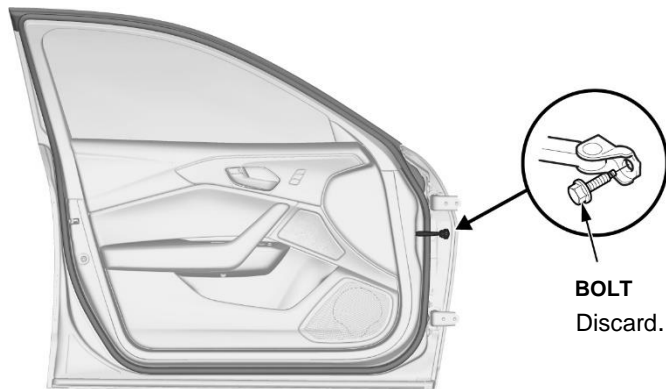
2. Remove the bolt from the door checker. Discard the bolt.

NOTICE: With the door-checker bolt removed, the door can overextend and cause damage to the door. Use care around the door until the new door-checker bolt is installed.

3. Complete the removal of the weatherstripping, then discard it.
4. Starting at the front of the door, install the new weatherstripping in the reverse order of removal.
5. Install the new door-checker bolt then tighten to the specification, **29 N·m (21 lb-ft)**.
6. Clear the weatherstripping contact areas around the door of any dirt or debris.

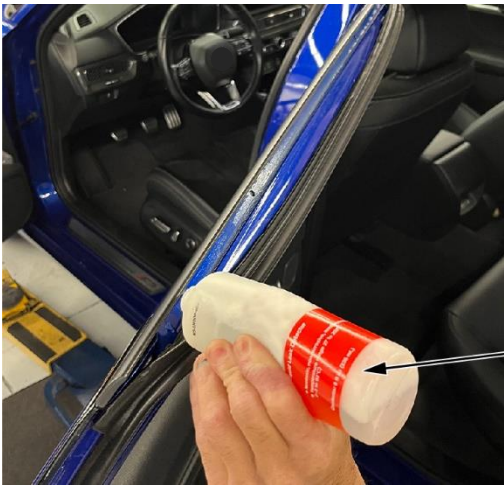
SOAP AND WATER
Place solution in
channel and on
weatherstrip.

7. Apply a soap and water solution to the channel on top of the door frame and the weatherstripping to aid installation.

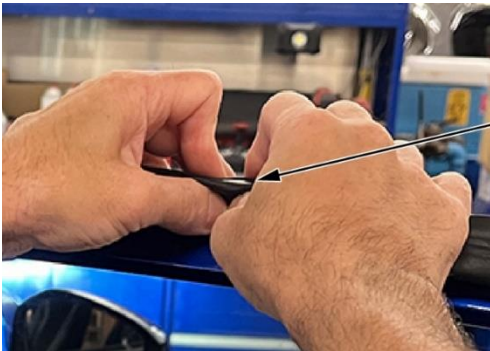
Pinch to aid in placing
edges into the channel.

- If the door checker is in the way of installing the weatherstripping, remove the door checker bolt then continue the REPAIR PROCEDURE at step 4.
- Pinch the weatherstripping to aid in installing its upper and lower edges into the channel of the door frame.

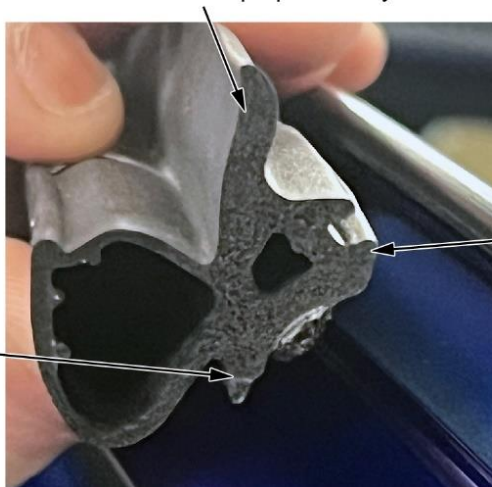
CROSS-SECTION
For illustration purposes only.

LOWER EDGE
Ensure lower edge
is inside channel.

UPPER EDGE
Ensure upper edge
is inside channel.

NOTE: Ensure both edges of the weatherstripping are firmly installed into the channel of the door frame.

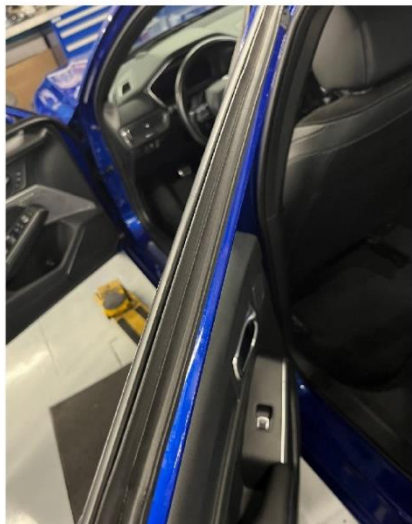
CORRECT ✓

NOTE: Be sure the weatherstripping is straight once installed.
