## TECHNICAL SERVICE BULLETIN

| <b>SERVICE BULLETIN SUBJECT:</b> | 35 Foot RR Front CS Charge Door Bumper Hardware Retrofit |
| <b>SERVICE BULLETIN #:</b> | SC-21-119 |

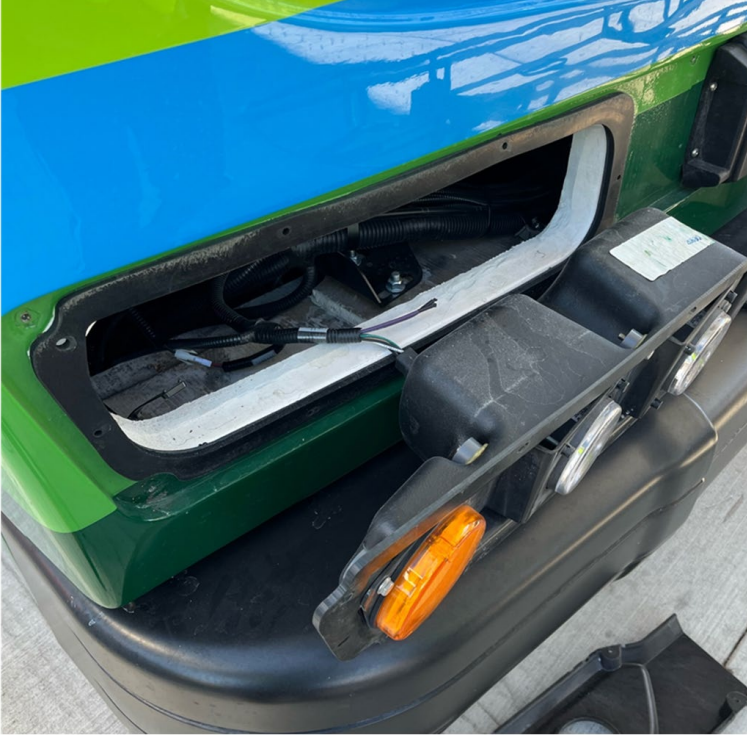
1. Complete the Proterra approved Lockout/Tagout procedure to make the bus safe for work.
2. Using a #3 Phillips Screwdriver, remove the Headlight Bezel and Headlights from the curbside of the bus.

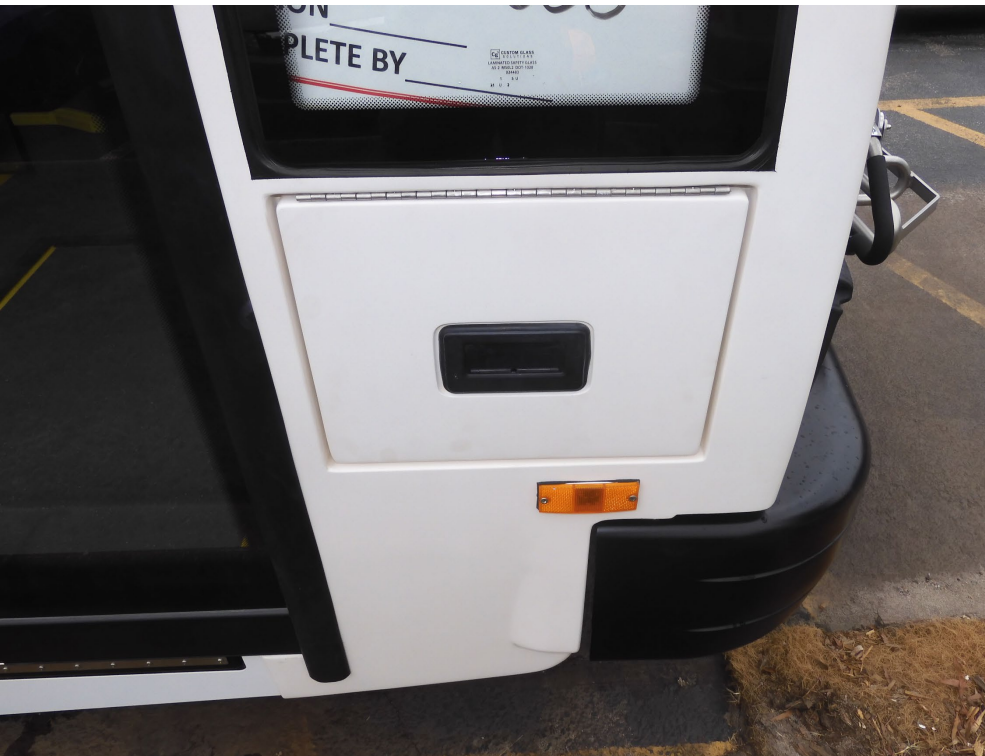
3. Open the Curbside Front panel on the bus.

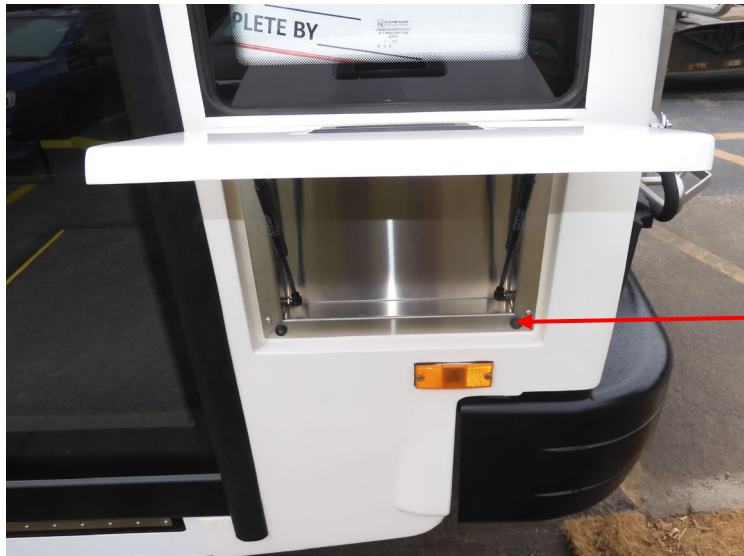
4. Working through the Headlight opening to reach the Nylock nuts on the back, use a #2 Phillips Screwdriver and a 10mm Ratchet/Socket, remove one of the two screws that secure the rubber bumpers to the bus. Remove the Rubber Bumper as well.

5. Using a #2 Phillips Screwdriver, reinstall the Rubber Bumper using an M4 Screw (018599-013).
6. Repeat the process to install the remaining M4 Screw (018599-013) for the other Rubber Bumper.
7. Close the Curbside Front panel.
8. Using a #2 Phillips Screwdriver and a 10mm Ratchet/Socket, reinstall the Headlight and Headlight Bezel.
9. Re-aim the Headlight if necessary.
10. Remove the Lockout/Tagout devices and return the bus to service.
