TECHNICAL SERVICE BULLETIN

ISSUE DATE:	6/8/2021
SERVICE BULLETIN SUBJECT:	Air Compressor High Voltage Connection Torque Retrofit
VINs or MODELS AFFECTED:	Service Specified Buses
COMPLETE BY:	Next Service Opportunity
SERVICE BULLETIN #:	SC-21-97
LABOR OPERATION CODE:	BC44Z

AIR COMPRESSOR HIGH VOLTAGE CONNECTION TORQUE RETROFIT

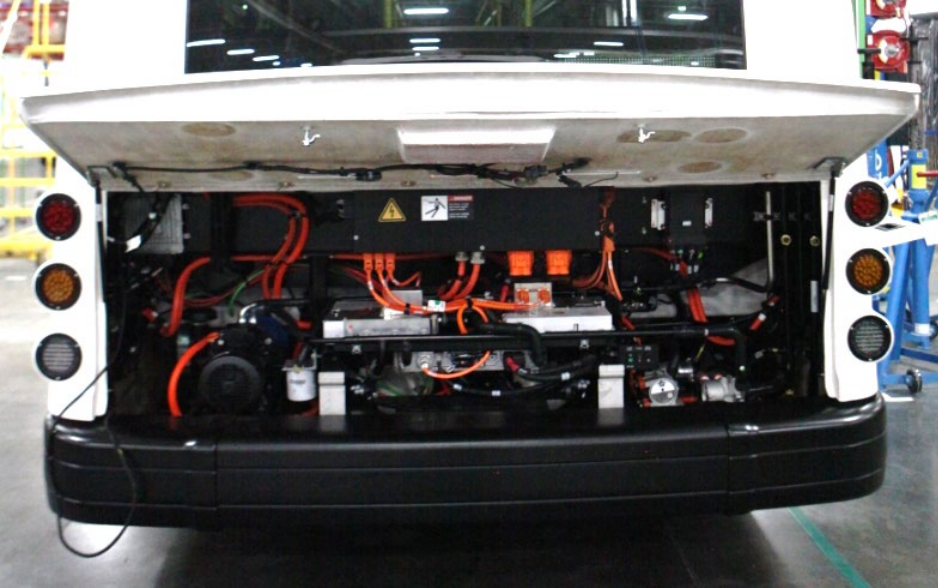
1. Complete the Proterra approved Lockout/Tagout procedure to make the bus safe for work.
2. Open the rear hatch to access the Air Compressor.

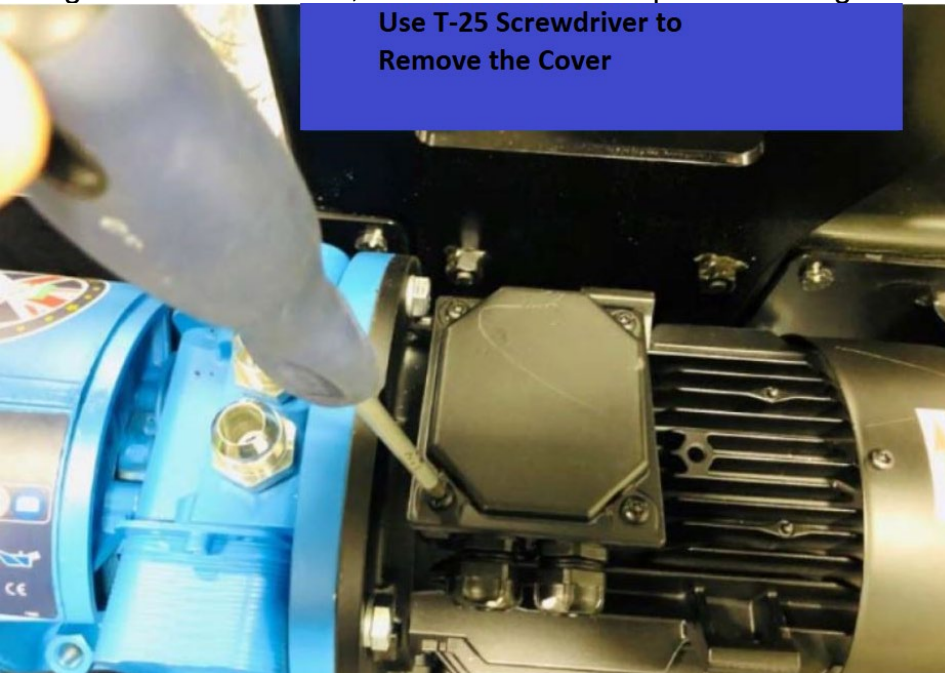
3. Using a T-25 Torx Driver, remove the Air Compressor wiring cover.
