**SERVICE BULLETIN**

**APPLICABILITY:** 2019-24MY Forester  
 2025MY Forester Wilderness

**NUMBER:** 07-218-23R

**SUBJECT:** Genuine Alternative Battery Replacement

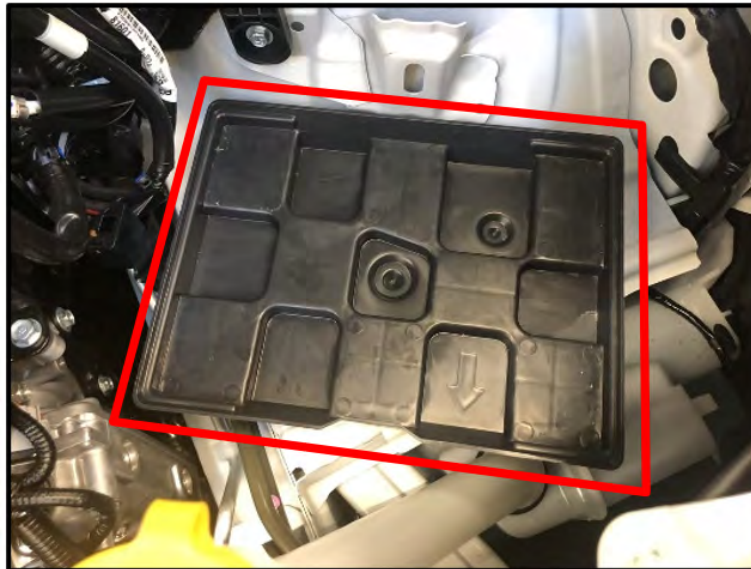
**STEP 3:** Replace the battery tray with the new part (p.n. 82190AN000).

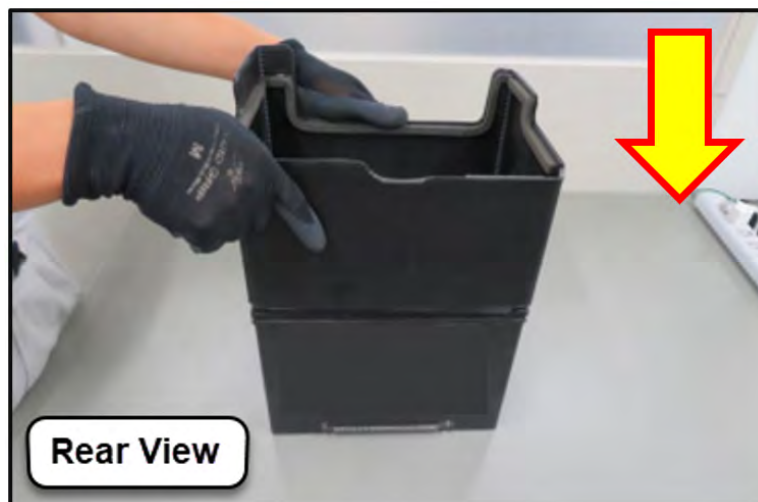
**STEP 4:** Install the NEW battery cover (p.n. 82123AN000) to the alternative replacement battery. Confirm the bottom of the cover is aligned flush with the bottom of the battery.

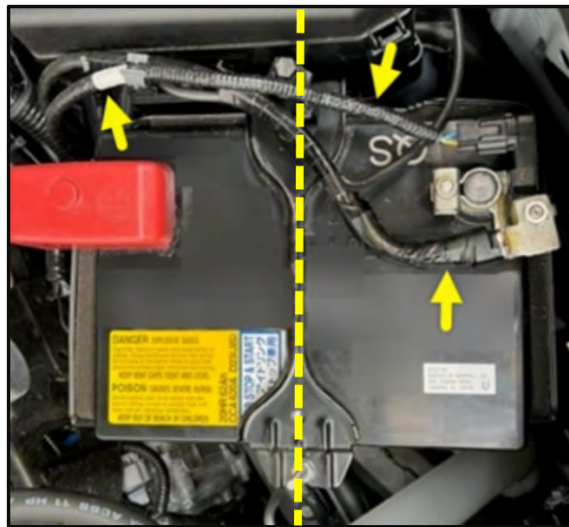
**STEP 6:** Install the original battery holder and holding rods on to the battery.

- A. Torque the two holding rod mounting nuts to **3.5 N·m (2.6ft-lbs. or 31inch-lbs.)**.
- B. Torque the positive terminal to **6 N·m (4.4ft-lbs. or 53inch-lbs.)**.
- C. Torque the negative terminal to **7.5Nm (5.5ft.-lbs. or 66inch-lbs.)**.
- D. If the battery sensor is removed or disconnected torque to 7.5Nm (5.5ft.-lbs. or 66inch-lbs.) while supporting the sensor with the other hand as outlined in the applicable Service Manual under: STARTING/CHARGING SYSTSEMS > Battery Sensor.

**NOTE:** Confirm the battery holder is center mounted with the battery cables secured and routed correctly.
