<b>REFERENCE:</b>	<b>TSB:</b> 14-002-25 <b>GROUP:</b> 14 - Fuel	<b>Date:</b>	January 28, 2025	<b>REVISION:</b>	-
<b>VEHICLES AFFECTED:</b>	<b>2024 - 2025 (B1) Jeep Renegade</b> <b>2024 - 2025 (H1) Jeep Commander</b> <b>2024 - 2025 (M1) Jeep Compass</b> <b>2024 - 2025 (N4) RAM Rampage</b> This bulletin applies to the vehicle built on or after <b>January 08, 2024 (MDH 0108XX)</b> and on or before <b>December 13, 2024 (MDH 1213XX)</b> .	<b>MARKET APPLICABILITY:</b>			
<b>CUSTOMER SYMPTOM:</b>	Customers may comment on the following: <ul style="list-style-type: none"> <li>• Difficult to refuel the vehicle.</li> </ul>				
<b>CAUSE:</b>	Loose quick connect fittings

This bulletin involves inspecting, and if necessary, properly connecting the fuel hose quick connects.

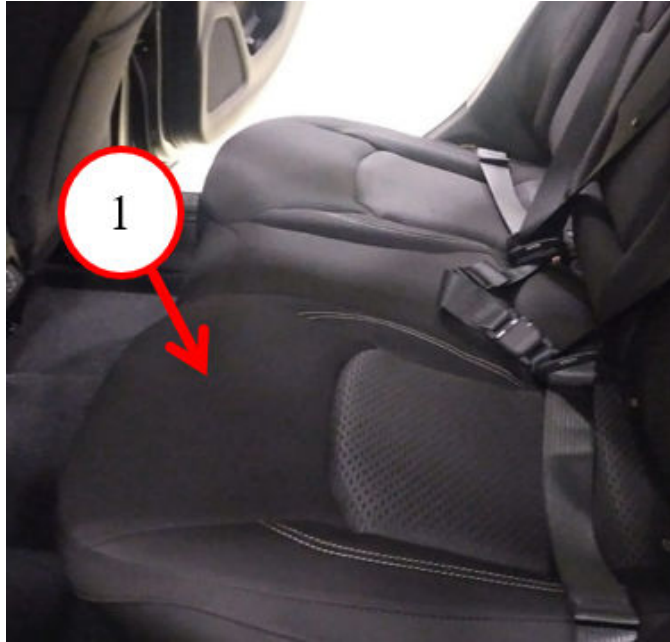
**Fig. 1**  
Rear Seat Cushion

1 - Raise Rear Seat Cushion

1. Raise the rear seat cushion [Fig. 1](#).

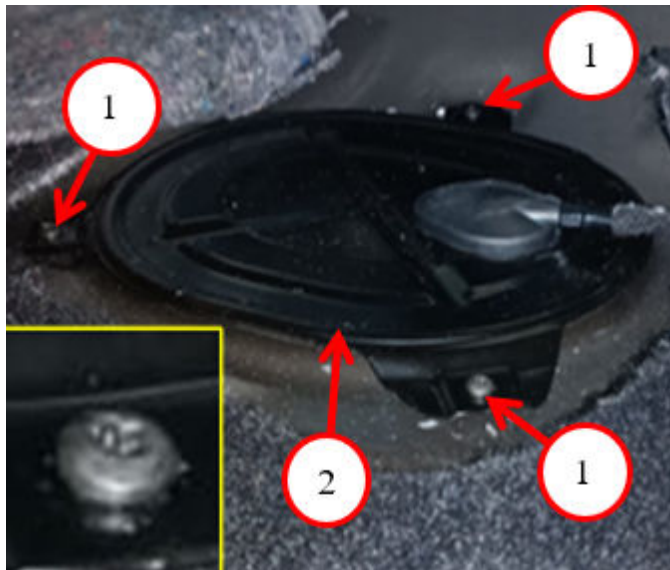
**Fig. 2**  
Fuel Pump Access Cover Screws

1 - Screws

2 - Fuel Pump Access Cover

2. Remove the three screws securing the fuel pump access cover [Fig. 2](#).

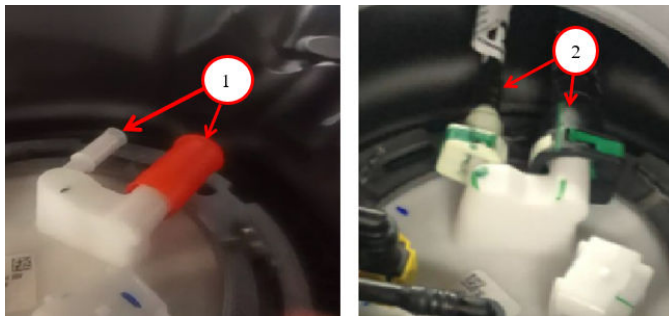
**Fig. 3**  
Fuel Pump Breather Tubes

3. Inspect the fuel breather tube connections to the fuel pump [Fig. 3](#).

1 - Fuel Breather Tubes Disconnected  
2 - Fuel Breather Tubes Connected

4. Are the fuel breather tubes connected to the fuel pump [Fig. 3](#)?

- YES>>> This bulletin has been completed. Use Inspection LOP (14-70-10-9B) to close the active RSU and proceed to [Step 6](#).
- NO>>> Proceed to [Step 5](#).

5. Remove the red tamper proof cover and connect the fuel breather tubes to the fuel pump [Fig. 3](#).

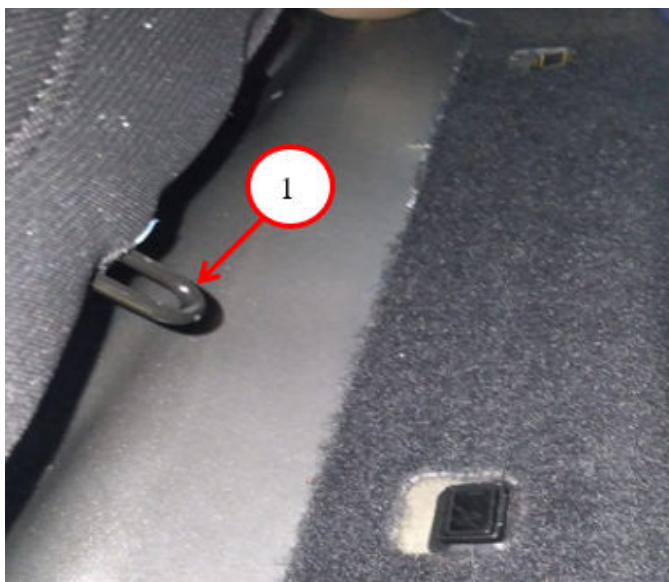
**Fig. 4**  
Rear Seat Cushion Locks

1 - Rear Seat Cushion Lock

6. Lower down the rear seat cushion to its installed position and engage both seat cushion locks [Fig. 4](#).
