ID # CBR-2299

Battery Electric Vehicle (BEV) - Vehicle Will Not "Start", Limited Speed, Instrument Cluster Showing Neutral After Gear Selected

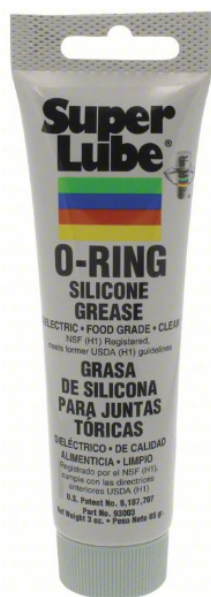
- Super Lube 93003 O-ring Silicone Grease (pictured below)

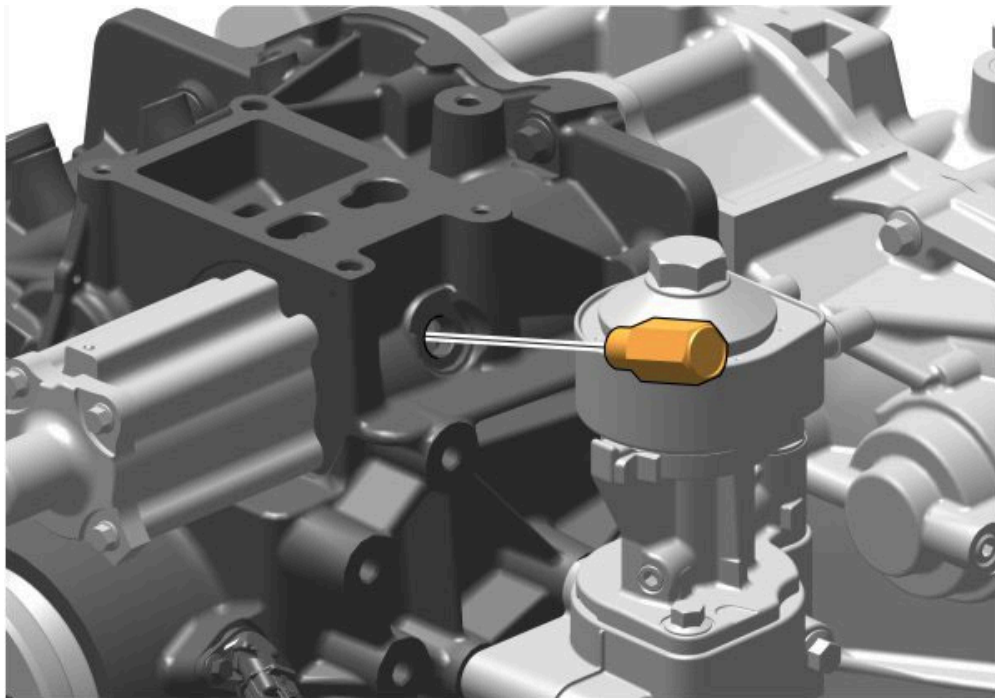
1. Remove the EVU.
2. Remove the Shift Detent.

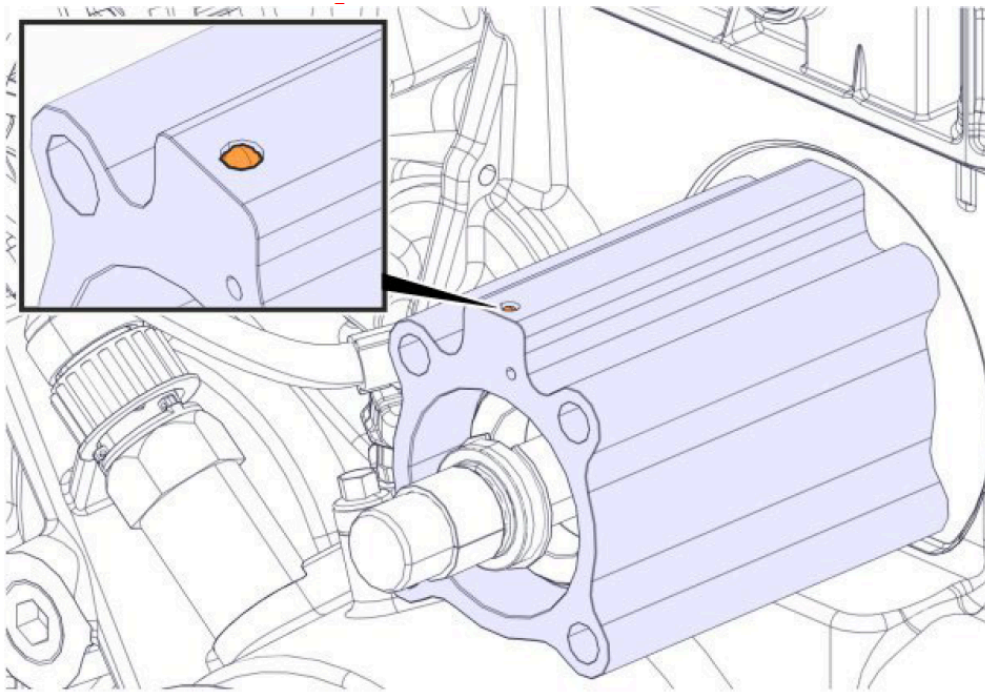
7. Lubricate the Detent and matching internal 1-N-2 geometry on the Shift Fork Yoke Detent Geometry, (through the Detent access hole).
