Technical Service Bulletin (TSB)
Driver Door Seat Massage Switch Inoperative

REFERENCE:	TSB: 08-017-25 REV. A GROUP: 08 - Electrical	Date:	January 30, 2025	REVISION:	08-017-25
VEHICLES AFFECTED:	2024 (WL) Jeep Grand Cherokee / Grand Cherokee L This bulletin applies to vehicles built on or after April 22, 2024 (MDH 0422XX) and on or before August 28, 2024 (MDH 0828XX) equipped with a 5.7L V8 HEMI MDS VVT Engine (Sales Code EZH) and Power Seat Back Massage - Driver (Sales Code CE9).	MARKET APPLICABILITY:			
CUSTOMER SYMPTOM:	Customers may comment on the following: <ul style="list-style-type: none"> The seat massage switch located on the driver door does not work. (Seat massage system still operates via the radio). 				
CAUSE:	Incorrect left front door wiring

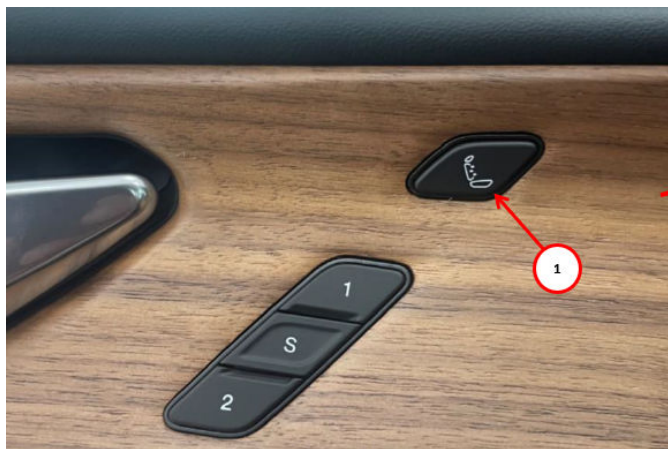
1. Attempt to operate the seat massage switch located on the front left door panel [Fig. 1](#).

Fig. 1
Front Left Door Panel Seat Massage Switch

1 - Front Left Door Panel Seat Massage Switch

2. Does the front left door seat massage switch operate?
 - YES>>> This bulletin has been completed. Use Inspection LOP (08-90-45-98) to close the active RSU.
 - NO>>> Replace the left front door harness. Proceed to [Step 3](#).
3. Remove the front left door carrier plate. Refer to the detailed service procedures available in DealerCONNECT/Service Library under: Service Info> 23 - Body / Doors - Front / Plate, Carrier / Removal.

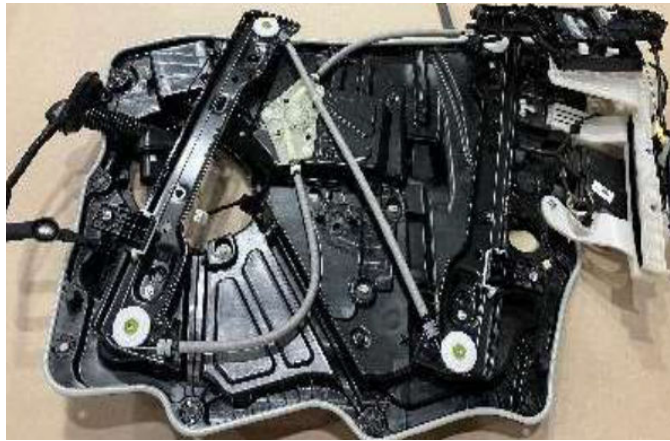
Fig. 2

Carrier Plate Dry Side Facing Down

4. Place the carrier plate dry side down [Fig. 2](#).

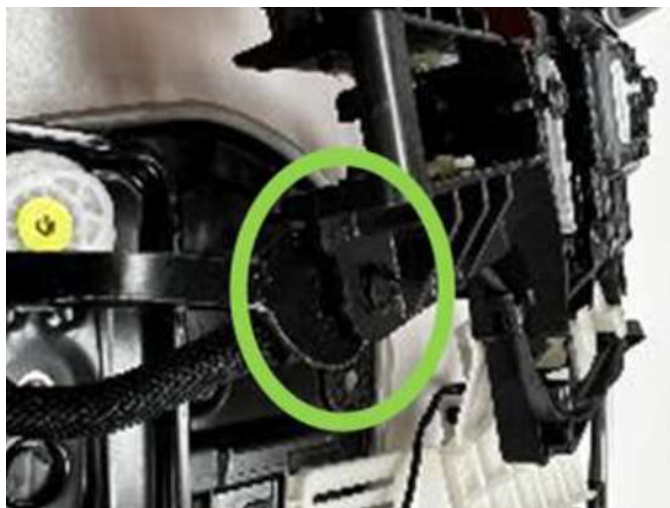
Fig. 4

Carrier Plate Chassis Clip

6. Remove clip from back left side of carrier plate chassis [Fig. 4](#).

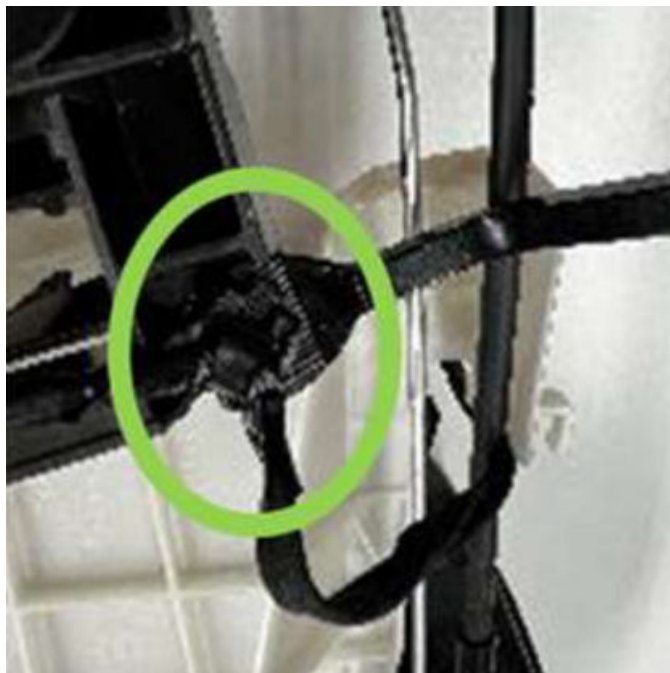
Fig. 6
Chassis Clip

8. Remove the other clip on the carrier plate chassis that is on the front side [Fig. 6](#).

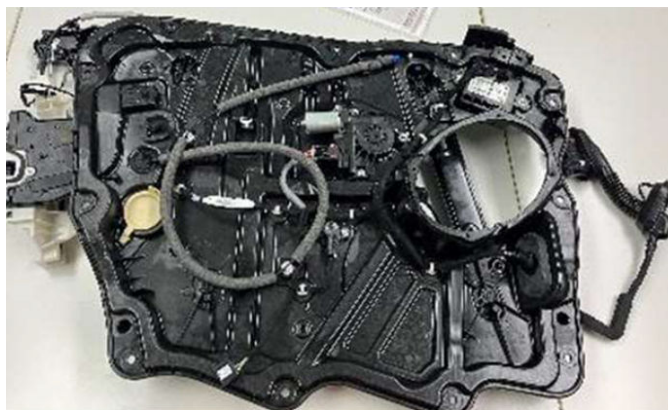
Fig. 9
Carrier Plate Wet Side Facing Down

11. Flip the carrier plate over so that the wet side is down on the table [Fig. 9](#).

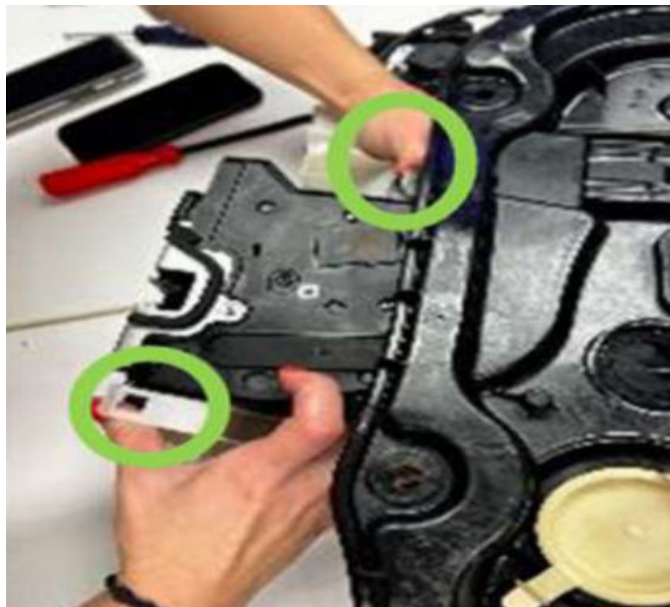
Fig. 11
Latch Removal

13. Slide the latch out of the clips by pulling back on the tabs and pushing out the latch [Fig. 11](#).

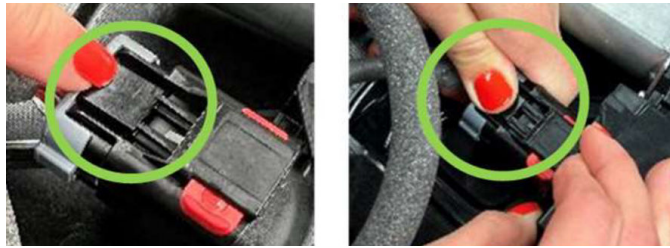
Fig. 17

Motor Tabs To Disconnect Wire Harness Connector

19. Once the motor connector tab is unseated, disconnect the wire harness connector [Fig. 17](#).

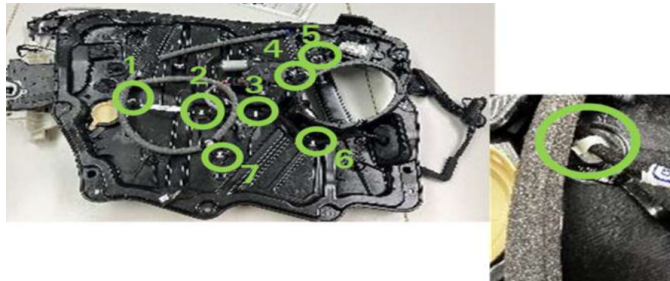
Fig. 21

Wire Harness Clips

23. Remove the seven wire harness clips attached to the door carrier plate [Fig. 21](#).

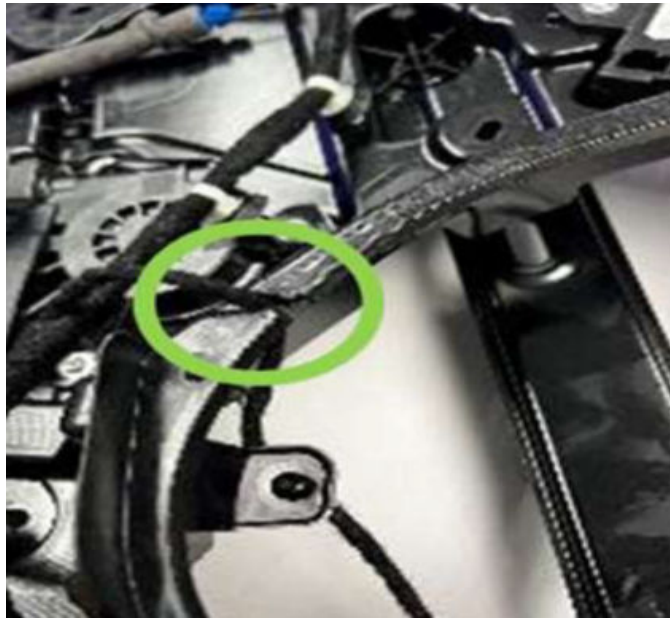
Fig. 22
Speaker Wire Retaining Clip

24. Remove the speaker wire from the retention clip [Fig. 22](#).

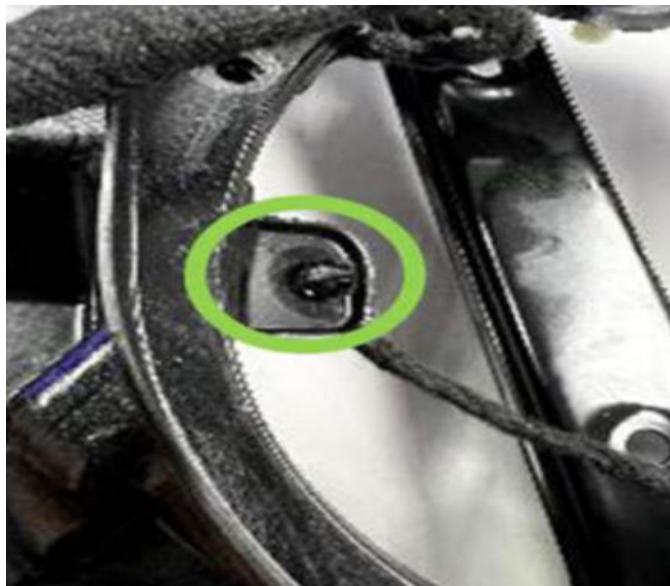
Fig. 23
Speaker Wire Harness Backside Clip

25. Remove the clip on the back side of the speaker hole [Fig. 23](#).

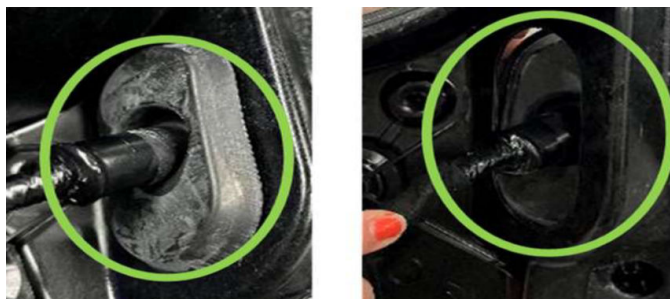
Fig. 24
Oval Grommet

26. Pop out the oval grommet by pushing it in towards the wet side [Fig. 24](#).

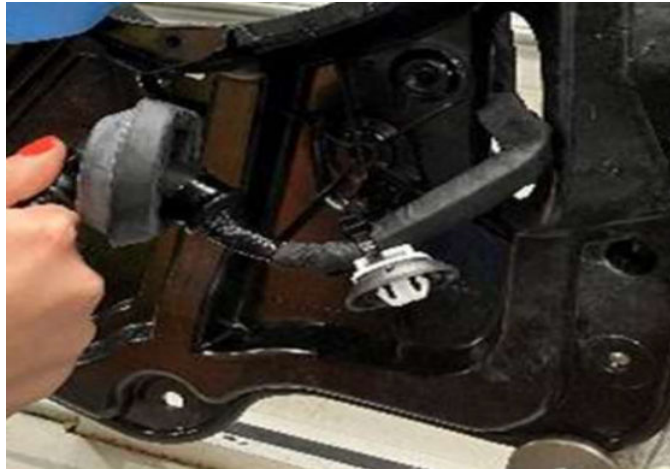
Fig. 25
Remove Grommet

27. Once the grommet is popped out, pull it and the wire harness boot through the oval hole so that the wire harness is free from the carrier plate [Fig. 25](#).

28. **DISCARD** the wire harness that is now freed from the carrier plate.

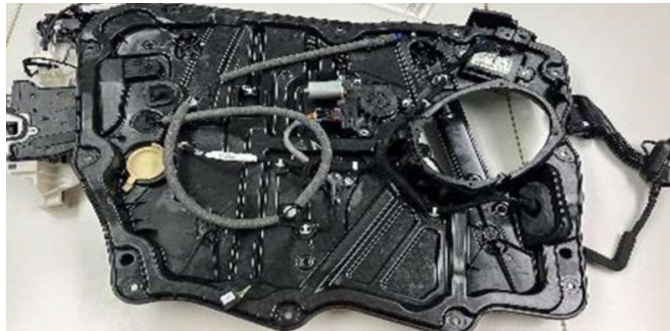
Fig. 26
Carrier Plate Wet Side Facing Down

29. Place the carrier plate wet side down [Fig. 26](#).

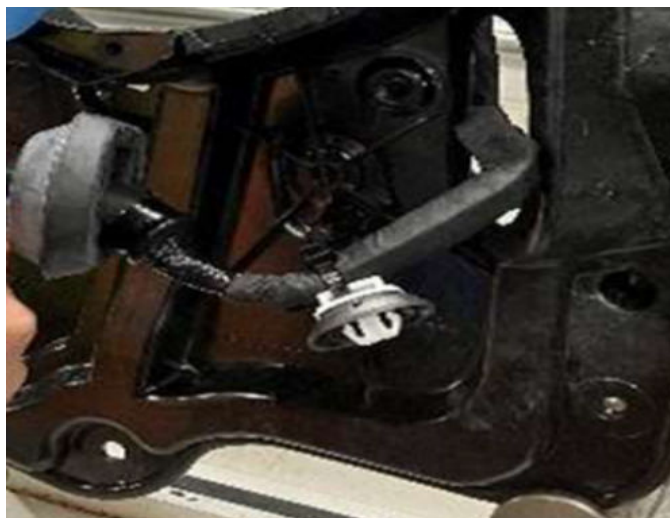
Fig. 27
Install Grommet

30. Route the **NEW** wire harness boot and oval grommet through the oval hole [Fig. 27](#).

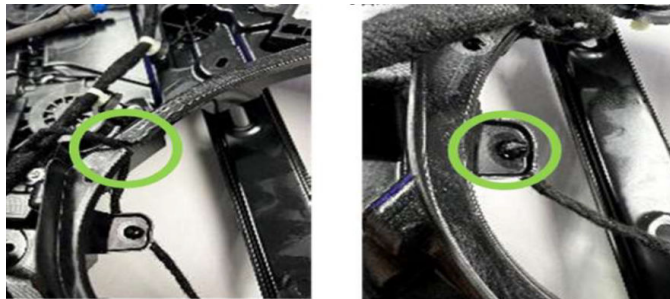
Fig. 30
Speaker Wire Clip

33. Route the speaker wire and clip it in the speaker wire clip [Fig. 30](#).

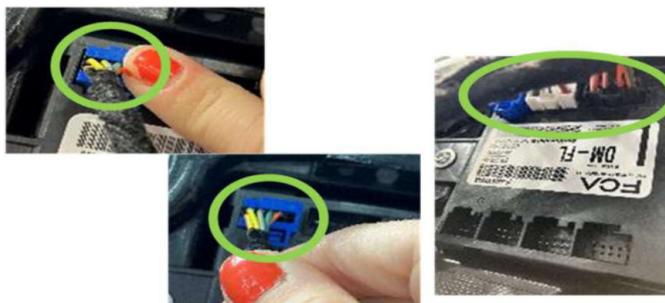
Fig. 32

DCU Wire Harness Connectors

36. Connect the wire harness connectors to the DCM Fig. 32.

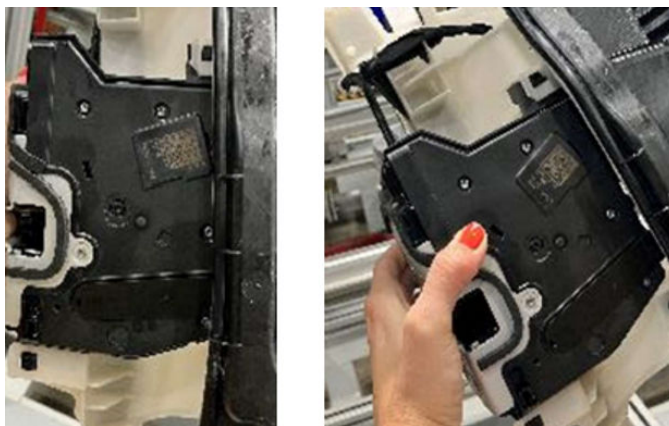
Fig. 38
Latch Assembly

42. Seat the latch and then pull back on latch to make sure the latching tabs are fully seated [Fig. 38](#).

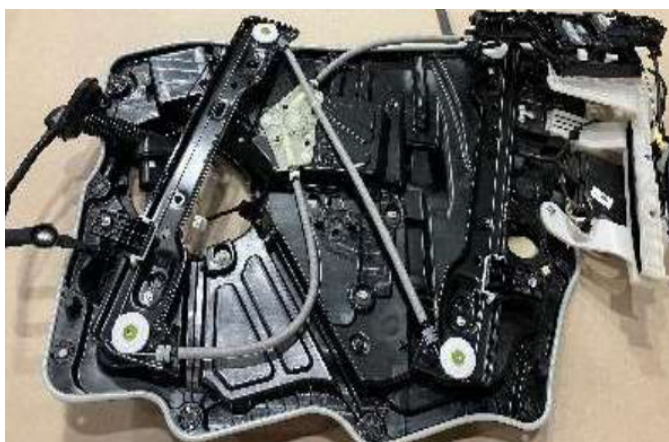
Fig. 39
Carrier Plate Dry Side Facing Down

43. Flip over the carrier plate so that the dry side is facing down [Fig. 39](#).

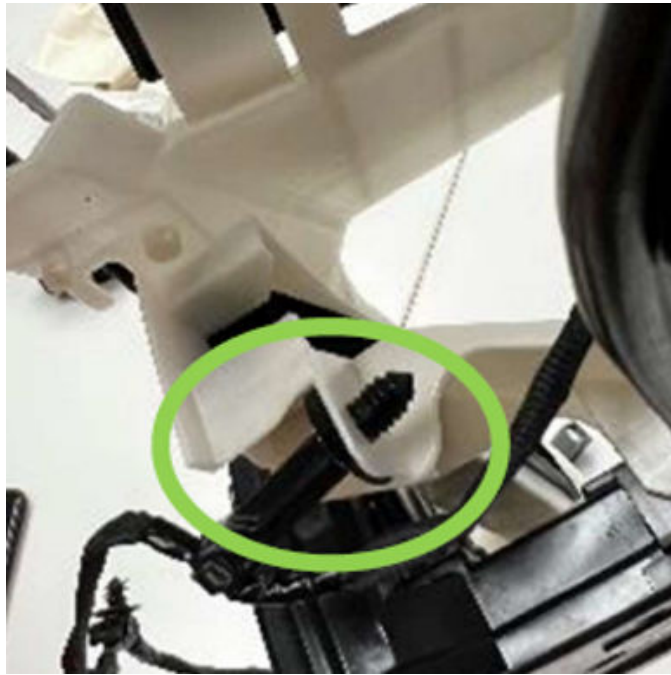
Fig. 41
Large Clip

45. Connect the large clip [Fig. 41](#).
