TECHNICAL SERVICE BULLETIN

ISSUE DATE:	3-23-2021
SERVICE BULLETIN SUBJECT:	Steering Gearbox Proud Boss Check and Bolt Loctite Retrofit
VINs or MODELS AFFECTED:	Service Specified Buses
COMPLETE BY:	Next Service Opportunity
SERVICE BULLETIN #:	SC-21-48
Labor Operation Code:	SC46Z

STEERING GEARBOX PROUD BOSS CHECK AND BOLT LOCTITE RETROFIT

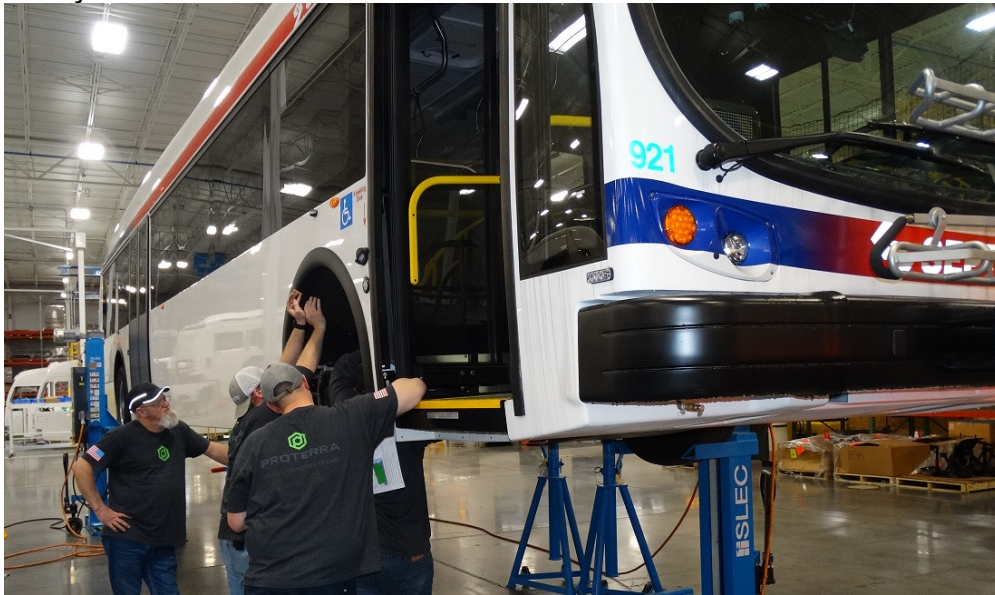
1. Complete the Proterra approved Lockout/Tagout procedure to make the bus safe for work.
2. Using four Wheel Lifts, raise the bus into the air. Using four Jack Stands, support the bus for safety.

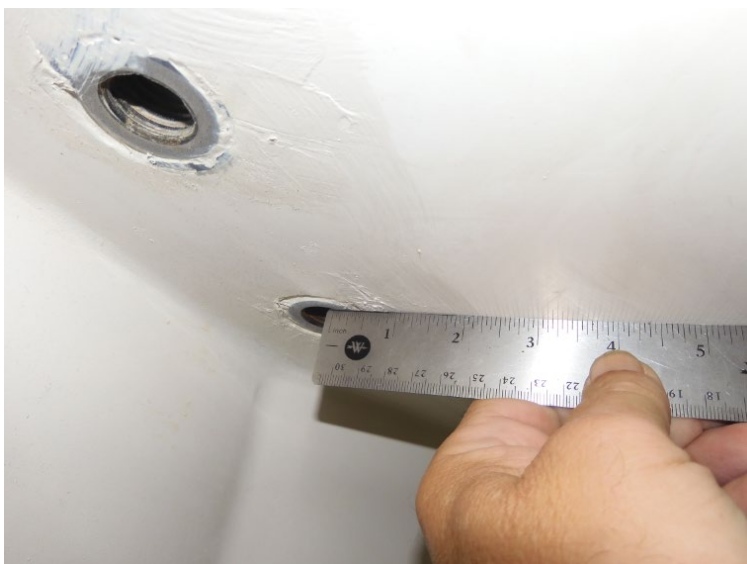
3. Access the Steering Box underneath the bus. Place a Transmission Jack or other approved lifting device underneath the Steering Box to support it.
4. Using a Calibrated Torque Wrench with a 1-5/16 Inch Ratchet/Socket, record the Breakaway Torque while loosening each of the four bolts so that body above the Gearbox Spacer Plate can be inspected. Add the recorded Breakaway Torques for each bolt in the work order.
5. Using a Straight Edge, inspect each of the mounting holes on the underside of the bus body. The bosses inside the mounting holes should be flush with the body or slightly recessed into it. There should not be a protruding or proud area inside any mounting hole.
Note: The bosses are shown below with the gearbox removed for clarity.

6. If the body has protruding areas within the holes, contact Proterra Customer Service for further instructions.
7. Using Alcohol and Shop Towels, remove any Orange Torque Stripe Paint from previous torquing operations.
8. Using a 1-5/16 Inch Ratchet/Socket, remove each bolt one at a time and replace it with a new one (018758-031). Add Loctite 248 to the threads of each new bolt. The Loctite 248 should fill the threads on the bolt where it engages the fastener.

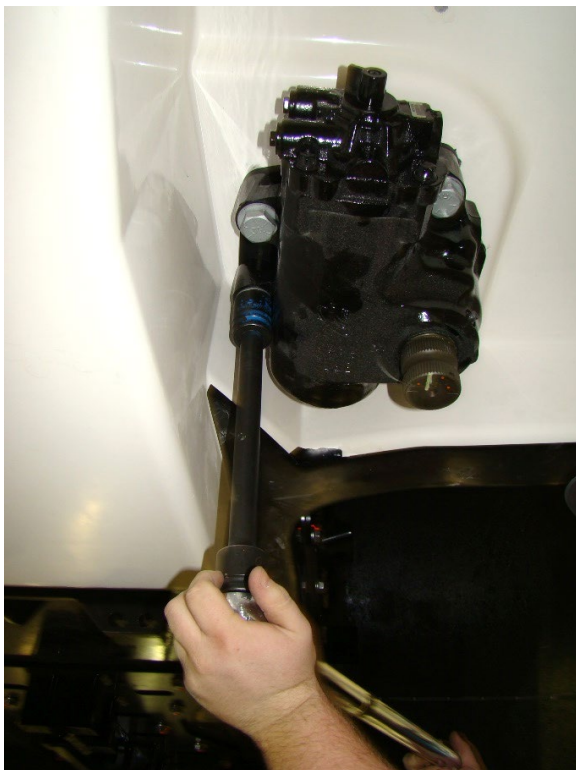
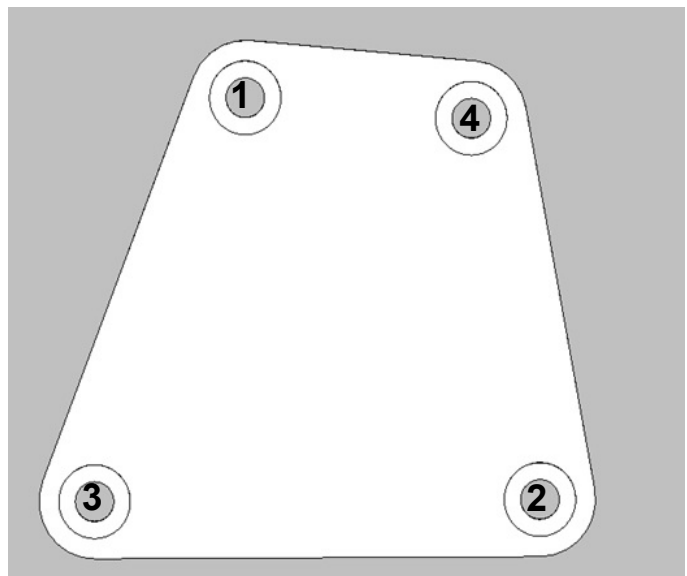
9. The Steering Box bolts will be torqued in three steps using a Cross-torquing process. Using a Calibrated Torque Wrench with a 1-5/16 Inch Socket, **torque each of the four bolts to 150 Foot Pounds**. Cross-torque the bolts by following the sequence shown in the illustration on the right below.

10. Using a Calibrated Torque Wrench with a 1-5/16 Inch Socket, **torque each of the four bolts to 369 Foot Pounds**. Cross-torque the bolts by following the sequence shown above.
11. Using a Calibrated Torque Wrench with a 1-5/16 Inch Socket, **torque each of the four bolts to 500 Foot Pounds**. Cross-torque the bolts by following the sequence shown above.
12. Using Orange Torque Stripe Paint, mark the four bolts as shown below.
