Campaign Service

CB24-R-001C

F-SERIES MOBILEYE CAMERA CABLE ROUTING – 24V-157

- 2019-2024MY F-Series Vehicles
Equipped with RPO Code I4V Mobileye Collision Warning System

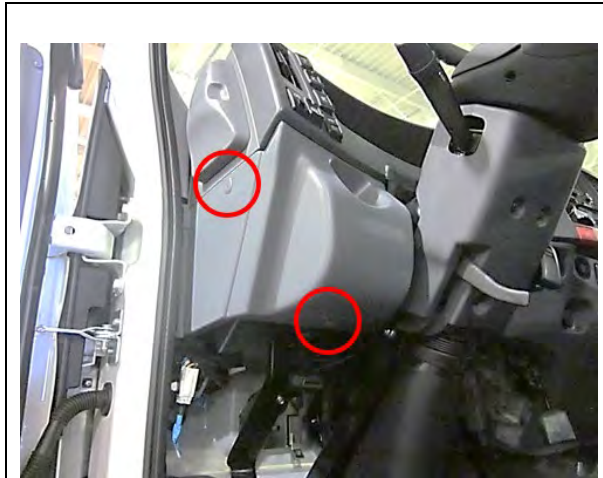
Figure 3

4. Remove the driver side instrument side cover. (See Figure 3.)

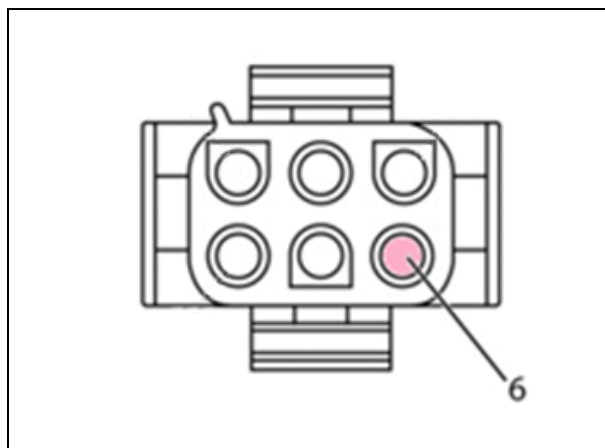
7. Using an ohm meter, test for continuity between the male end of connector MH-2, Pin 6 (pink wire) and body ground. (See Figure 6.)
 - a. If the wire has continuity to ground, the appropriate cable(s) and T-Harness specific to the Mobileye system must be replaced. Refer to the Parts Information section for more information.
 - b. If the wire has no continuity to ground, reconnect connector MH-2 and go to Step 8.

Figure 6
1. Pin 6 of Connector MH-2

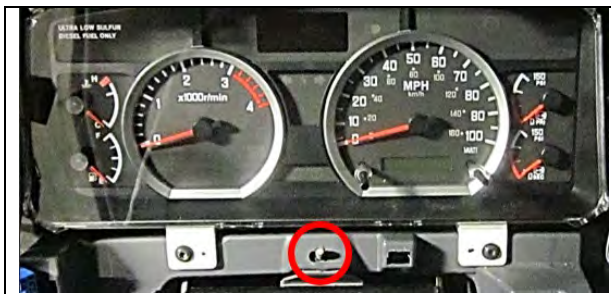
Figure 11

12. Remove the one (1) nut from the IP. (See Figure 11.)

Nut shown removed

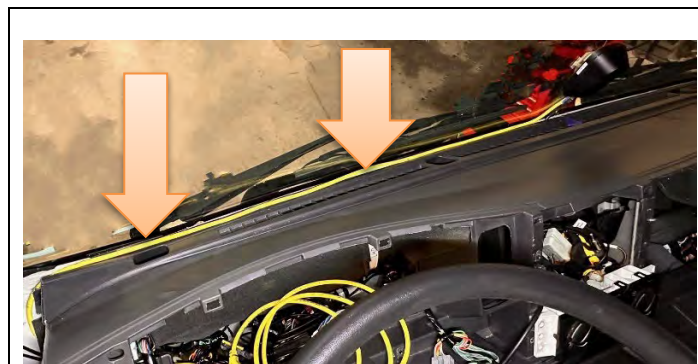
Figure 12

13. Pull back on the IP and remove the Mobileye camera cable from behind the instrument panel. (See arrows in Figure 12.)

Camera cable to be removed from behind the instrument panel (shown in yellow).

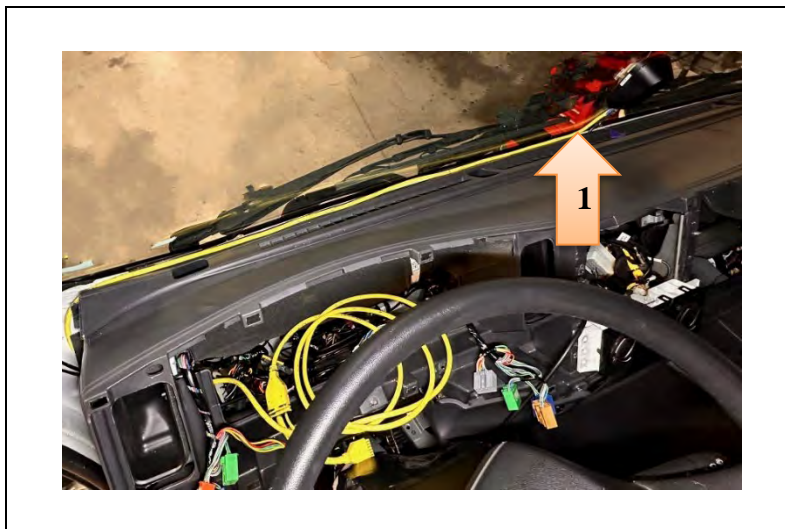
22. Pull out the entire camera cable from its current routing and lay it on top of the IP to the right of the tape mark placed in Step 8. (See Figure 23.)

Figure 23
 Current Cable Routing (painted yellow for reference)
 1. Tape Location

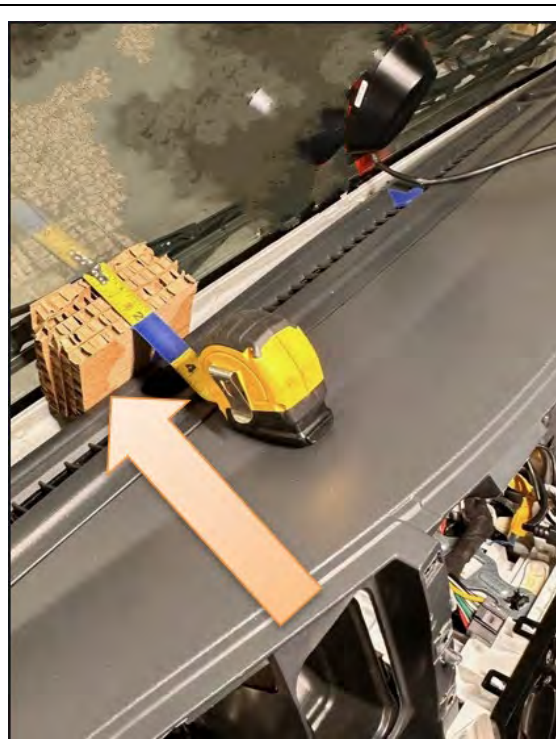
23. Pull the IP away from the windshield to create a 2" gap between the IP and the windshield as shown in Figure 24. Place a piece of wood, cardboard or rubber block (e.g. rubber mallet head) directly inline from the driver's right HVAC vent to maintain this gap.

Figure 24
Item wedged between IP and windshield.

IMPORTANT: Do not place too much pressure on the windshield! Doing so may result in a broken windshield.

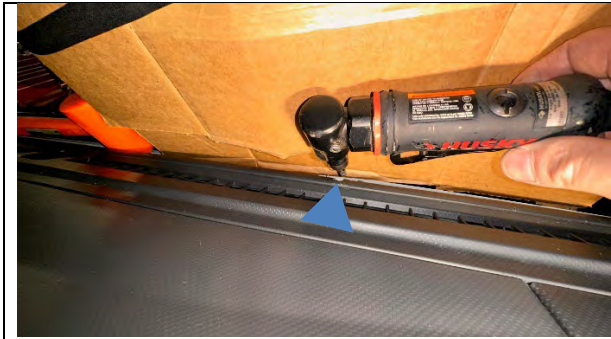
Figure 26

25. Using a rotary cutting tool or rat tail file, create a notch (relief) in the IP at the location previously marked in Step 8 where the camera cable will pass between the IP and the windshield. The notch should be at least one-quarter (1/4) inch in depth and in diameter. (See Figure 26.)

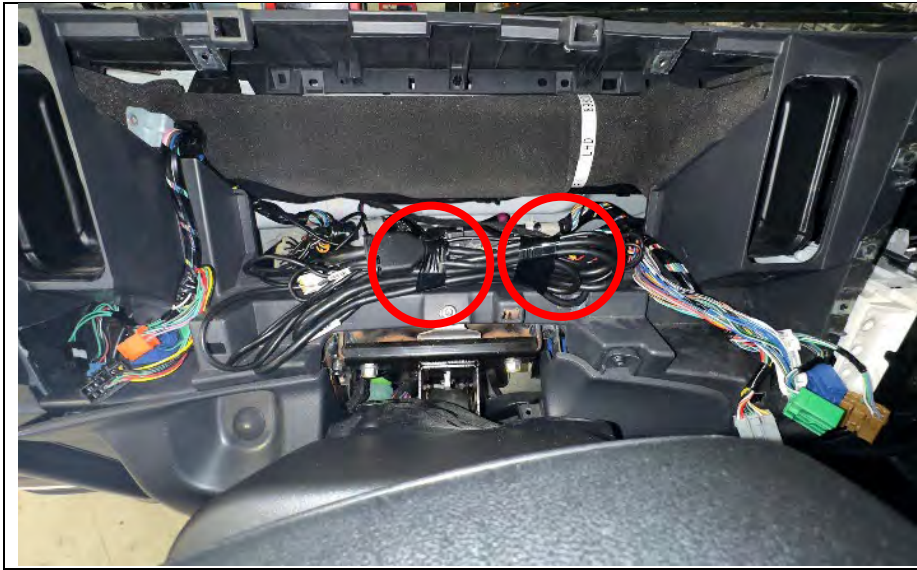
Figure 30

29. Bundle the Mobileye harnesses back together and secure them with electrical tape in the two locations shown in Figure 30.

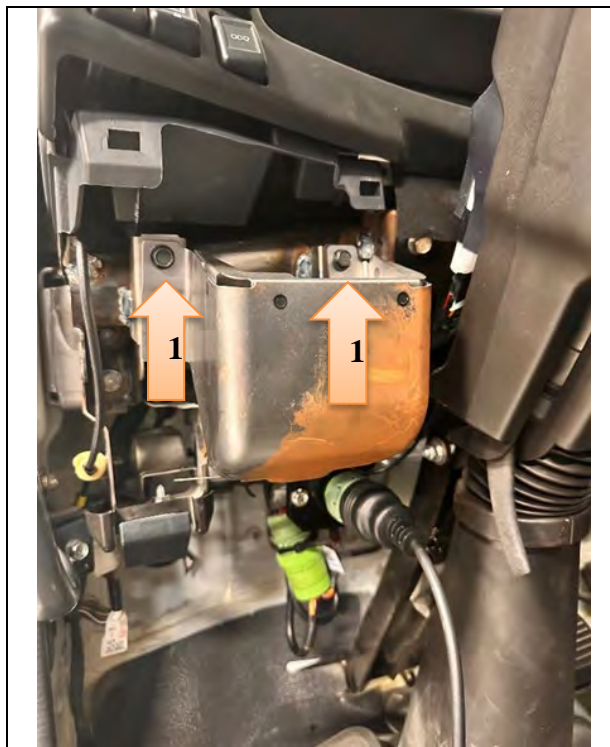
Figure 36

35. Install the knee bracket and torque the two (2) 10mm bolts removed in Step 5. (See Figure 36.) **Torque Specification 4.0 N•m (35 lb•in)**

1. Bolts

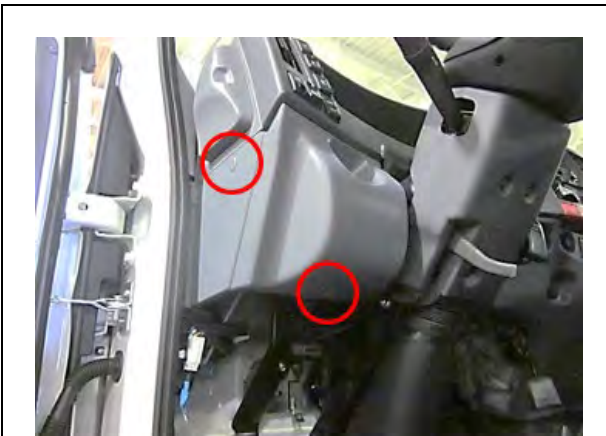
36. Install the driver side instrument side cover removed in Step 4. (See Figure 37.)

Figure 37
Drivers Side Instrument Side Cover

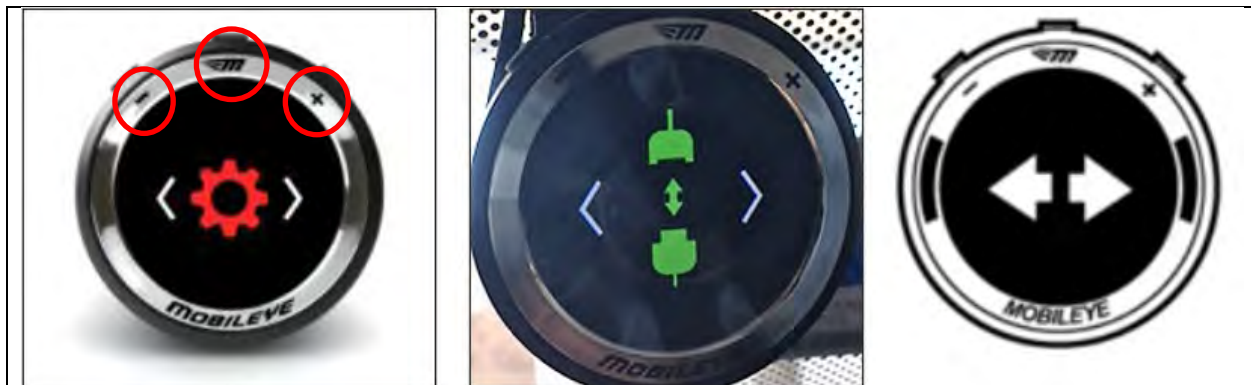
Figure 41
EyeWatch Display

42. Press the (+) button on the Mobileye EyeWatch display until it beeps, continue to hold the (+) button and press the (-) button on the display for ~2 seconds until the red gear appears. (See Figure 41.)

43. When the red gear appears, press (+), When the green connectors appear, press (M). Move the turn signal lever to turn left, and then to turn right, verify double arrows appear on the display each time as shown. (See Figure 41.)

- a. If either the left or right turn signal does not operate correctly, check wiring to ensure all connections are fully seated.
- b. After confirming both turn signals operate correctly (i.e., the double arrows appeared in the EyeWatch display), turn the Engine Control Switch off.

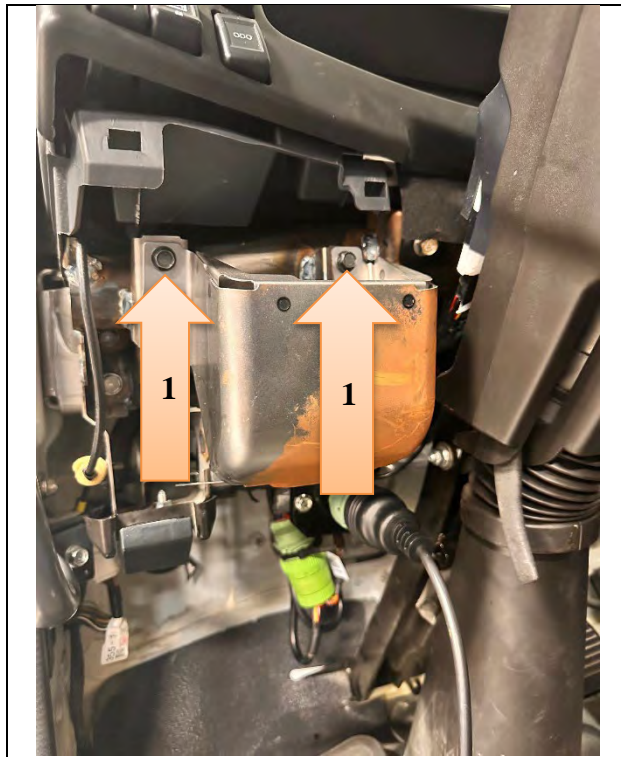
Figure 44
1. Bolts

48. Remove the two (2) 10mm bolts and remove the knee bracket. (See Figure 44.)

99. Install the knee bracket and torque the two (2) 10mm bolts removed in Step 48. (See Figure 89.) **Torque Specification 4.0 N•m (35 lb•in)**

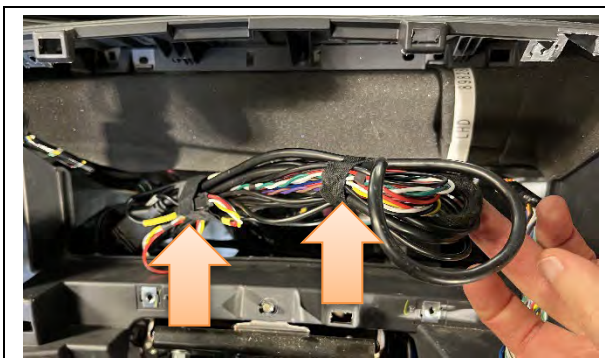
Figure 54
Tape

58. Unwrap and discard the tape, around the harnesses and separate the Mobileye harnesses from the other wires. (See Figure 54.)

NOTE: Pay close attention to how the Mobileye harness is bundled together. You will need to secure these harnesses in the same manner later in this procedure.

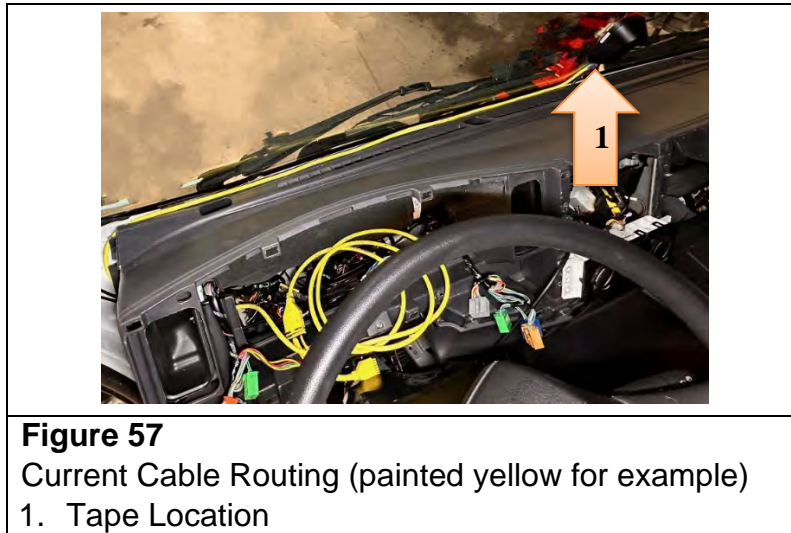
60. Pull out the entire camera cable from its current routing and lay it on top of the IP to the right of the tape mark placed in Step 49. (See Figure 57.)

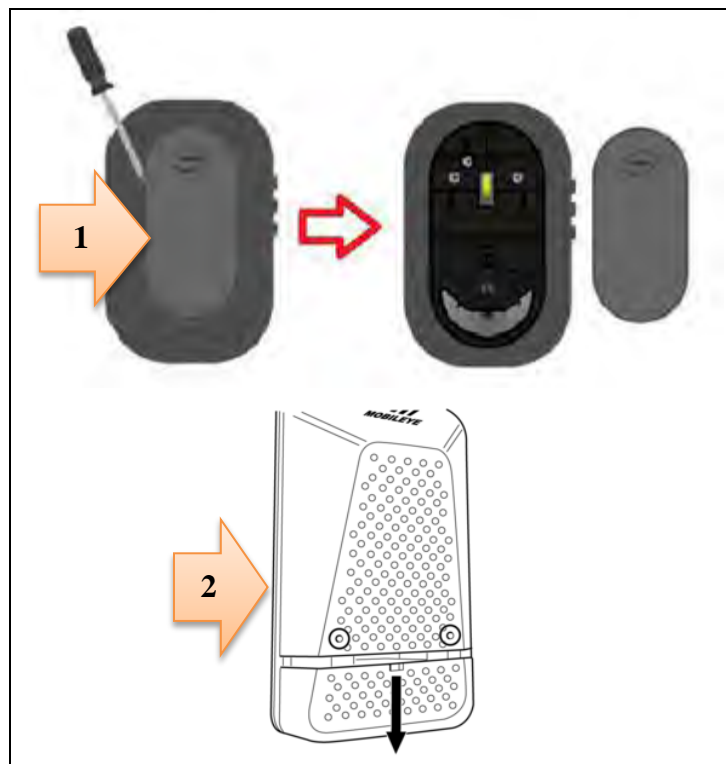
62. **For Mobileye 8**, use a small flat screwdriver, to pop out the oval cover of the camera. If equipped with Mobileye 6, use a small flat tip screwdriver to remove the rectangular cover of the camera (See Figure 58.)

Figure 58
1. Mobileye 8: Remove oval cover.
2. Mobileye 6: Remove rectangular cover.

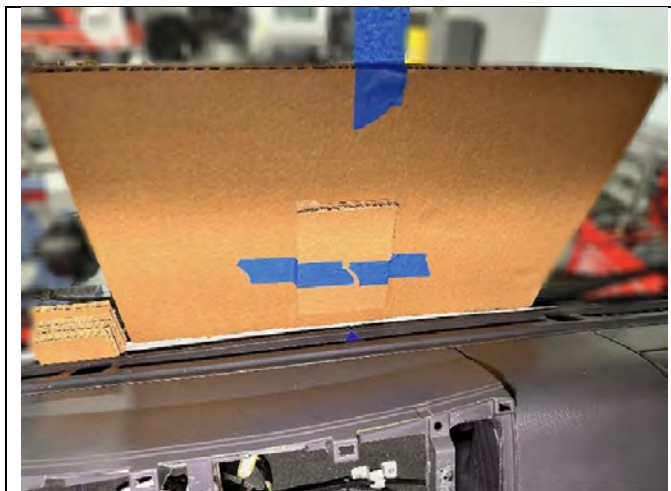
Figure 64

68. Use a piece of cardboard or something similar to protect the windshield. (See Figure 64.)

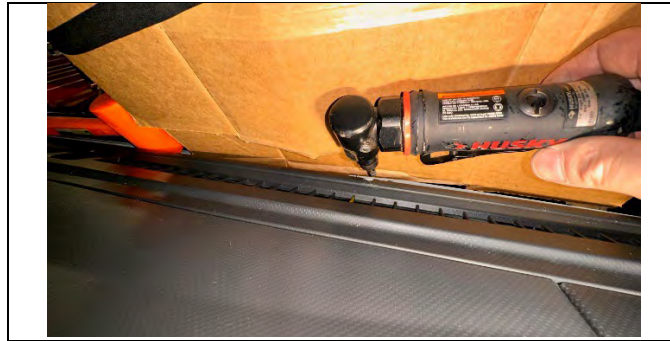
Figure 65

69. Using a rotary cutting tool or rat tail file, create a notch (relief) in the IP at the location previously marked by tape in Step 49 where the camera harness will pass between the IP and the windshield. The notch should be at least one-quarter (1/4) inch in depth and in diameter. (See Figure 65.)

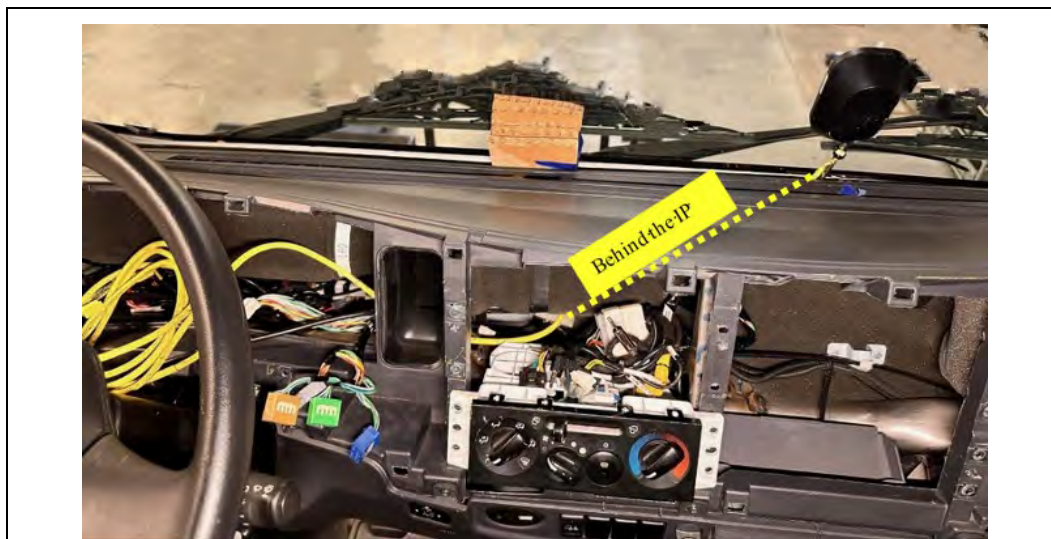
Figure 66

75. Route the new camera cable down, behind and under the instrument panel and HVAC duct toward the radio opening. If necessary, pull out the cup holder for more access. Grab the end of the camera cable and pull out the remaining length of cable. Loosely route the cable from the radio opening into the area behind the instrument panel cluster. (See Figure 66.)

New camera cable routing (painted in yellow for reference).

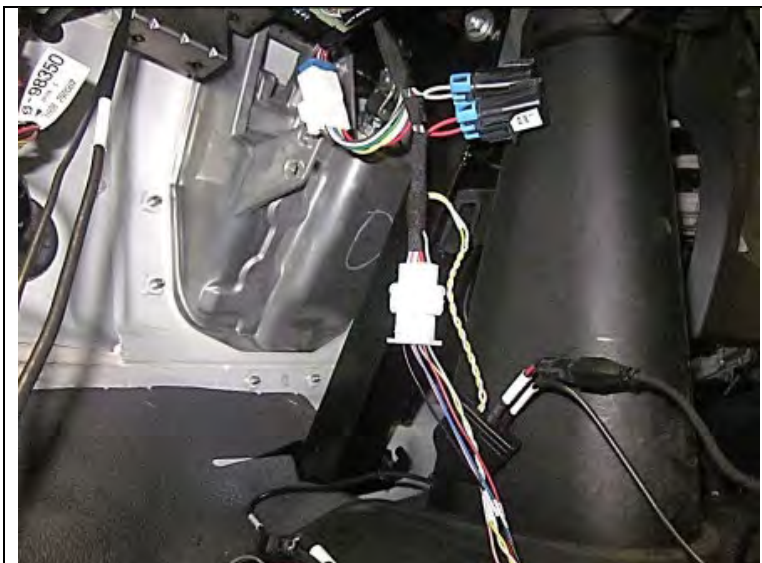
Figure 70

78. Following the original routing of the T-Harness, feed the T-Harness alongside the IP harness down to the left side of the steering column. (See Figure 70.) Then:

T-Harness

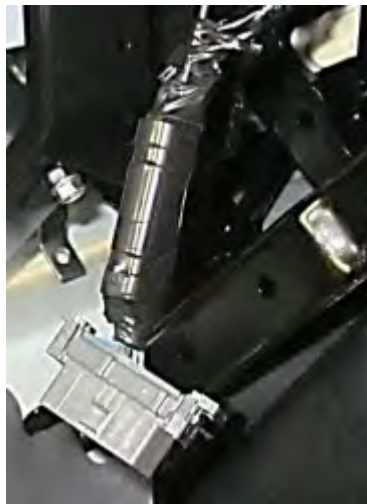
Figure 71
2019-2021 MY

80. Locate the CAN reader and remove the tape securing it to the DLC harness. (See Figures 71 and 72.)

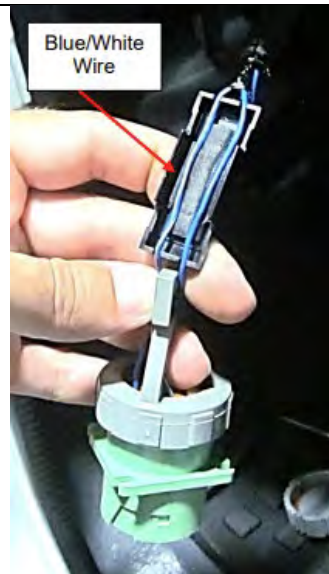
Figure 74
2022-2023 MY

81. Using a small flat head screwdriver, pry open the caps for the old and new CAN readers.
82. Remove the adhesive tape backing from the new CAN reader cover.
83. Transfer the CAN low (Solid color) wires and CAN high (Striped color) wires from the old CAN reader cap into the new CAN reader cap. (See Figures 73 and 74.)

1. CAN High (Blue wire with stripe)
2. CAN Low (Solid blue wire)

IMPORTANT: Do not switch the orientation of the CAN wires. Failure to follow these instructions carefully will result in Mobileye not working properly.

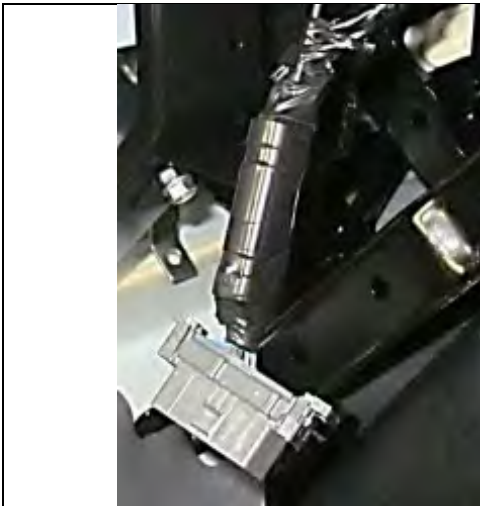
Figure 77

85. Tape the new CAN reader back to the DLC harness using electrical tape. (See Figures 77 and 78.)

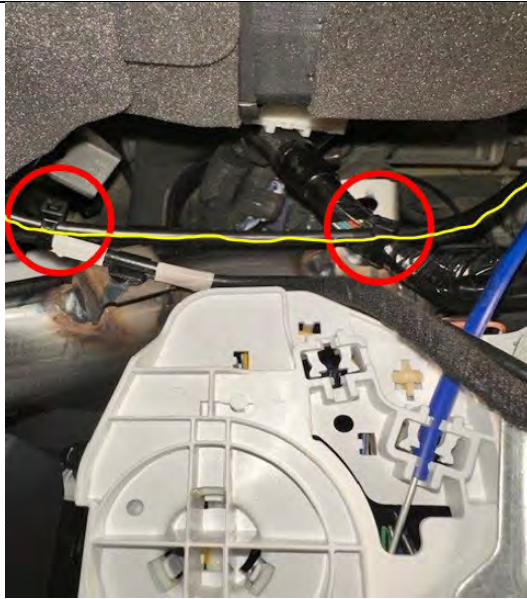
Figure 81

91. Install two (2) zip ties to secure the harness behind the radio. If needed, pull out the cup holder for more access. (See Figure 81.)

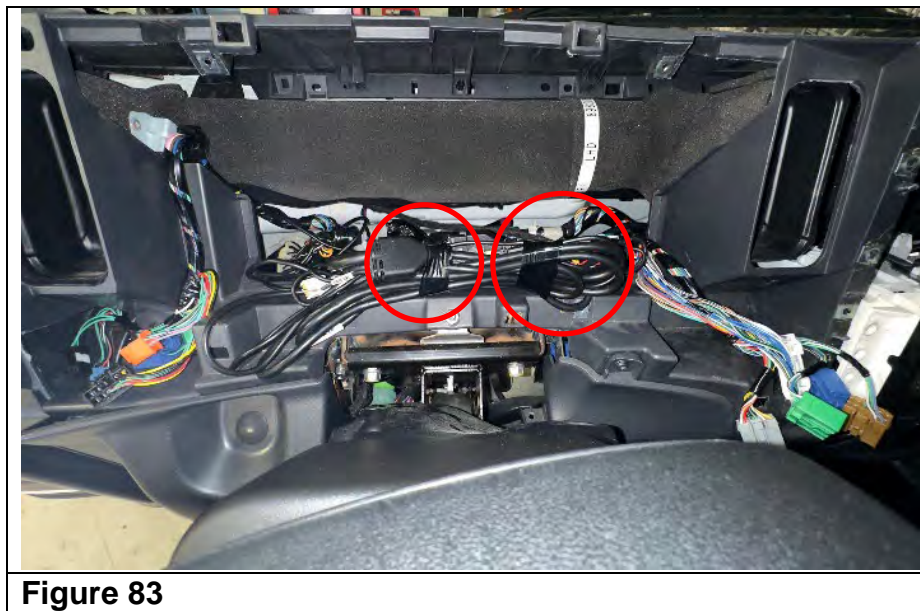
93. Bundle the Mobileye harnesses back together and secure them with electrical tape in the two locations shown in Figure 83.

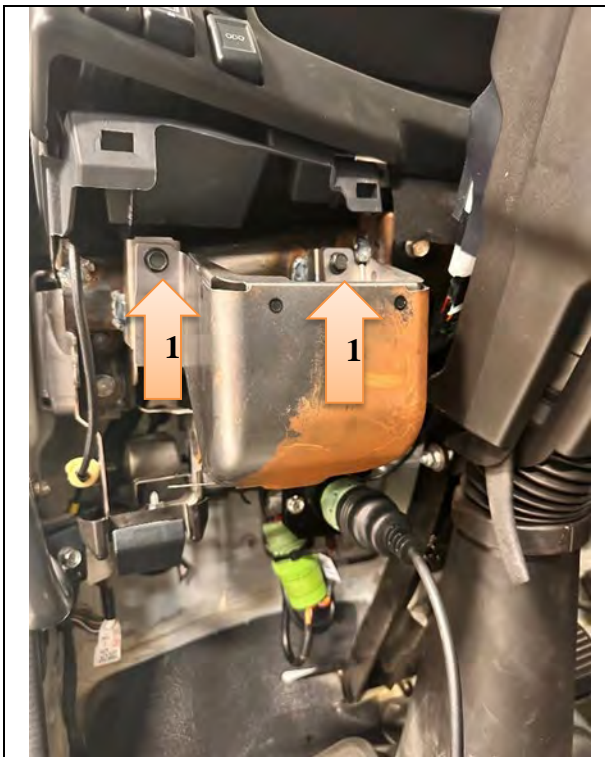
Figure 89

1. Bolts

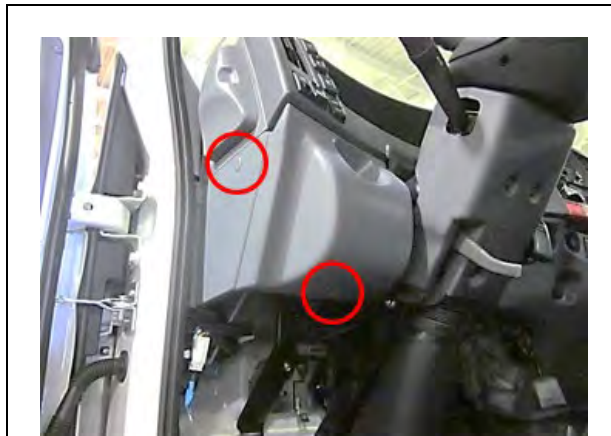
Figure 90

100. Install the driver side instrument side cover removed in Step 47. (See Figure 90.)
