AR878 2018-2019 SOI-F Front Frame Reinforcement

Complaint: Structural stress crack of chassis frame at front of rear suspension

Vehicles Affected: 2018/2019 Spirit of Independence - Ford (SOI-F)

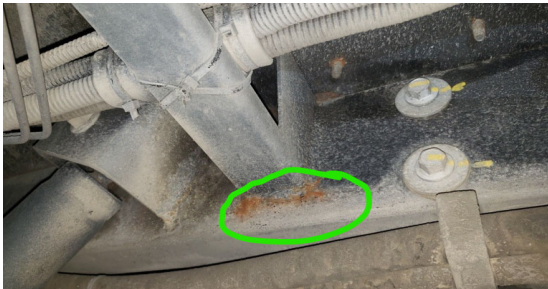
Cause : Concentrated stress loads

Step 4) If unit has cracks in frame - drill 1/8 inch holes at the ends of the cracks , grind surface clean and weld cracks and holes closed

Correction: Drill stop holes into frame,weld cracks and weld provided reinforcement plate to affected area

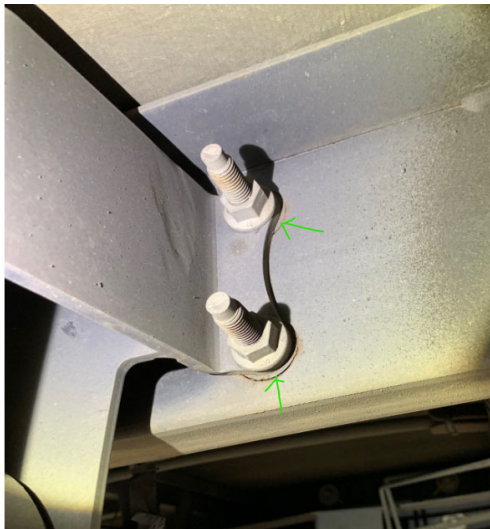
Step 5) Grind surface smooth , install reinforcement plate and weld plate into place following weld guidelines below.

NOTE : While repairing this area inspect Drawn Over Mandrel Tube (DOM) in frame for cracking (see green arrows in picture) - If cracking has occurred perform repairs per ARBOC repair instrucion AR880.
