Technical Service Bulletin

Mazda North American Operations
Irvine, CA 92618-2922

Subject: LEATHER STEERING WHEEL SURFACE WEAR / PEEL	Bulletin No.: 06-001/25
	Last Issued : 01/23/2025

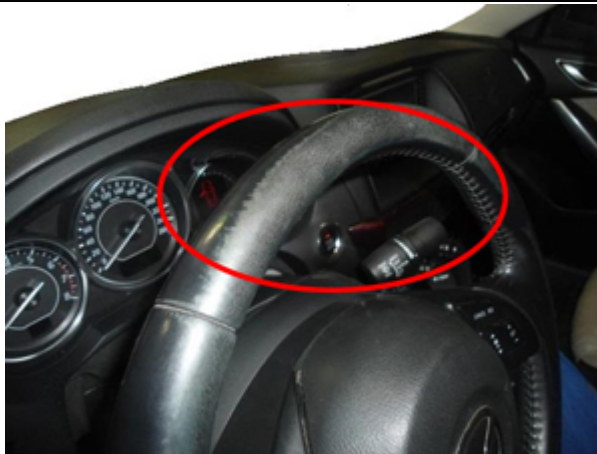
Some vehicles may exhibit wear/peel-off of the leather steering wheel surface causing a poor appearance. This concern

may be caused by an insufficient wear resistance of the steering wheel surface.

3. Replace the steering wheel (A) according to the repair instructions on MGSS online:

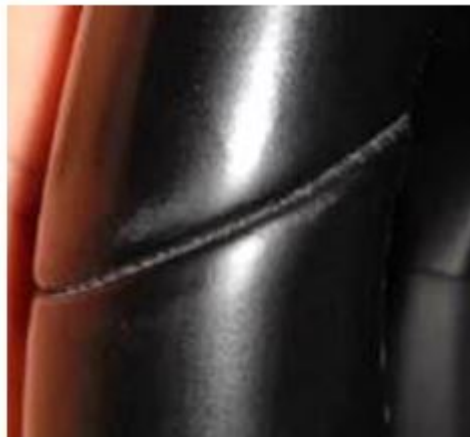
NOTE: Slight wear on a seam of the steering wheel is not applicable to this bulletin. It is inevitable since friction and force are applied while turning the steering wheel.

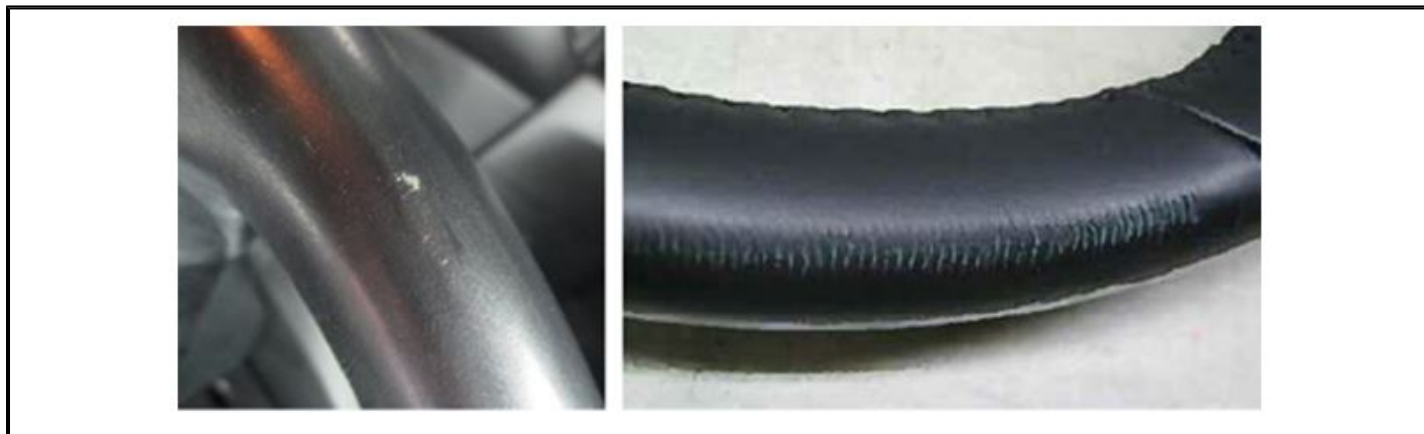
- Do not use general leather cleaners or waxes when wiping off dirt since it may deteriorate the leather coating of the steering wheel. In addition, perfumes, cosmetics, hand creams, sun screens, wet tissue papers, excessive sweat and sebum may also deteriorate the coating.
- Do not scratch or scrub the leather with anything hard, such as a belt buckle, wrist watch, bracelet or rings etc.

NOTE: The examples above are caused by outside influence and therefore not covered under this bulletin.
