Technical Service Bulletin

87 Air conditioner console: display on temperature control differs from set temperature

87 25 97 2075688/2 January 23, 2025. Supersedes Technical Service Bulletin Group 87 number 24-91 dated October 21, 2024 for reasons listed below.

Model(s)	Year	VIN Range	Vehicle-Specific Equipment
Q5, Q5 e quattro, Q5 Sportback, SQ5, and SQ5 Sportback	2022 - 2025	All	Not Applicable

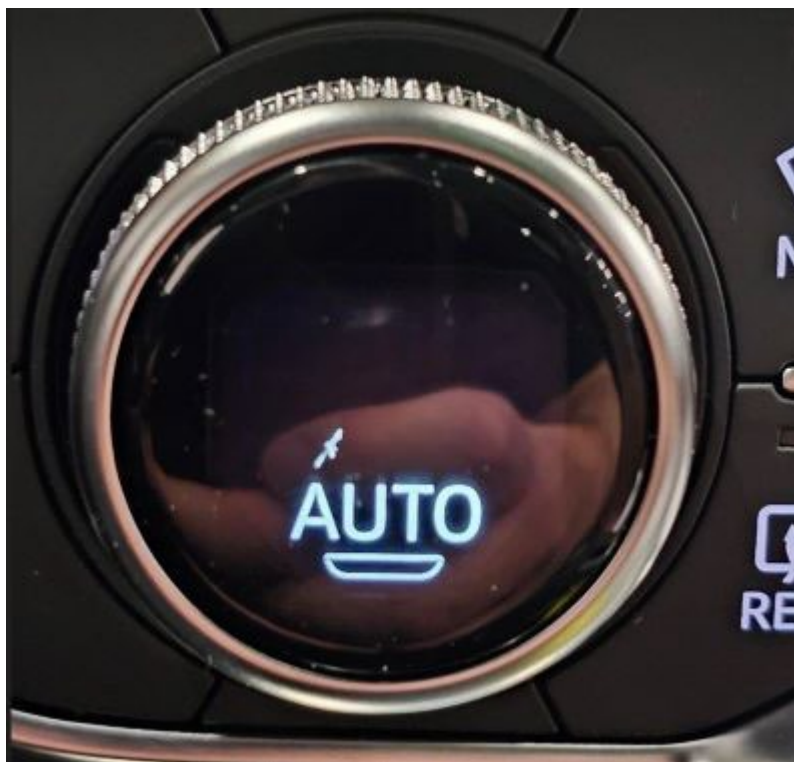
Figure 1. Display with missing temperature value.

The complaint can be reproduced in the workshop. The temperature is displayed similarly to in the following example images. The temperature can still be adjusted with the rotary knob despite the display issue.

Figure 1 shows a display with a missing temperature value.

Tension in the component can cause internal pressure on the LCD panel, resulting in an issue with the display.

If the display on the air conditioner operating unit behaves as described above under workshop findings, remove the entire unit from the vehicle and unplug it. Then, reinstall the same air conditioner operating unit in the car. If the complaint continues to occur after this process, then the air conditioner operating unit is defective, and we recommend replacing it.

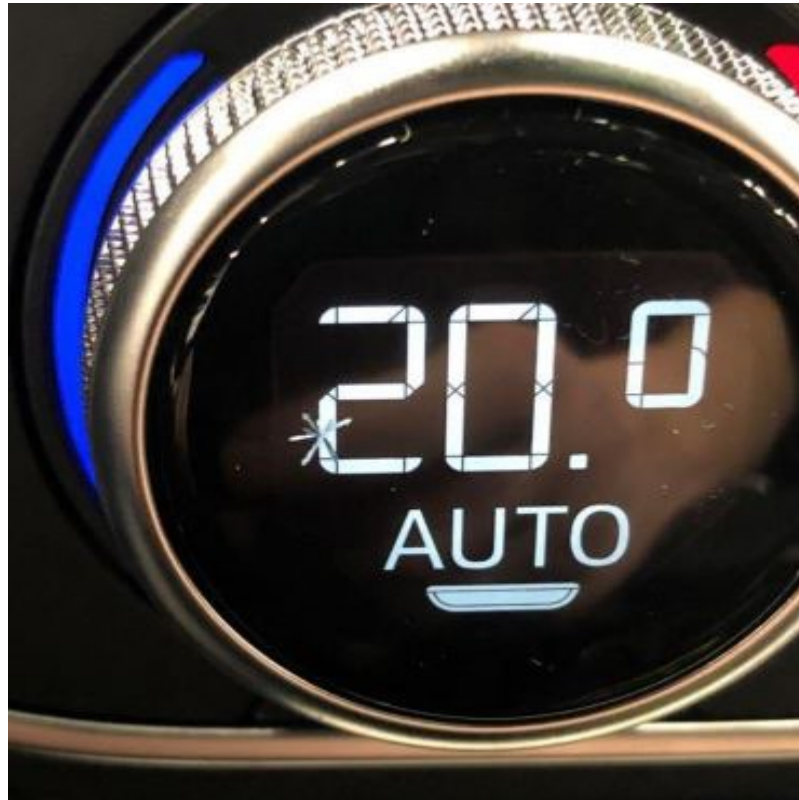
Figure 2. Display with distorted pixels.

Figure 2 shows a display with distorted pixels.
