Technical Service Bulletin

40 Noises from front end of vehicle when steering and/or when suspension compresses

40 25 95 2075251/2 January 27, 2025. Supersedes Technical Service Bulletin Group 40 number 24-83 dated September 17, 2024 for reasons listed below.

Model(s)	Year	VIN Range	Vehicle-Specific Equipment
Q4 e-tron, and Q4 Sportback e-tron	2022 – 2025	All	Not Applicable

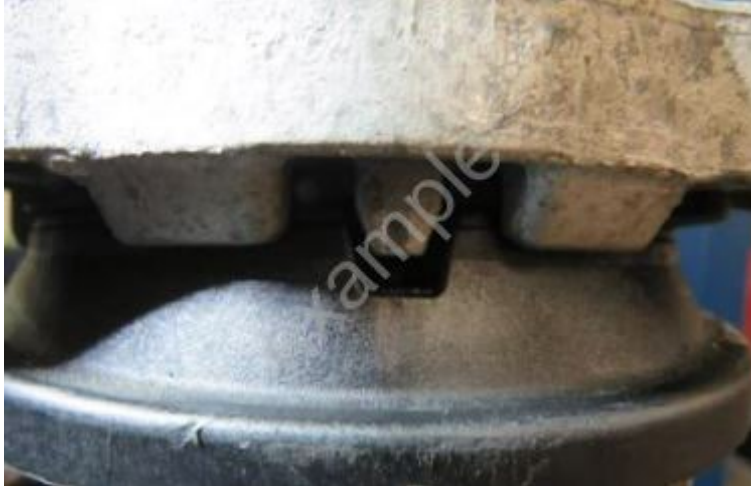
Figure 2. Example: sufficient clearance between suspension strut mounting and deep groove ball thrust bearing.

- Reassemble suspension strut mounting and deep groove ball thrust bearing and check that there is sufficient clearance (see Figure 2):
- If there is sufficient clearance, continue with the next step.

- If there is insufficient clearance, file down/shorten positioning lug on suspension strut mounting further as required. Then continue with the next step.
