**PROTERRA**

# TECHNICAL SERVICE BULLETIN

<b>ISSUE DATE:</b>	11-16-2020
<b>SERVICE BULLETIN SUBJECT:</b>	Rear Door Aux Heat Tube Retrofit
<b>VINs or MODELS AFFECTED:</b>	Service Specified Buses
<b>COMPLETE BY:</b>	Next Service Opportunity
<b>SERVICE BULLETIN #:</b>	SC-20-162
<b>Labor Operation Code:</b>	VD41Z

This procedure updates the rear door aux heat to stainless steel material for improved corrosion resistance.

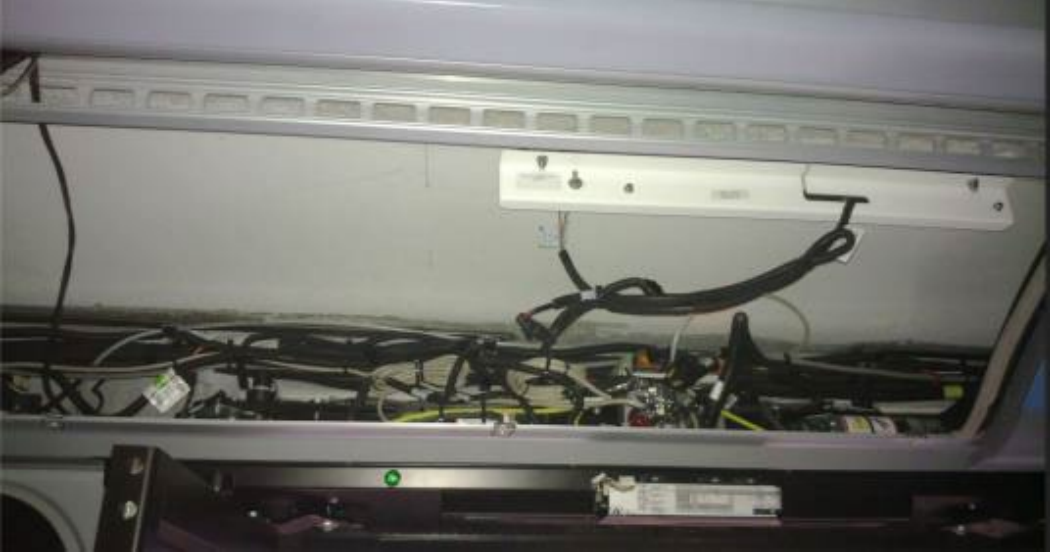
1. Complete the Proterra approved Lockout/Tagout procedure to make the bus safe for work.
2. Using a 3/16-Inch Allen Driver, remove the Hadley Panel above the exit door.

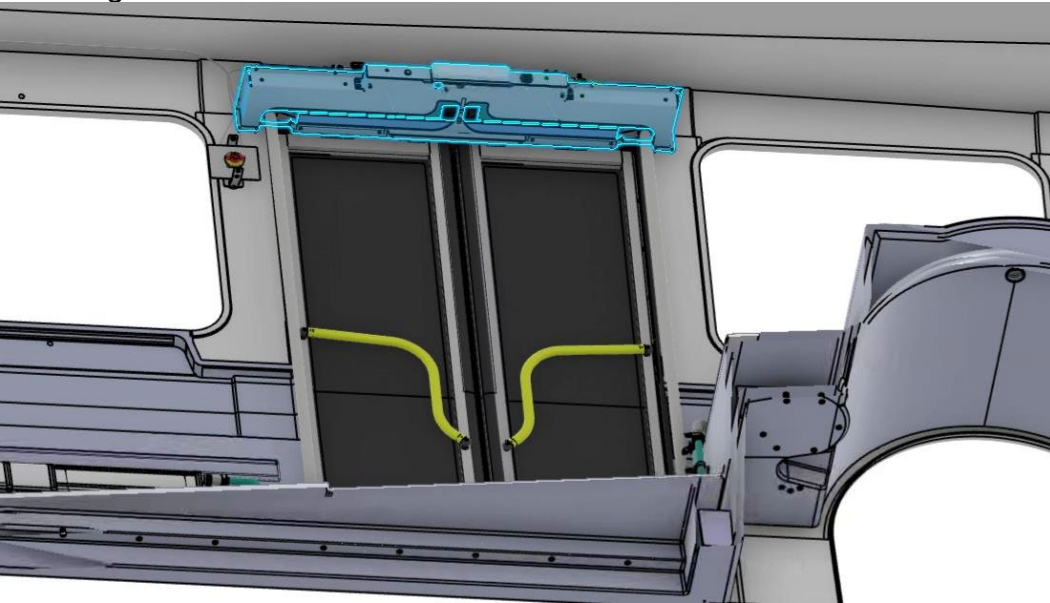
3. Using a T-30 Torx Driver, remove the Rear Door Closeout Panel shown highlighted in the following illustration.

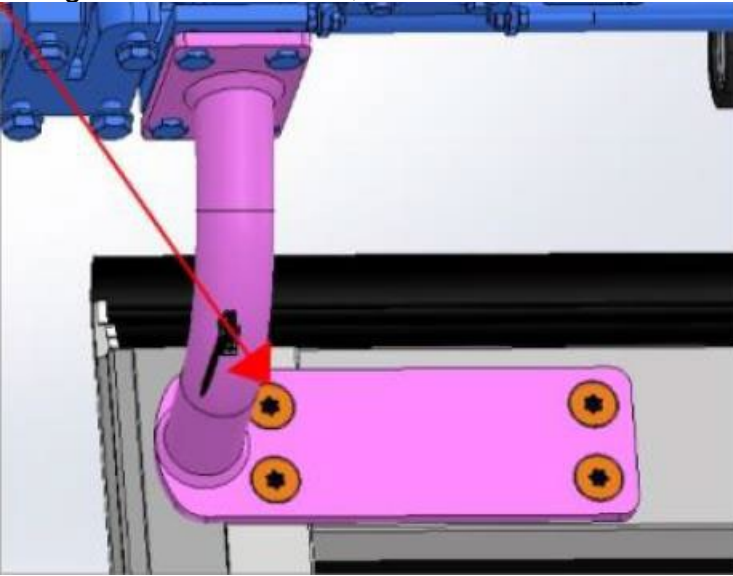
5. Using a T-55 Torx Driver, remove the M12 Torx Screws at the top of each door leaf.

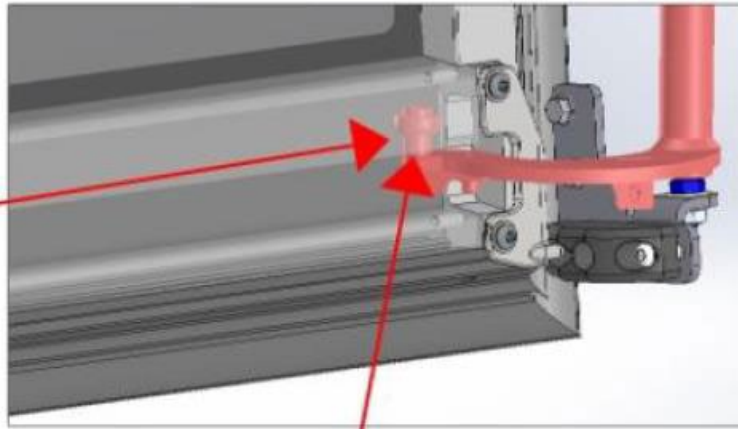
**Bearing**

6. Remove each Door Leaf from the door frame by lifting them off the lower bearing as shown in the following illustration.

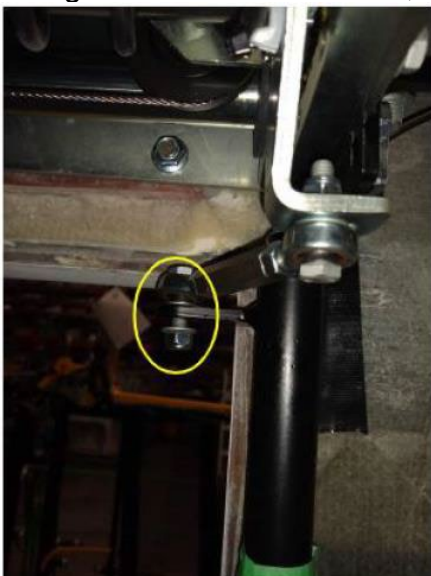
7. Using an M8 Ratchet/Socket, remove the turnbuckle bolts at the top of each door leaf.

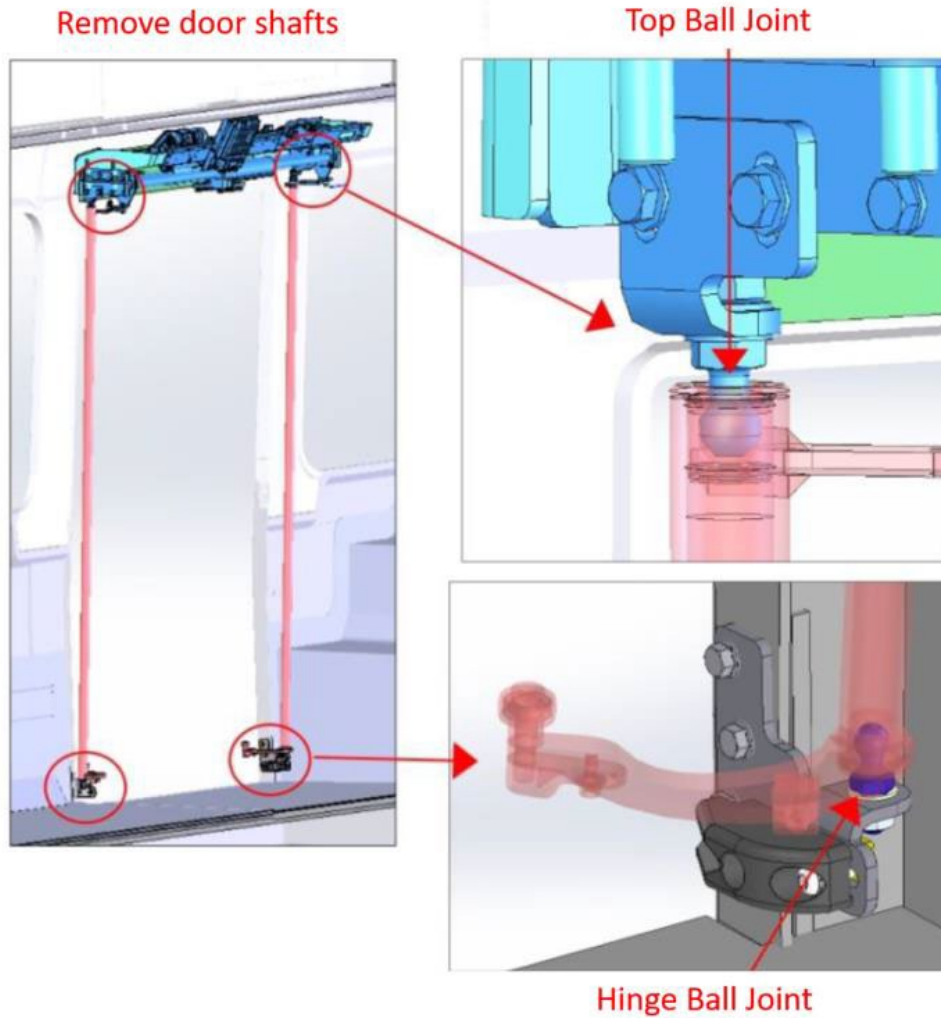
8. Using an M8 Ratchet/Socket, loosen the hinge brackets at the bottom of the doorway. Remove the door shafts from the upper and lower ball joints.

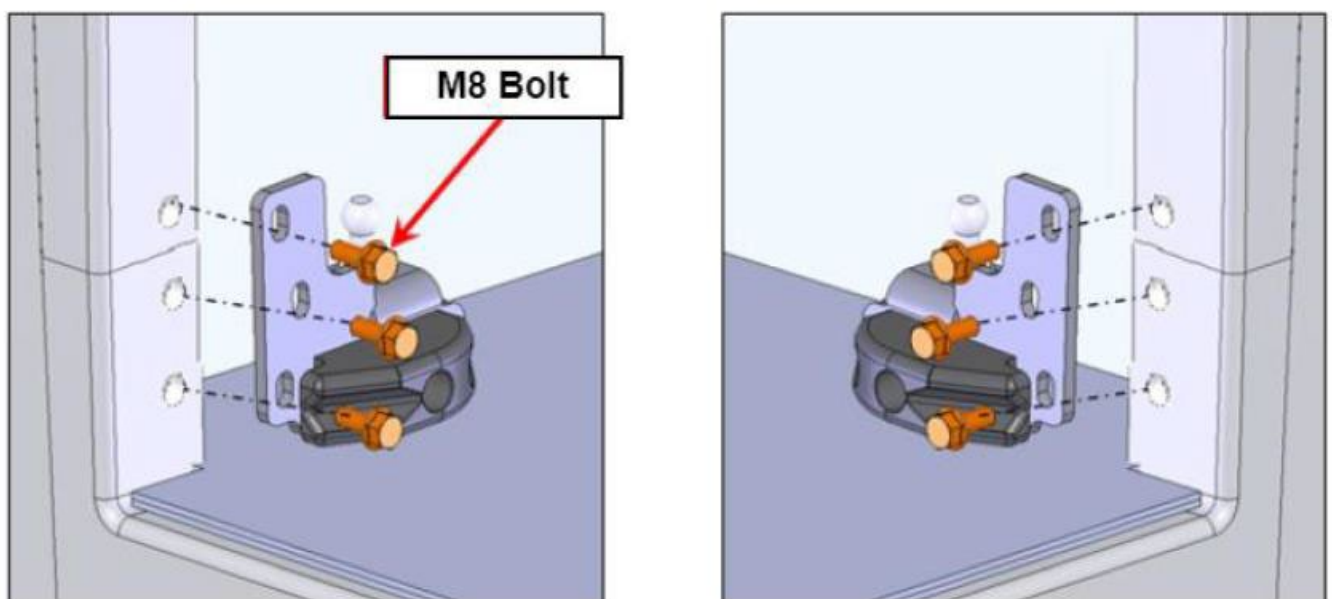
9. Using a 13mm Ratchet/Socket, remove the hinge brackets from the bottom of the doorway.

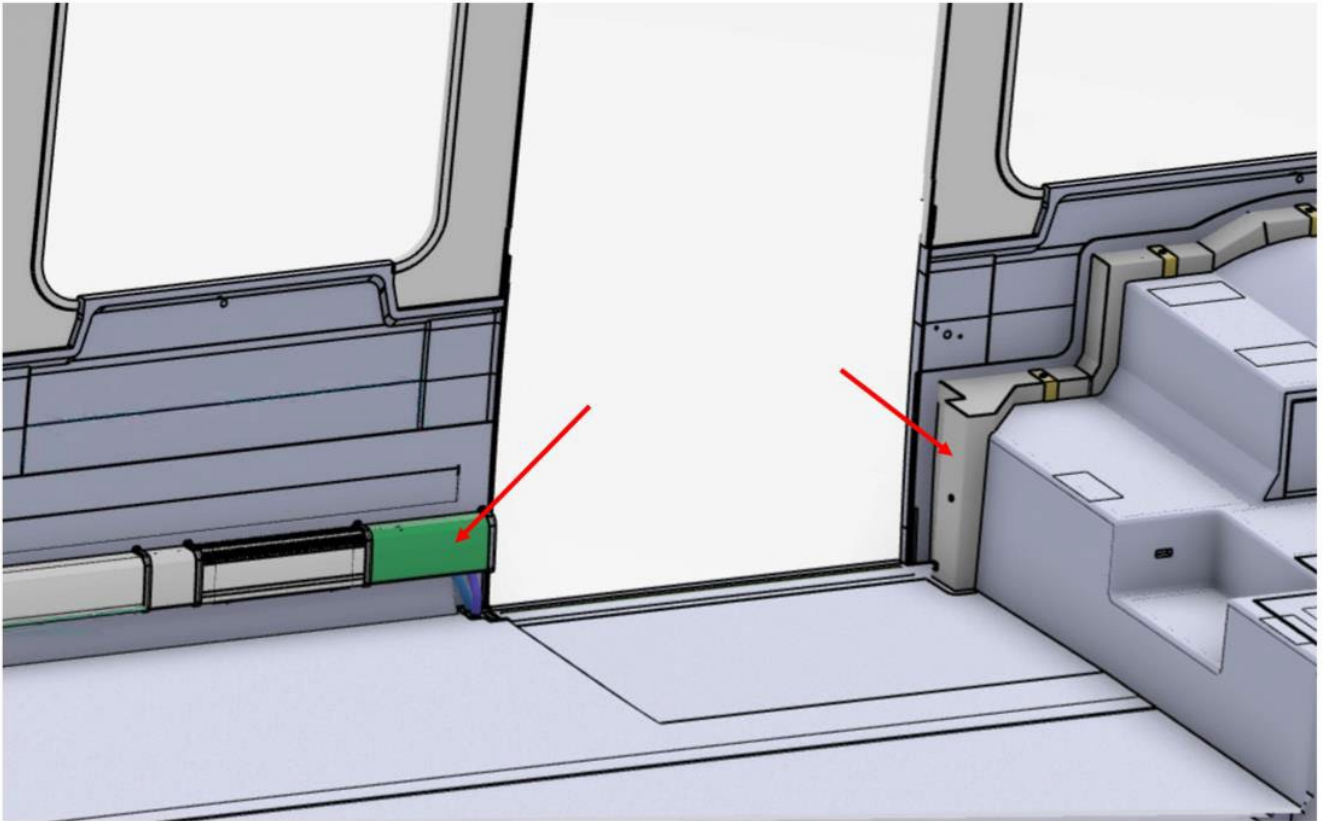
10. Using a T-20 Torx Driver, remove the metal covers on each side or the rear doorway.

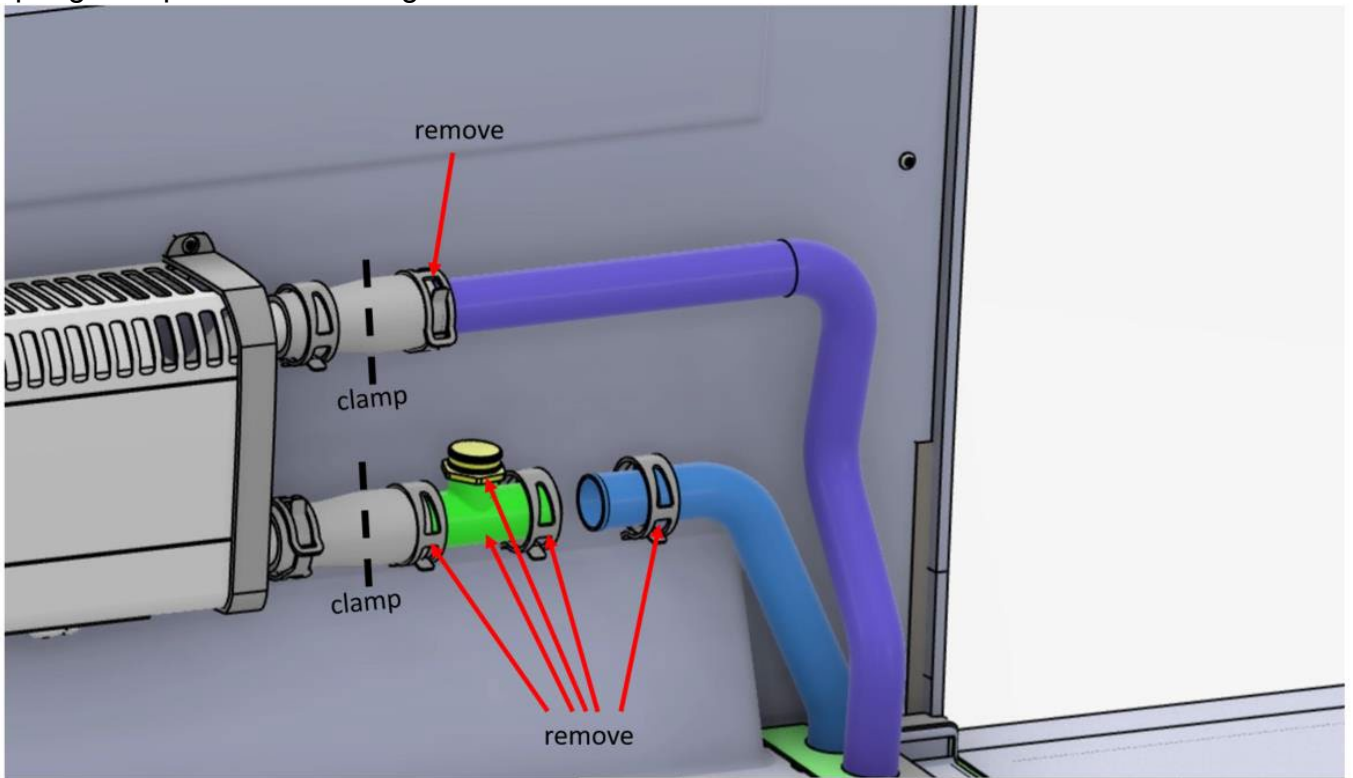
11. Using Pinch Clamp Pliers, clamp the coolant tubes in the location shown below. Remove the spring clamps and Tee Fitting as shown.

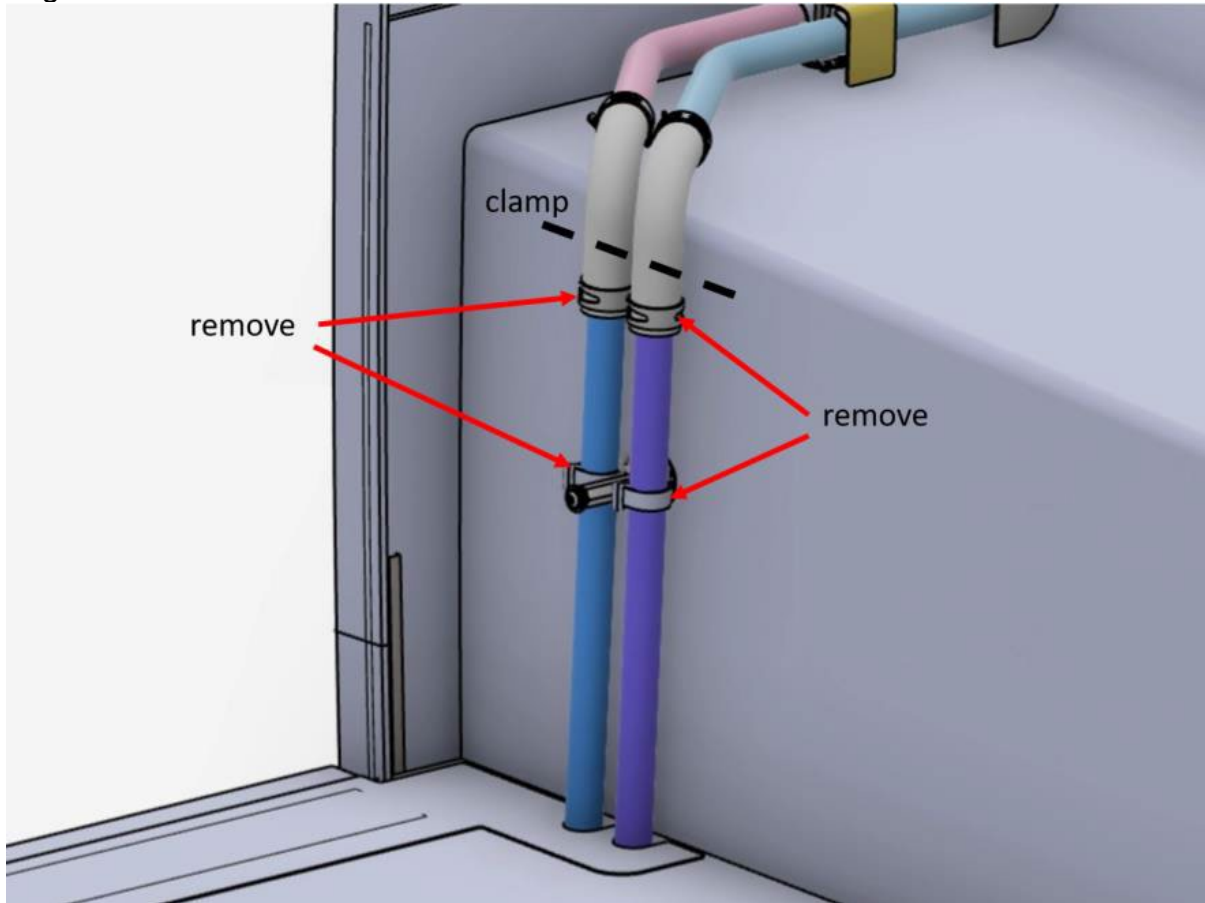
12. Using Pinch Clamp Pliers, clamp the coolant tubes in the location shown below. Remove the Cable Ties and Spring Clamps. Detach the rear passthrough tube assembly from the 90-degree tubes.

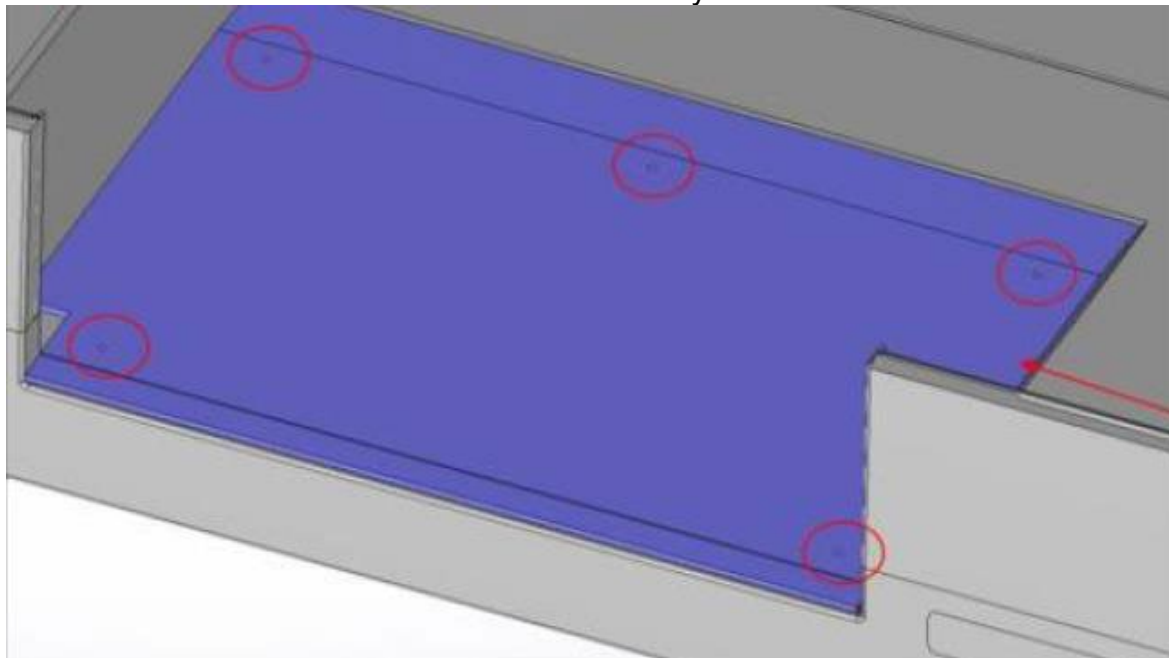
13. Using a Flat Blade Screwdriver, remove the M6 Screws shown circled in red below. Disconnect the heated mat harness. Remove any caulk around the mat. Remove the mat.

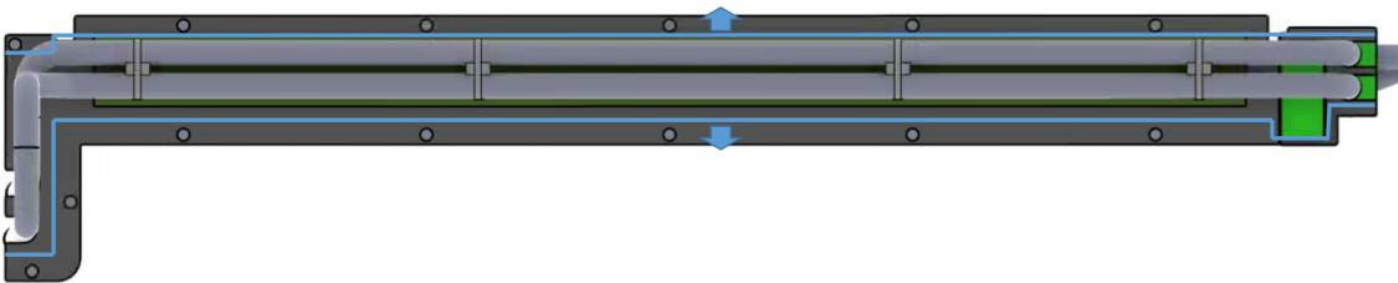
14. Using a Heat Gun, weaken the Bondo on top of the Tube Assembly. Using a Putty Knife, remove the Bondo to access the Plexus adhesive on the Tube Assembly.
15. Using a Heat Gun and Putty Knife, de-bond the Plexus Adhesive that secures the Tube Assembly to the bus body.
16. Remove the Tube Assembly from the Bus.
17. Using a Heat Gun and Putty Knife, remove any excess Plexus and/or Bondo from the area where the Tube Assembly was removed.
18. Using 36-Grit Sandpaper, scuff the bus body for bonding to the new Tube Assembly (122-9226).
19. Using a Power Drill with a 36-Grit Sanding Disk, scuff the areas shown outside the blue lines on the new Tube Assembly (122-9285)

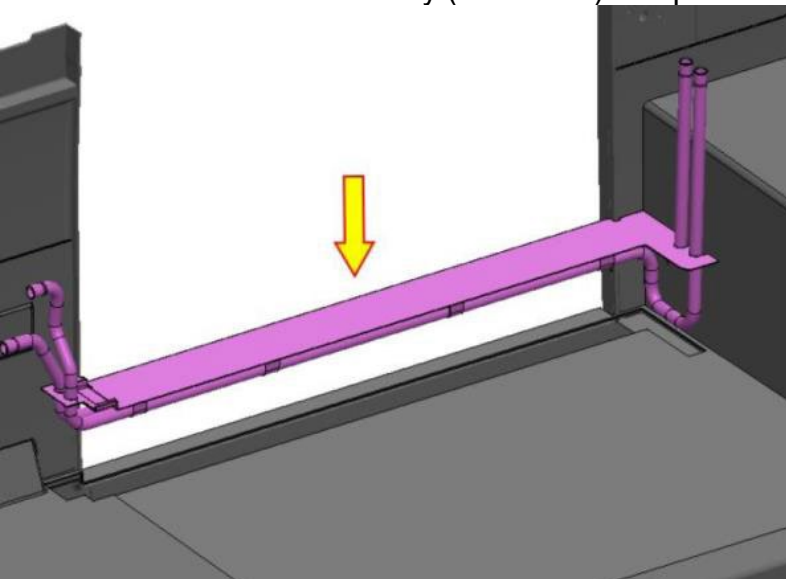
20. Using Alcohol and Shop Towels, clean the scuffed areas on the bus body and the Tube Assembly (122-9285).
21. Using a Shop Towel, apply Plexus Primer to the scuffed areas on the new Tube Assembly (122-9285).
22. Using a Plexus Gun, apply Plexus to the scuffed area on the new Tube Assembly (122-9285).
23. Lower the new Tube Assembly (122-9285) into position on the bus.

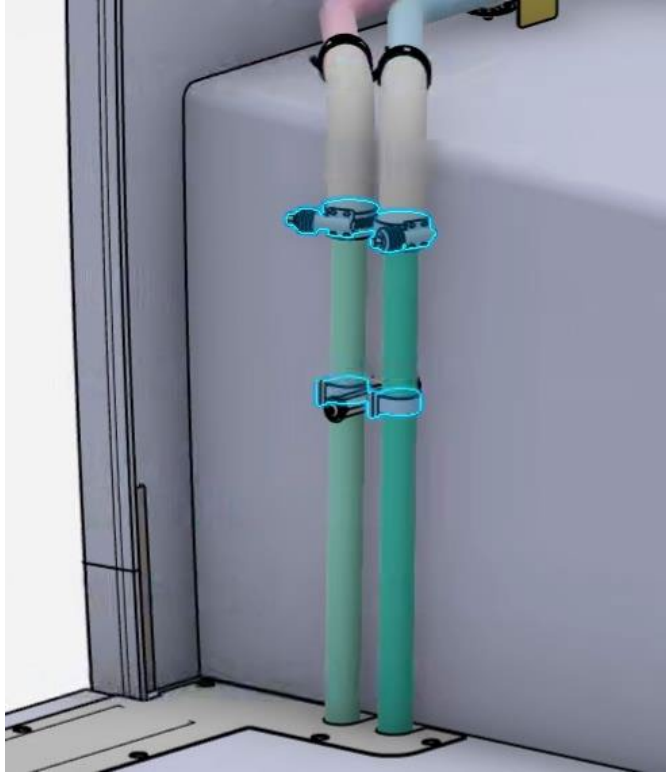
24. Using a Plexus Gun, apply a bead of Plexus around the perimeter of the new Tube Assembly (122-9285) to seal its edges.
25. Allow time for the Plexus to cure.
26. Using Pinch Clamp Pliers, connect the 90 degree silicone tubes at the rear to the new Tube Assembly (122-9285).

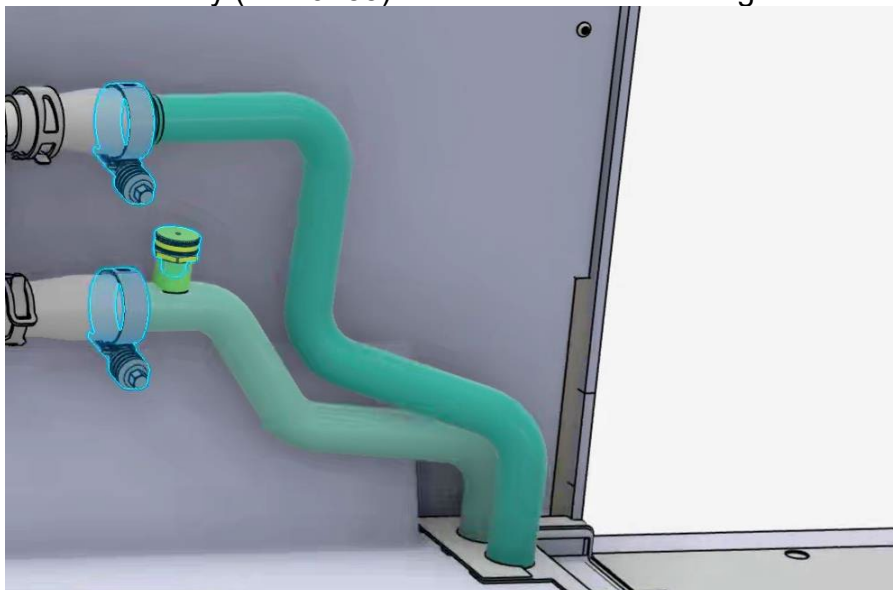
27. Using Cable Ties (012138), secure the tubes to the mounting hardware.
28. Using an XX-Inch Combination Wrench, install the new Drain Fitting (043090) into the new Tube Assembly (122-9285) as shown in the following illustration.

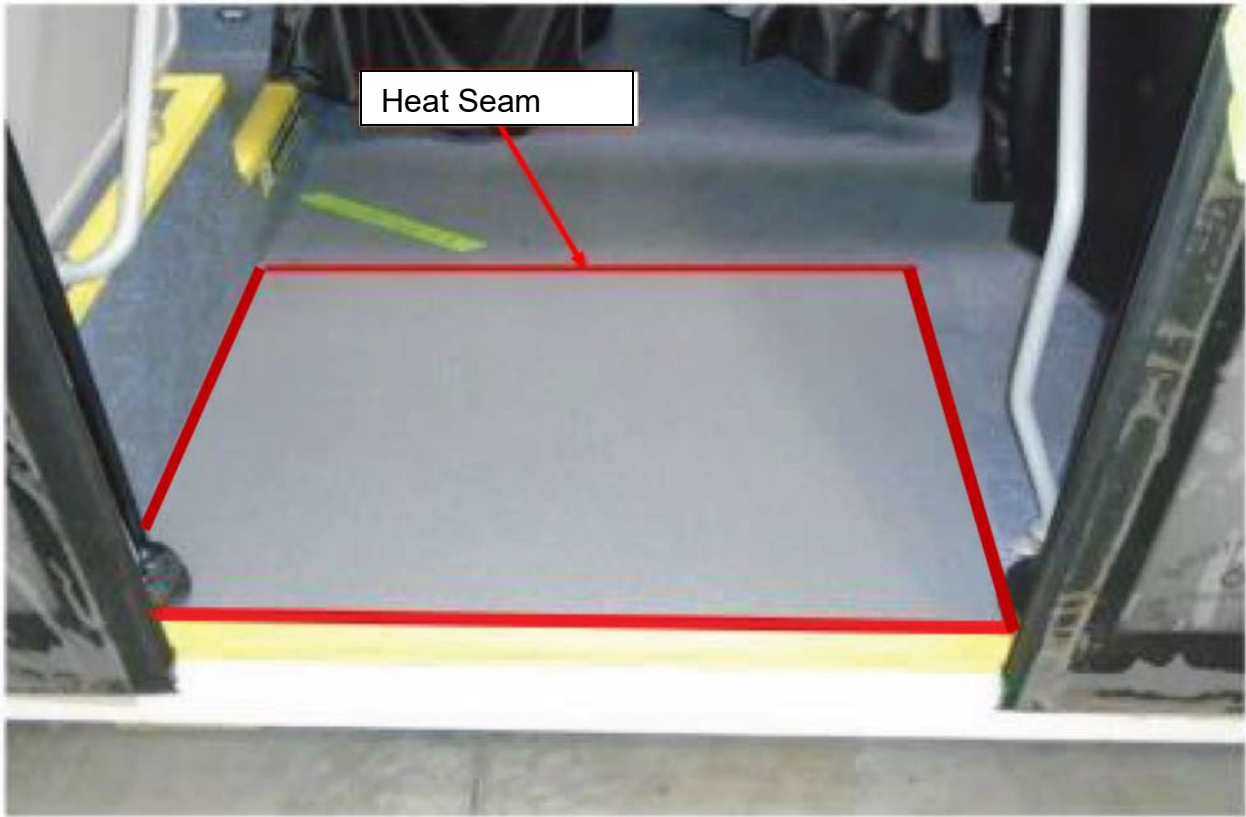
29. Secure the new Tube Assembly (122-9285) to the reducer coolant tubes using Constant Tension Worm Clamps (044137).
30. Using a Putty Knife, apply Bondo above the Tube Assembly (122-9285) to create a flat surface for the heated mat. The Bondo may cover the entire passthrough plate as well as the surrounding floor.  
**Note:** Keep the Bondo out of the threaded inserts.
31. Reinstall the Heated Map.
32. Using a Caulking Gun, apply Caulk (009314) to the edges of the heated mat.

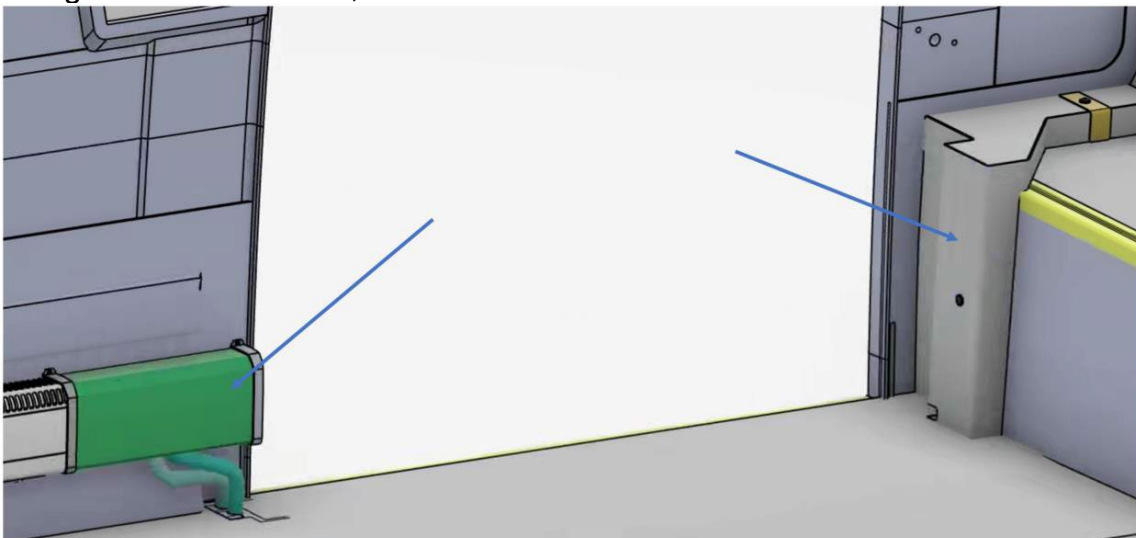
33. Using a T-20 Torx Driver, reinstall the metal covers that were removed earlier.

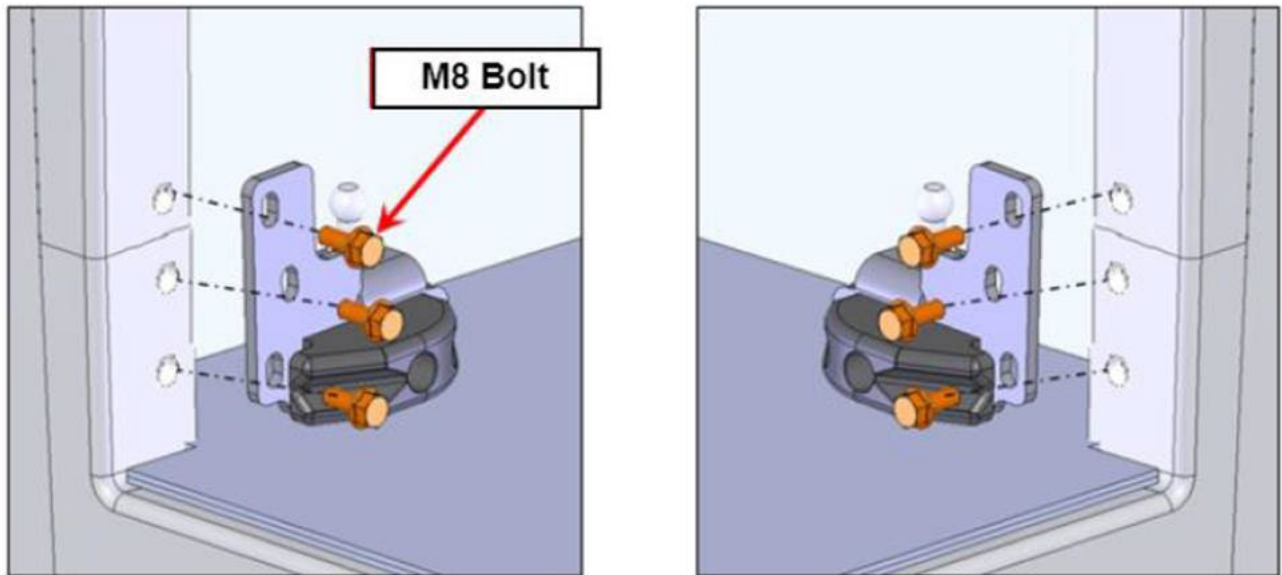
34. Using a 13mm Ratchet/Socket, reinstall the hinge brackets at the bottom of the doorway. Do not tighten the bolts completely.

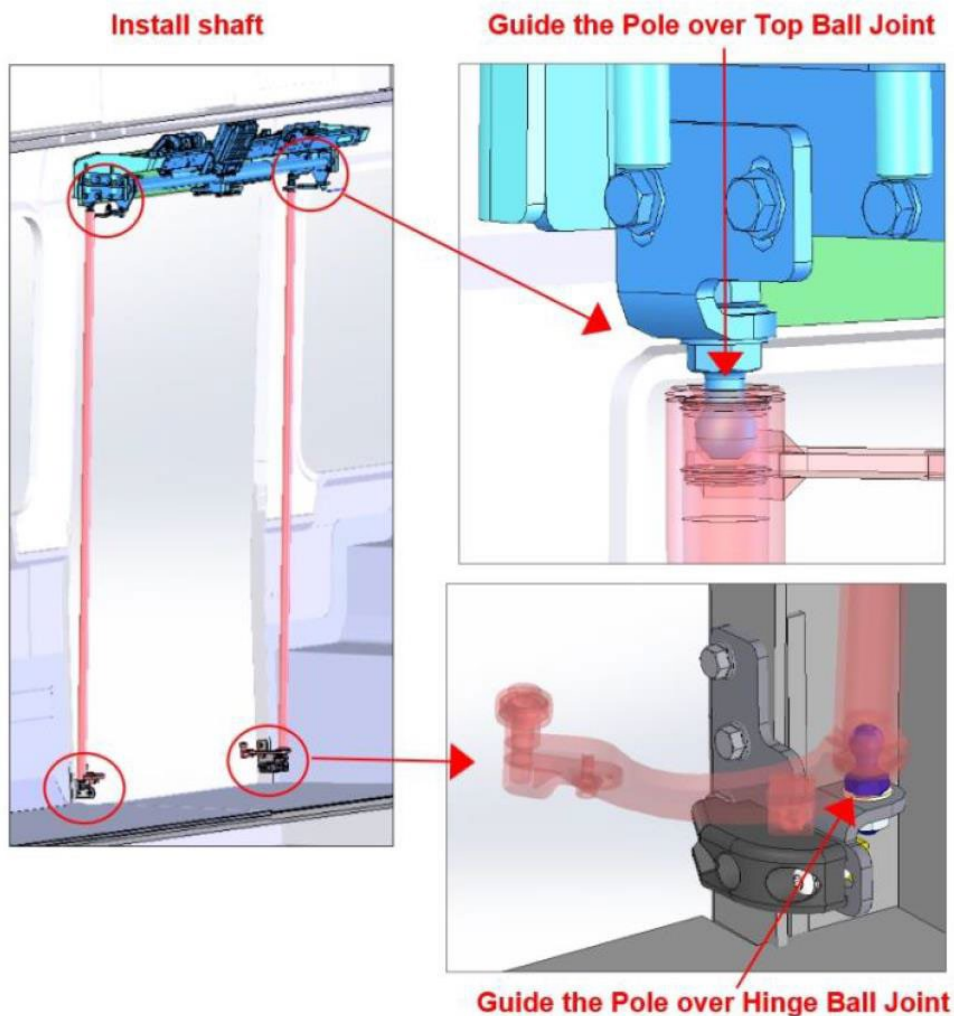
35. Reinstall the Door Shafts. Position the shafts over the bottom ball joint and guide them into place.

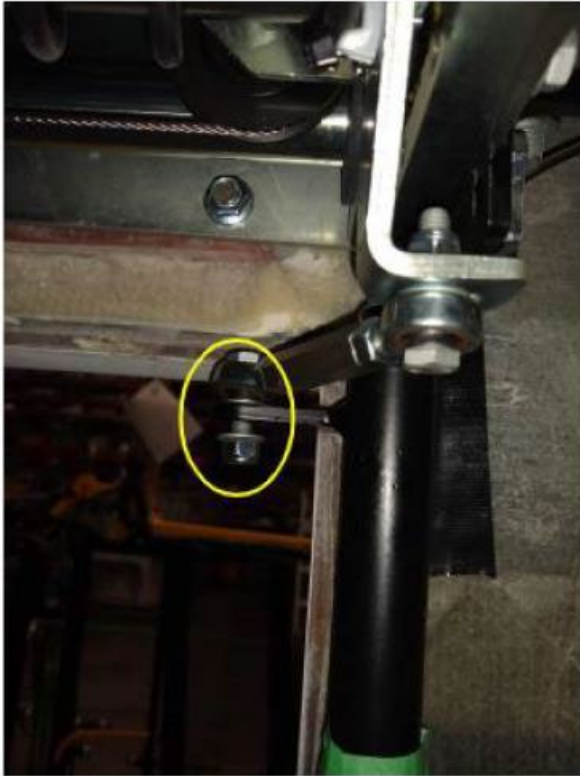
37. Using an M8 Ratchet/Socket, reinstall each turnbuckle bolt.

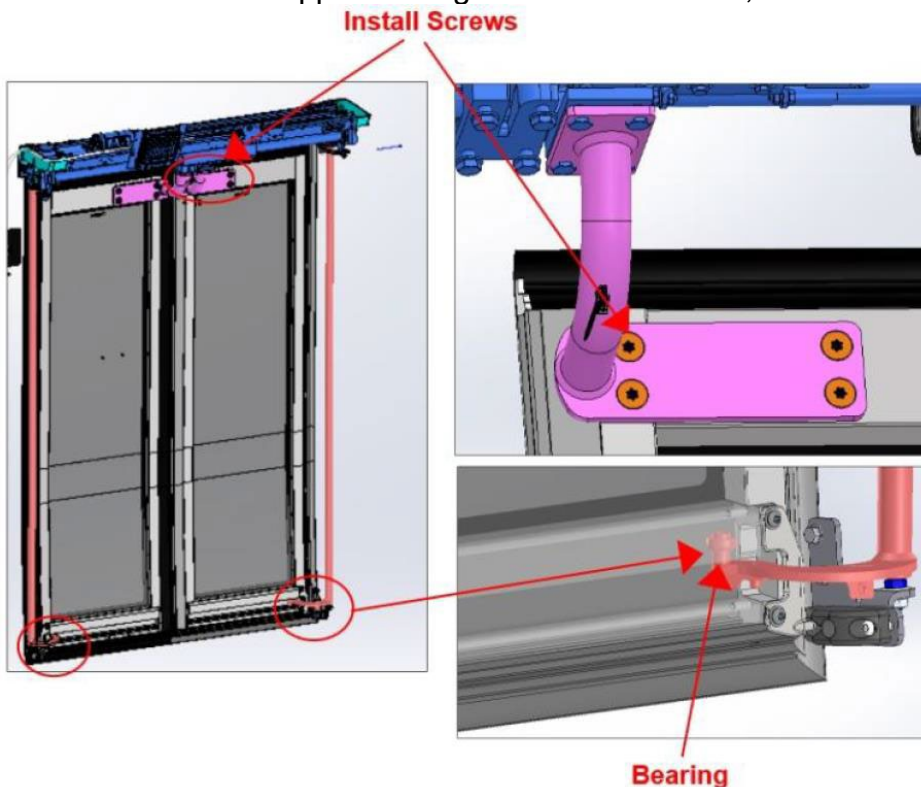
38. Lift each door leaf so that the bottom slot is over the lower bearing. Align the upper face of the door with the door support. Using a T-55 Torx Socket, install the M12 Countersunk screws.

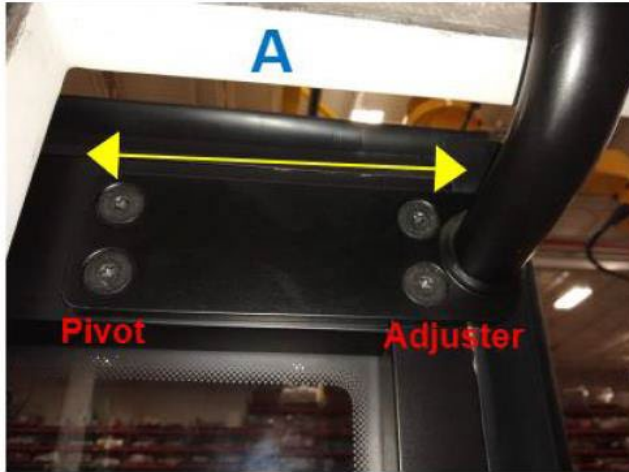
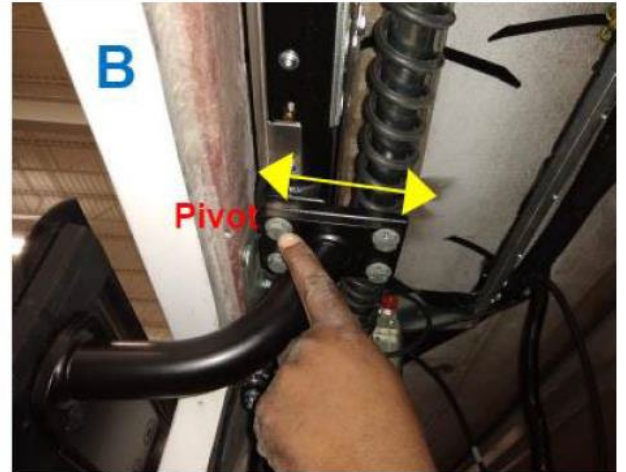
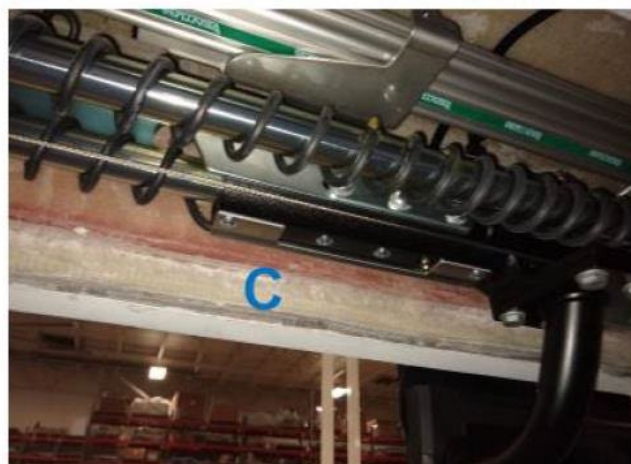
39. Reconnect the sensitive edge harness. Use Cable Ties (012138) to secure the cables so that they do not interfere with the motion of the doors.
40. Adjust the doors as necessary using the following illustrations.
- A Adjust for forward and aft direction.
  - B Adjust for door clearance (Cross-car with body direction).
  - C Adjust the tightness of the doors.

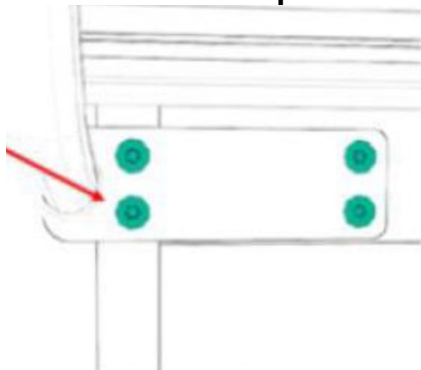
41. Adjust the Turnbuckle for the bottom leaf position.
42. Using a 13mm Socket, and a Calibrated Torque Wrench, **torque the M8 Bolts on the hinge brackets to 22 foot pounds.**
43. Using a T-55 Torx Socket and a Calibrated Torque Wrench, **torque the M12 Countersunk screws to 41 foot pounds.**

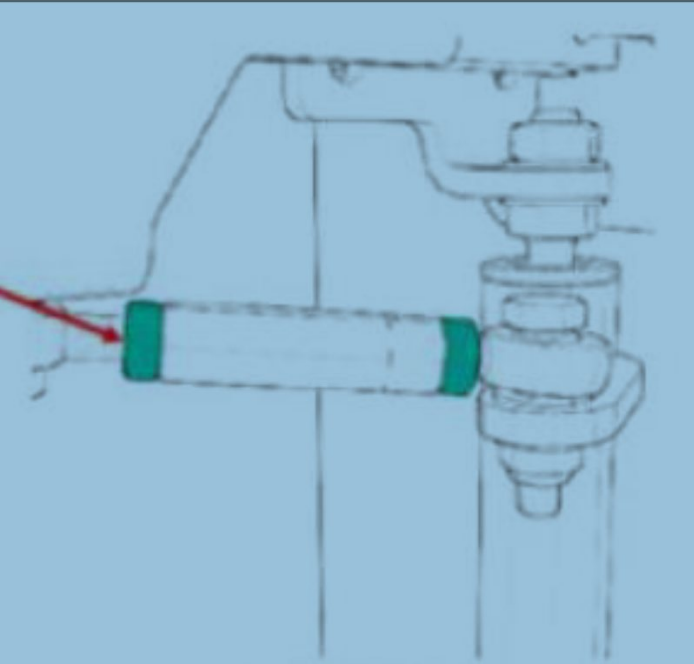
44. Using a 13mm Crow Foot Socket, and a Calibrated Torque Wrench, **torque the turnbuckle jamb nuts to 10 foot pounds.**

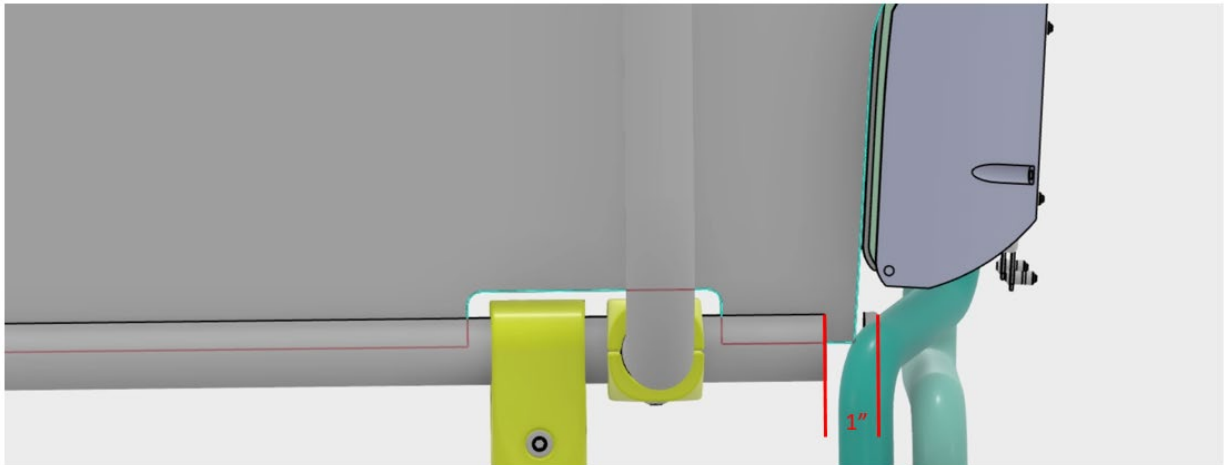
45. Using a Tubing Cutter, remove 1-Inch of the Stanchion shown in the following illustration.

46. Using a Deburr Tool, smooth the edge of the modified Stanchion.

47. Paint the cut end of the Stanchion using Yellow Stanchion Paint RAL 1023.

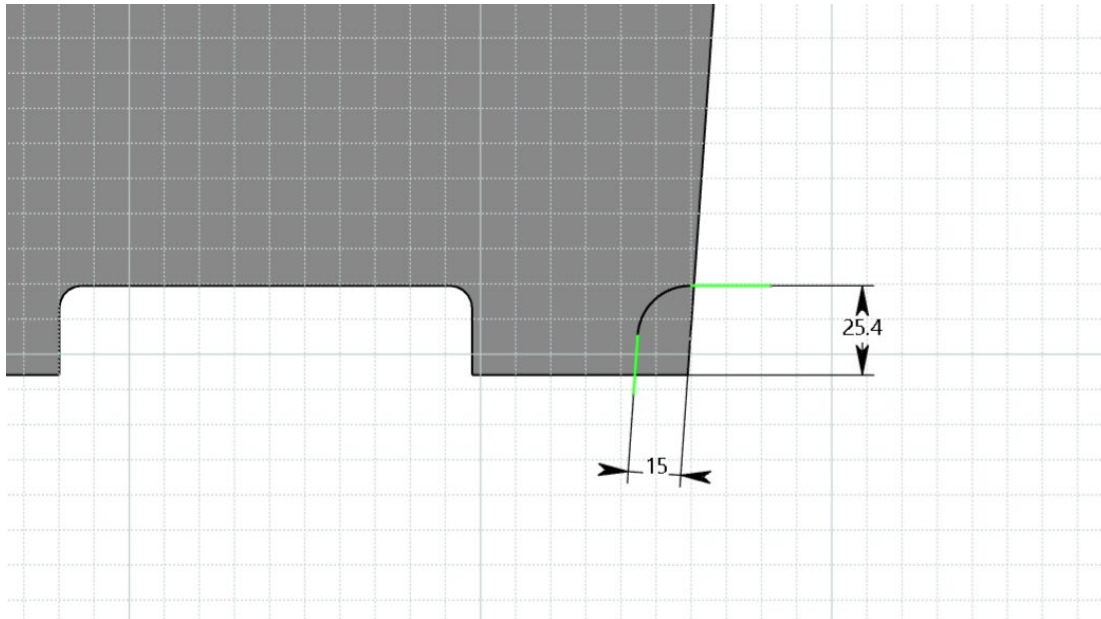
48. Using an Approved Safety Knife, modify the modesty panel as shown in the following illustration.

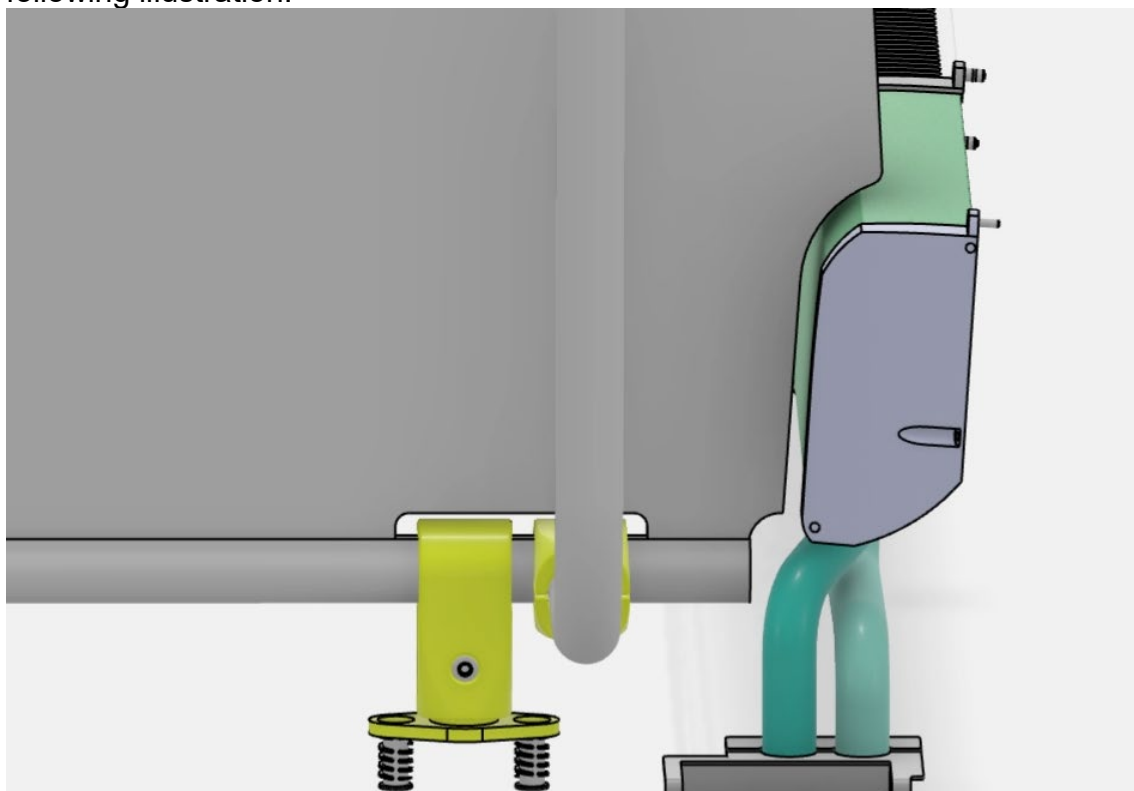
49. Reassemble the Modesty Panel and Stanchion. The modified Modesty panel is shown in the following illustration.
