January 30, 2025

## Weatherstripping Loose or Not Set

Year	Model	Trim Level	VIN Range
2023–25	Accord	ALL	1HGCV1F***A000074–1HGCV2F***A023161

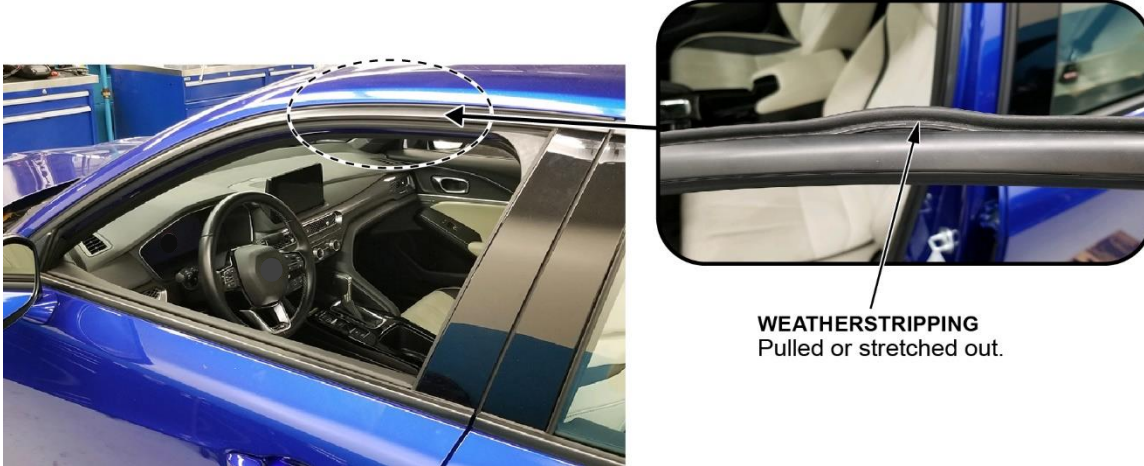
If the weatherstripping is pulled out of the sash and is undamaged, continue to the REPAIR PROCEDURE section in this bulletin to replace the weatherstripping on all doors.

NOTE: If the weatherstripping is damaged, this procedure does not apply.

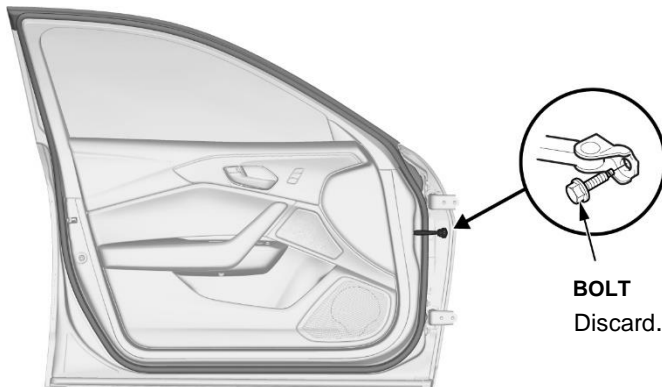
2. Remove the bolt from the door checker. Discard the bolt.

NOTICE: With the door-checker bolt removed, the door can overextend and cause damage to the door. Use care around the door until the new door-checker bolt is installed.

3. Complete the removal of the weatherstripping, then discard it.
4. Starting at the front of the door, install the new weatherstripping in the reverse order of removal.
5. Install the new door-checker bolt then tighten to the specification, **29 N·m (21 lb-ft)**.
6. Clear the weatherstripping contact areas around the door of any dirt or debris.

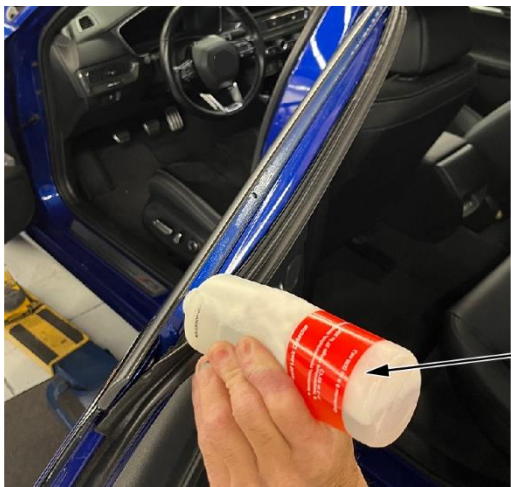
**SOAP AND WATER**  
Place solution in channel and on weatherstrip.

7. Apply a soap and water solution to the channel on top of the door frame and the weatherstripping to aid installation.

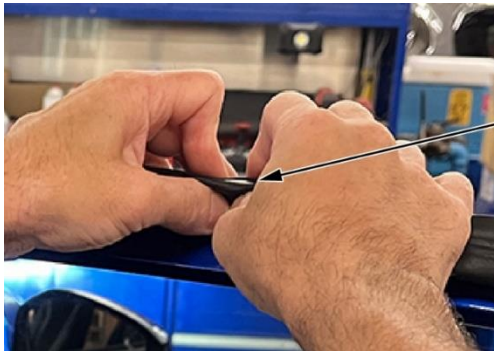
Pinch to aid in placing edges into the channel.

- If the door checker is in the way of installing the weatherstripping, remove the door checker bolt then continue the REPAIR PROCEDURE at step 4.
- Pinch the weatherstripping to aid in installing its upper and lower edges into the channel of the door frame.

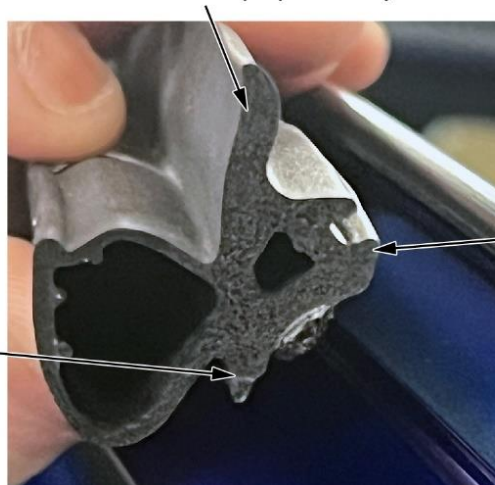
**CROSS-SECTION**  
For illustration purposes only.

**NOTE:** Ensure both edges of the weatherstripping are firmly installed into the channel of the door frame.

**LOWER EDGE**  
Ensure lower edge is inside channel.

**UPPER EDGE**  
Ensure upper edge is inside channel.

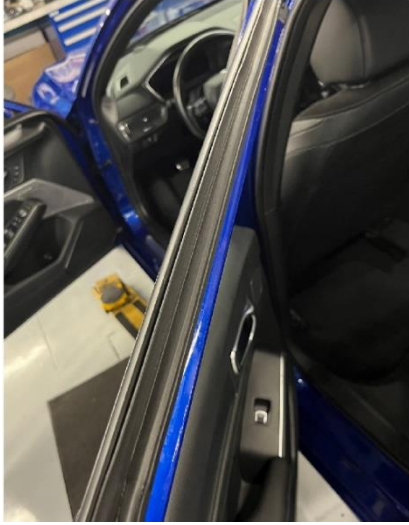
**CORRECT** ✓

NOTE: Be sure the weatherstripping is straight once installed.
