TECHNICAL SERVICE BULLETIN

ISSUE DATE:	11-2-2020
SERVICE BULLETIN SUBJECT:	800 Volt Rear Coolant Hose Retrofit
VINs or MODELS AFFECTED:	Service Specified Buses
COMPLETE BY:	Next Service Opportunity
SERVICE BULLETIN #:	SC-20-155
Labor Operation Code:	CC45Z

800 VOLT REAR COOLANT HOSE RETROFIT

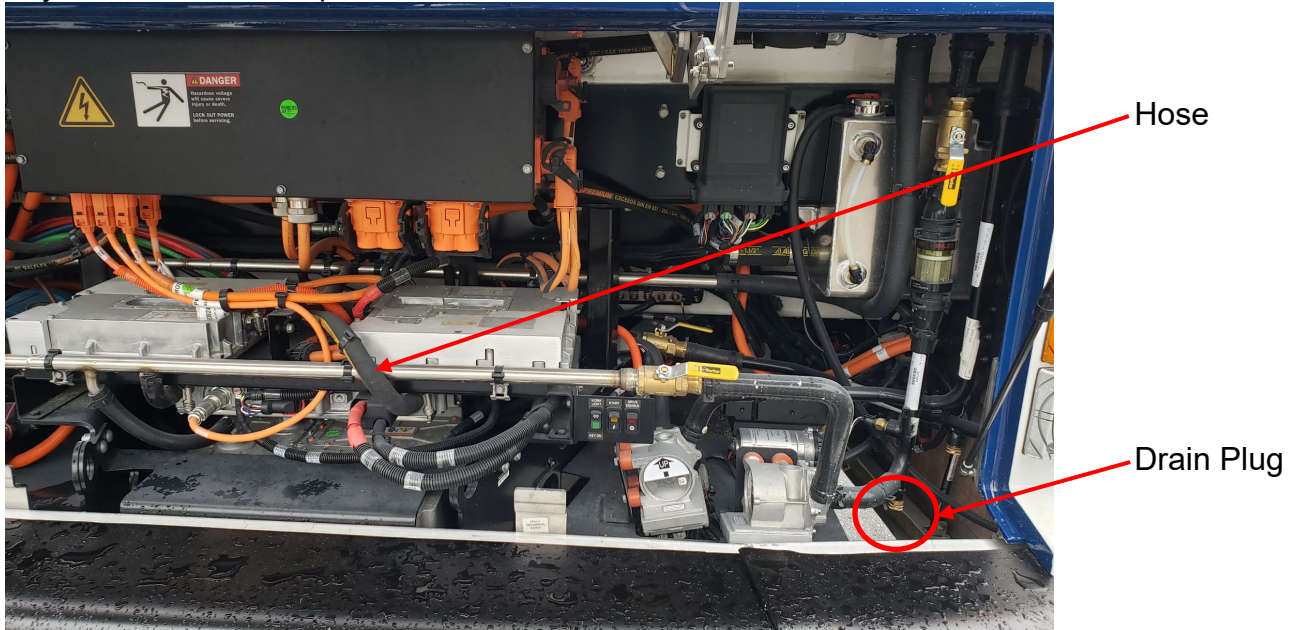
1. Complete the Proterra approved Lockout/Tagout procedure to make the bus safe for work.
2. Using a Catch Pan, drain the power electronics coolant loop so that the rear coolant hose may be removed for replacement.

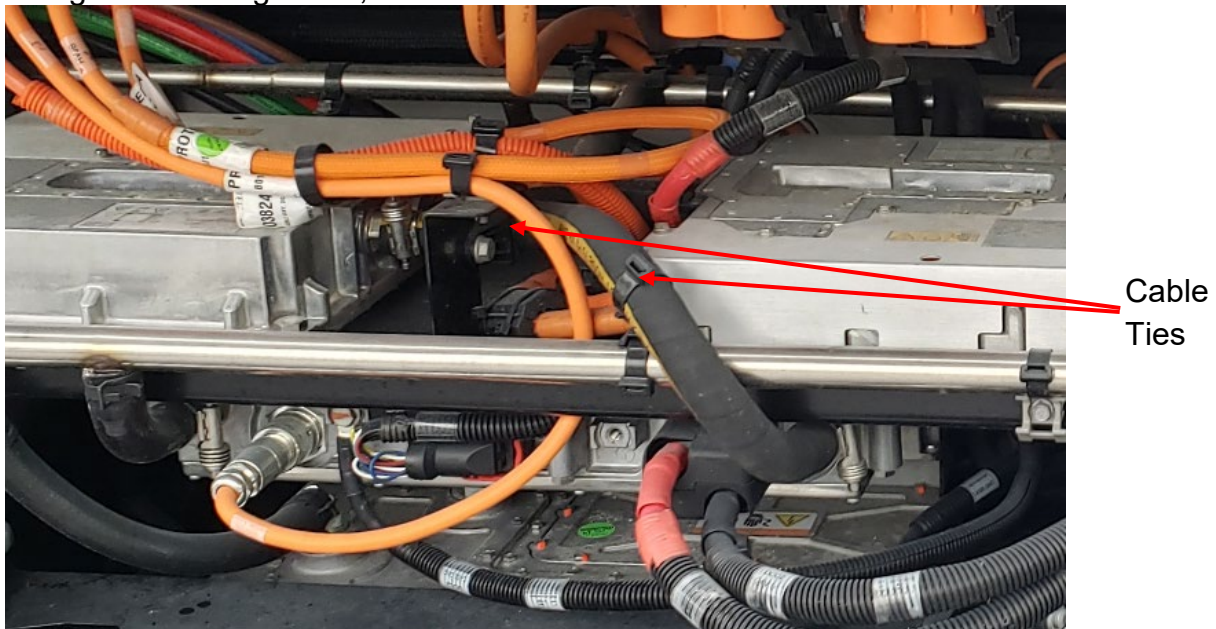
3. Using Side Cutting Pliers, remove the two cable ties that secure the hose.

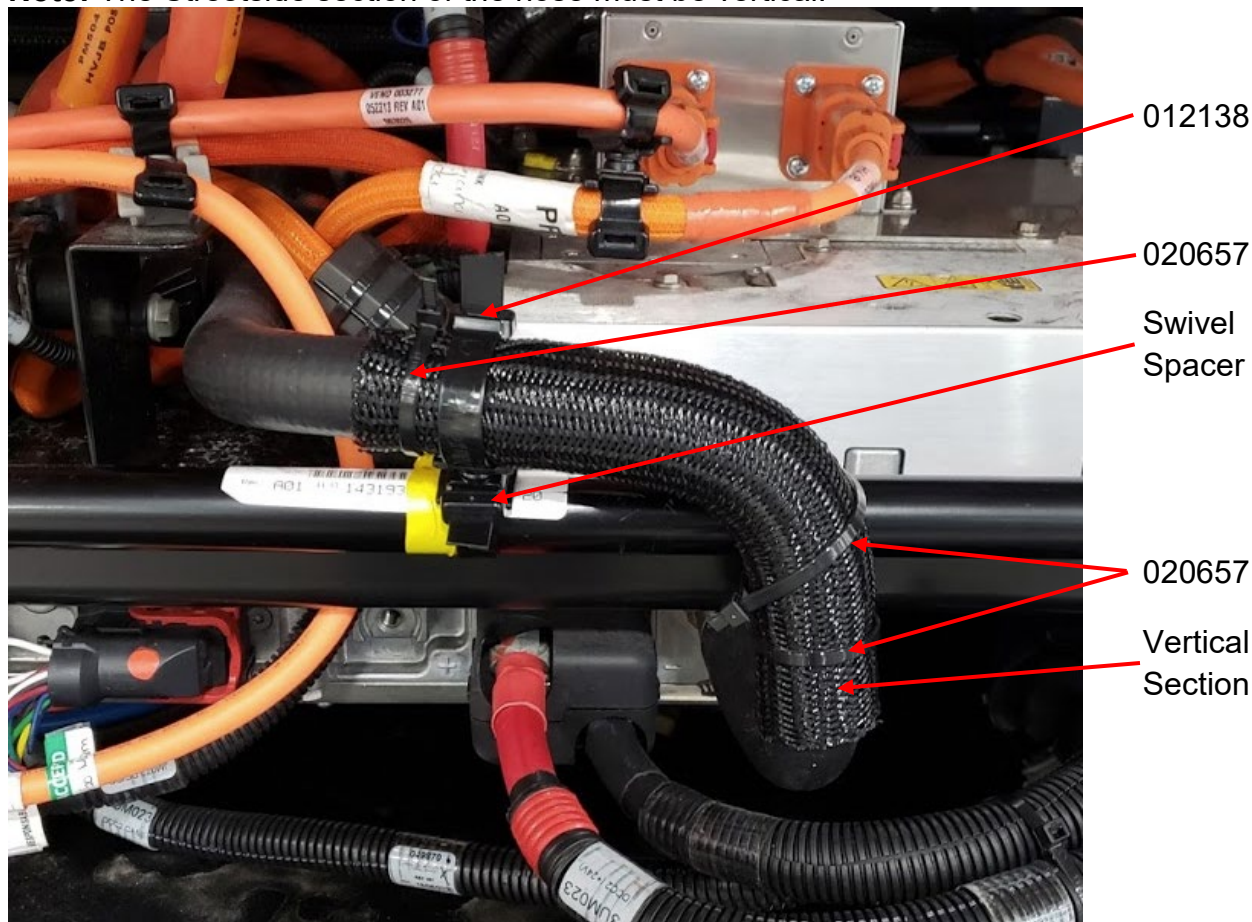
5. Wrap the Molded Hose (048059) with Pipe Wrap (045827).
6. Using a Flat Blade Screwdriver, install the Hose (048059) and Pipe Wrap (045827) in place of the original hose using the Hose Clamps that were removed earlier. Using Cable Ties (020657), secure the Pipe Wrap to the Hose.

Note: The Streetside section of the hose must be vertical.

7. Using Electrical Tape, wrap the steel tube even with the Streetside end of the Lenze. Using Cable Ties (012138), secure the Cable Tie Mount and Swivel Spacer to the Hose and steel tube on the electrical tape as shown in the previous photograph. Secure the Hose to the steel tube with a Cable Tie leaving a small gap between the Hose and steel tube.

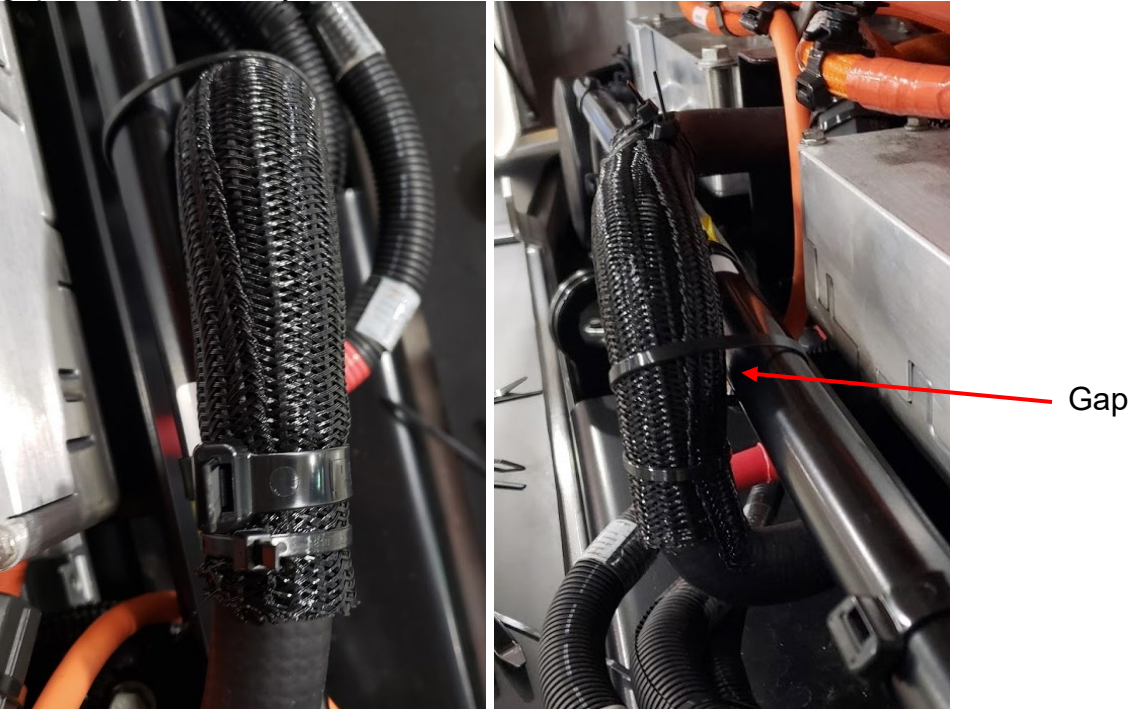
8. The following photographs show top and Curbside views of the completed Hose (048059) installation.

Note: Do not overtighten the Cable Tie (020657) shown in the second photograph. Leave a gap of approximately 5mm between the Hose and steel tube.

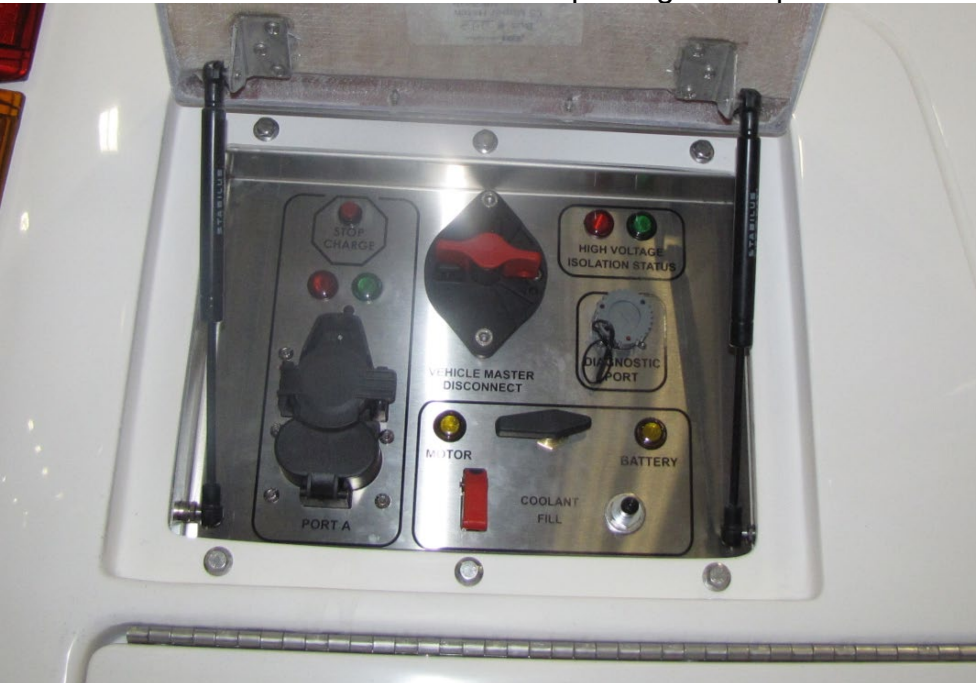
10. Refill the Power Electronics Coolant Loop using the fill port at the rear of the bus.
