PROTERRA

TECHNICAL SERVICE BULLETIN

ISSUE DATE:	10-13-2020
SERVICE BULLETIN SUBJECT:	Lower Rear Access Door Opening Angle and LV Battery Tray Retrofit
VINs or MODELS AFFECTED:	Service Specified Buses
COMPLETE BY:	Next Service Opportunity
SERVICE BULLETIN #:	SC-20-145
Labor Operation Code:	N/A

LOWER REAR ACCESS DOOR OPENING ANGLE AND LV BATTERY TRAY RETROFIT

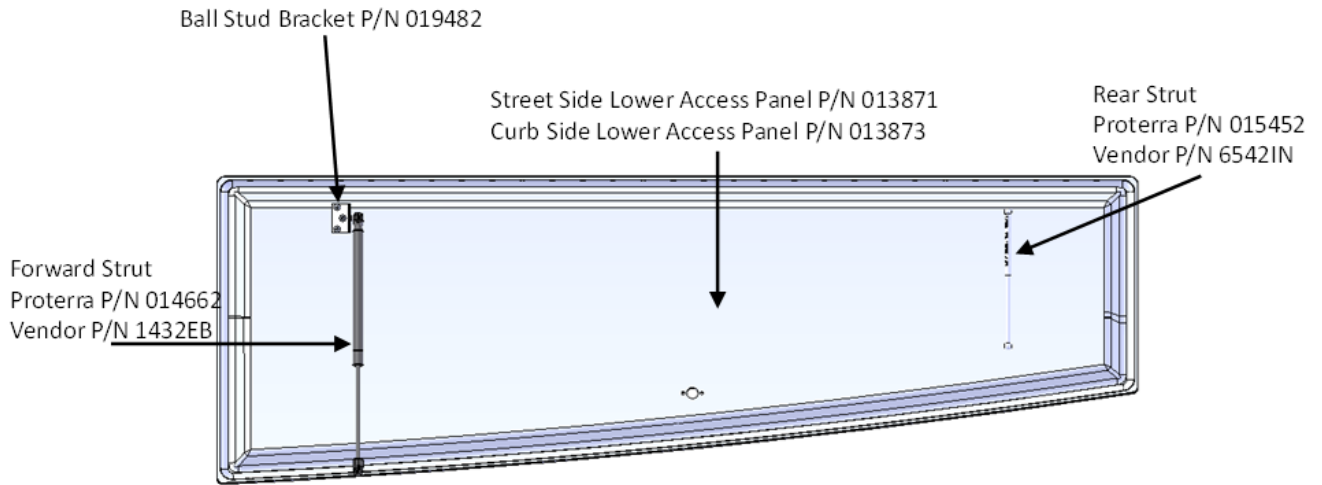
2. Using the following illustration as a guide, inspect both rear hatches and the gas struts installed on them.

3. Verify that the forward strut on both hatches is Proterra Part Number (014662) or Vendor Part Number (1432EB).
4. Verify that the rear strut on both hatches is Proterra Part Number (015452) or Vendor Part Number (6542IN).
5. Replace any struts that are damaged or are not the correct part number.
6. Once the correct struts are installed on both doors, inspect the opening angle of the doors. Each door should open approximately 120 degrees and not contact the bus body as shown in the following photograph.

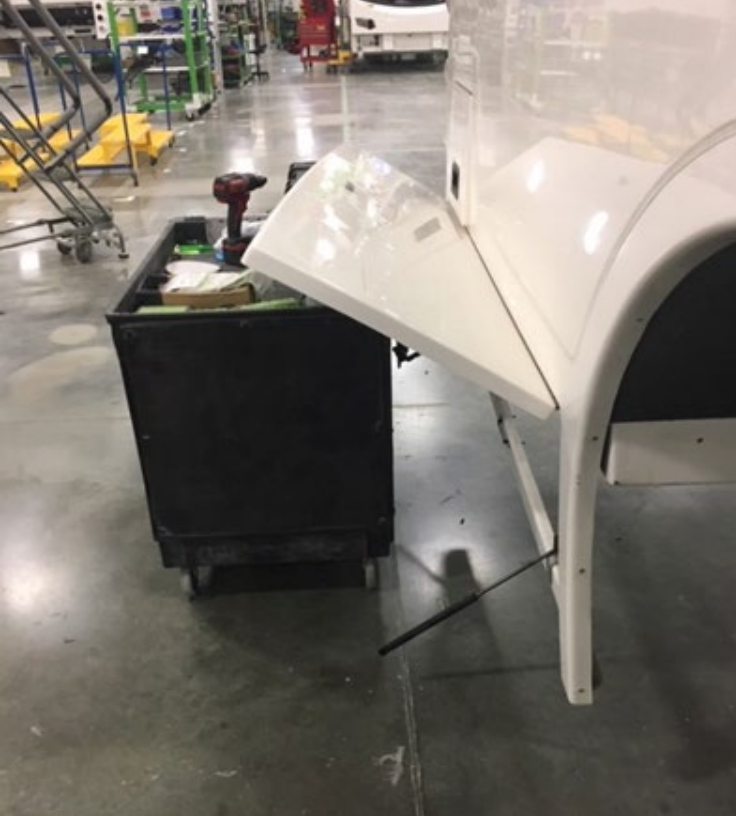
7. If the doors open correctly, proceed to the section of this document labeled “LV Battery Tray Retrofit”. Do not complete the remainder of this section. Proceed to the section labeled “LV Battery Tray Retrofit”.
8. If either door opens less than 120 degrees or it opens far enough to contact the body, the hatch or hatches must be repaired by following the remaining instructions in this section.
9. Disconnect the gas struts from a hatch that needs repair and support it as shown in the following illustration. An adjustable rod or other device may be used.

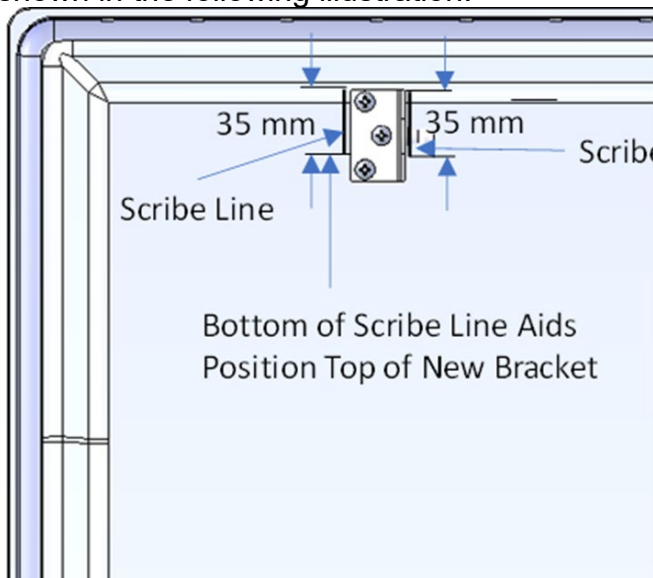
10. Using a Permanent Marker, mark both sides of the bracket 35mm down from the top as shown in the following illustration.

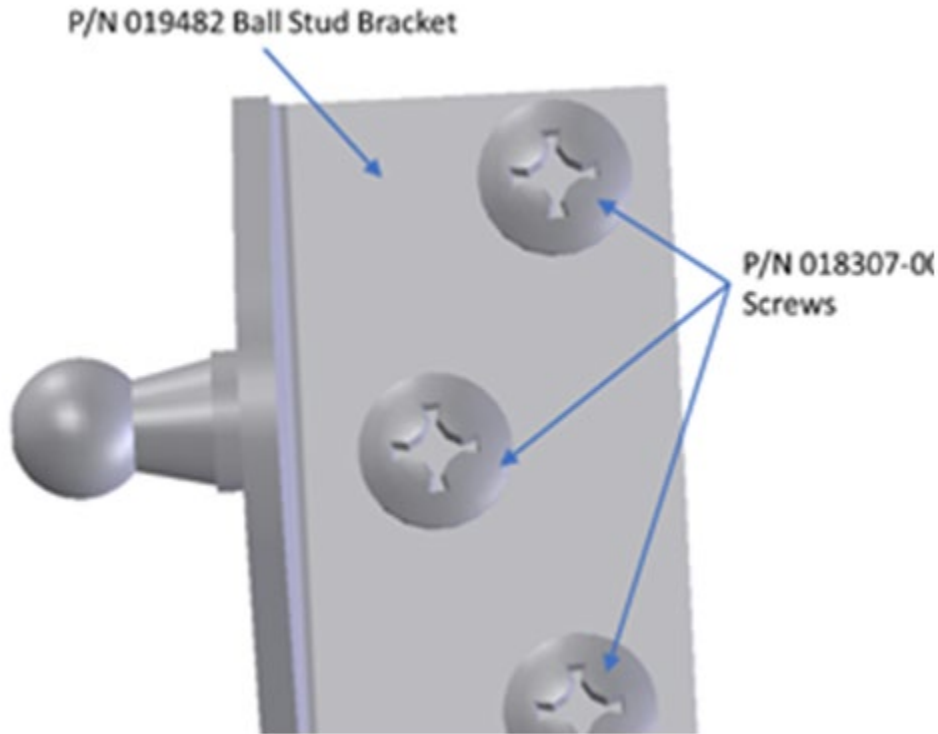
11. Using a #2 Phillips Screwdriver, remove the three self-tapping screws that attach the ball stud bracket to the hatch.

12. Using a Heat Gun, heat the Plexus Adhesive (018362) that secures the ball stud bracket to the hatch to soften it.
13. Remove the Bracket.
14. Using a Side Grinder, carefully remove any Plexus (018362) remaining on the hatch.
15. Using Alcohol and Shop Towels, clean the area on the hatch where the bracket and Plexus were removed.
16. Using the marks made earlier, position a new Bracket (019482) as shown in the following illustration.

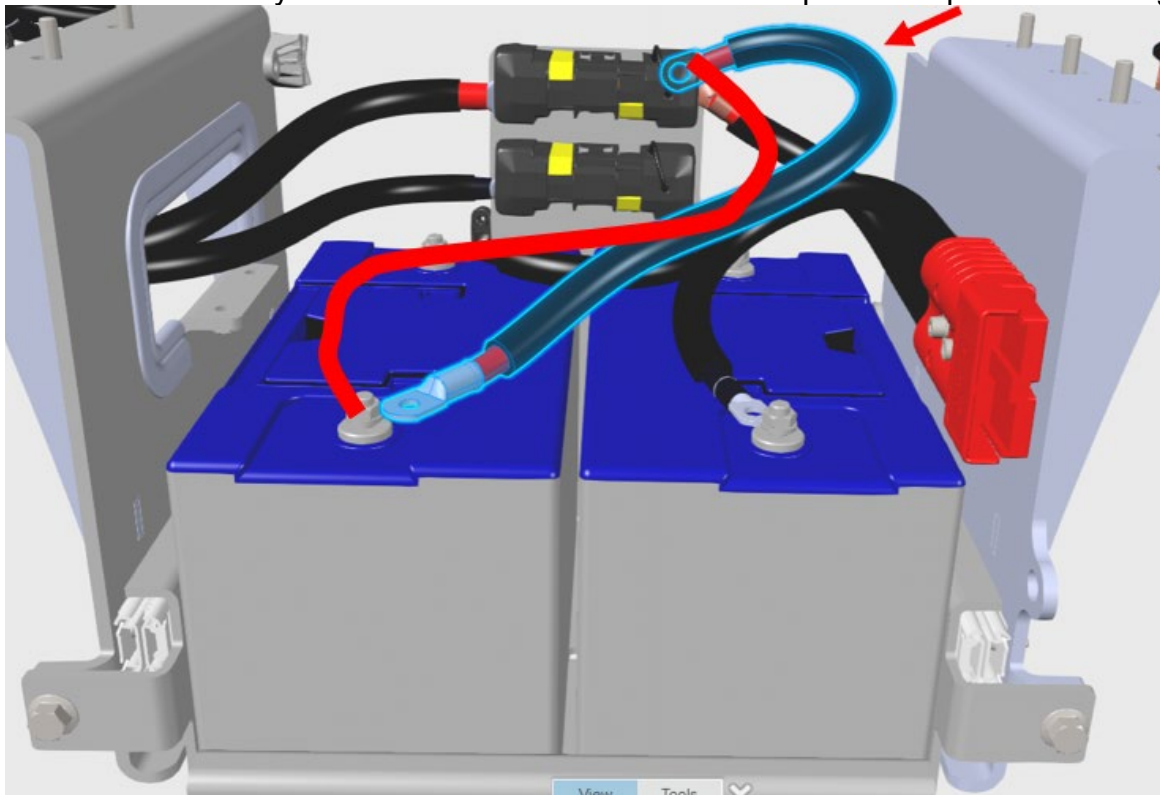
39. Working inside the Curbside hatch, access the low voltage batteries.
40. Using an 13mm Ratchet/Socket, reroute the Cable (EPWR 109) shown by the red arrow. The new routing is shown by the curved red line. The cable should enter the fuse panel from the bottom as shown by the red line and be routed in an "S" pattern to prevent chaffing.

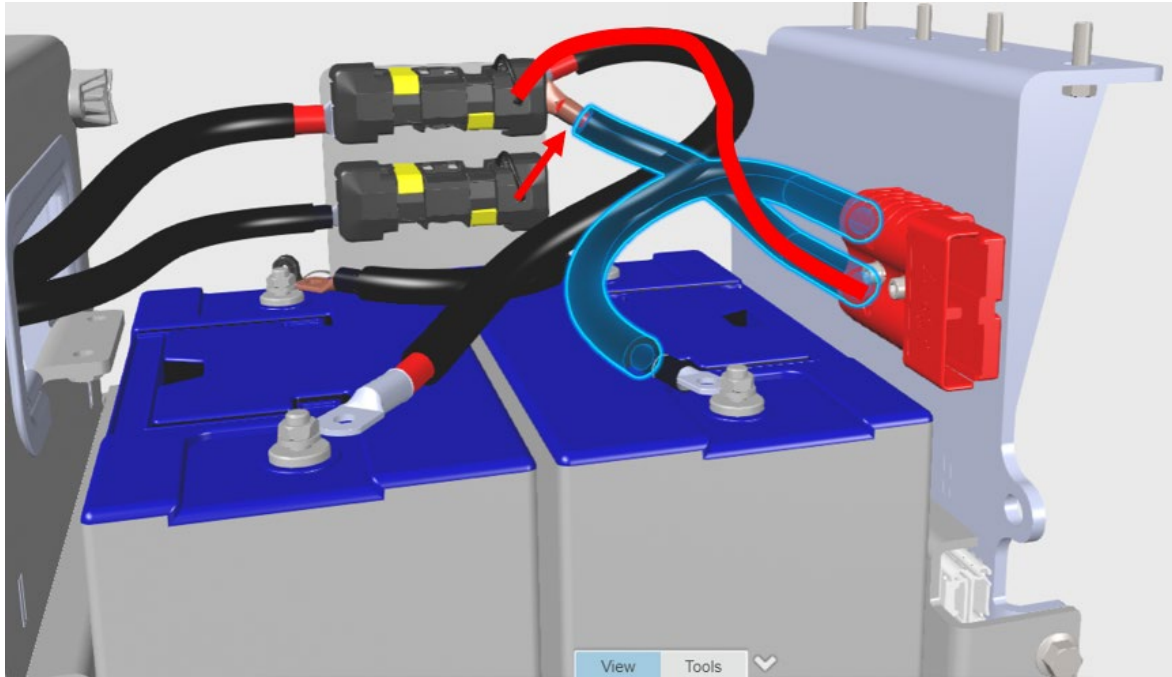
41. Using an 13mm Ratchet/Socket, reroute the cable shown by the red arrow. The new routing is shown by the curved red line. The cable should enter the fuse panel from the top as shown by the red line.

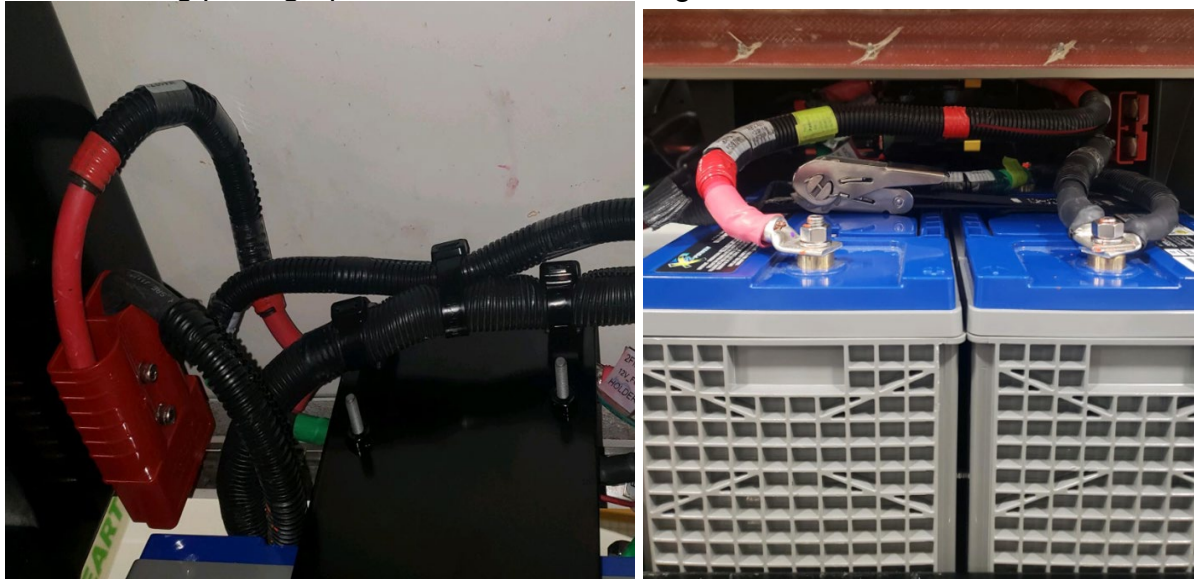
42. The following photographs show the new routing.

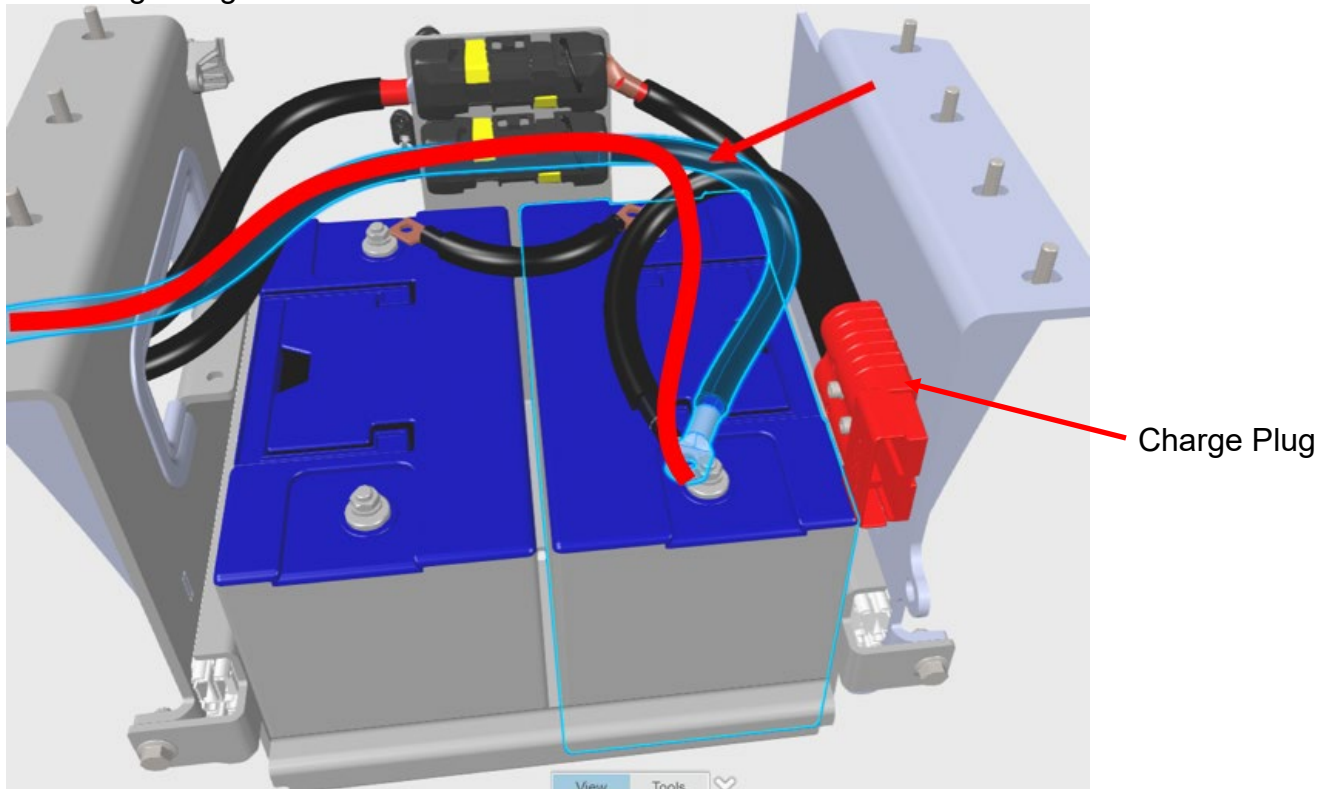
43. Using an 13mm Ratchet/Socket, reroute the Cable (EPWR 106) shown by the red arrow. The new routing is shown by the curved red line. The original route of this cable should be swapped with the Negative Cable from the Charge Plug and straightened so that it doesn't chaff against the battery box when it is slid from the hatch. The negative cable is on the top of the Charge Plug.

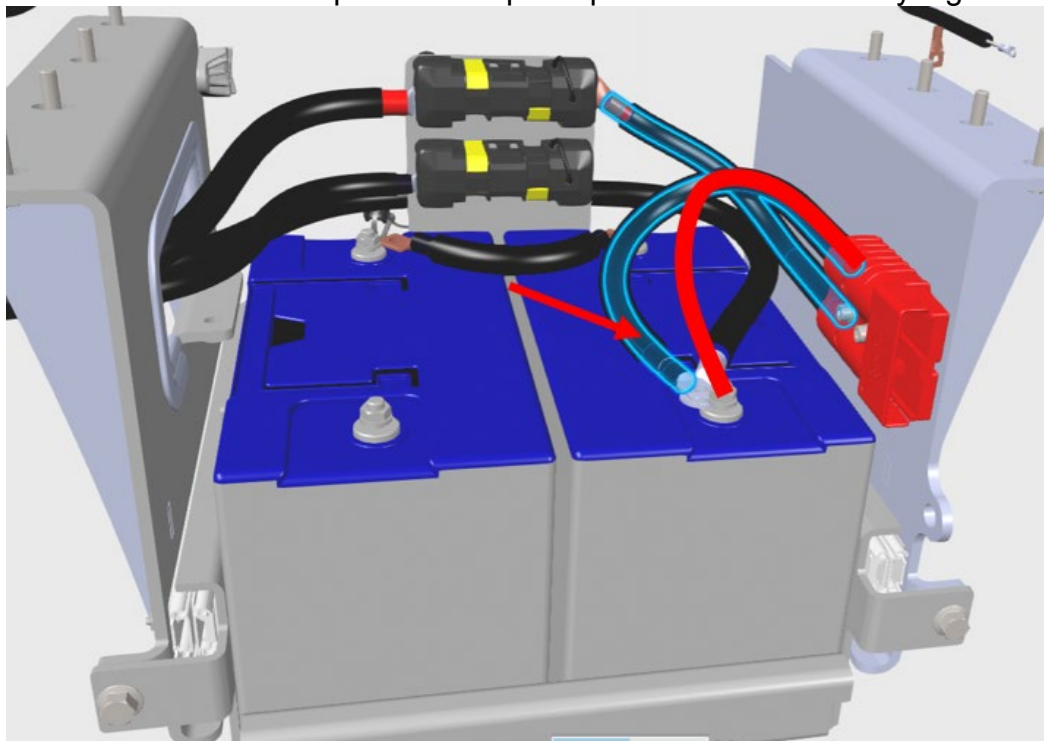
44. Using an 13mm Ratchet/Socket, reroute the cable shown by the red arrow. This is the negative cable from the Charge Plug. The new routing is shown by the curved red line. Note that the cable from the previous step swaps sides on the battery lug.

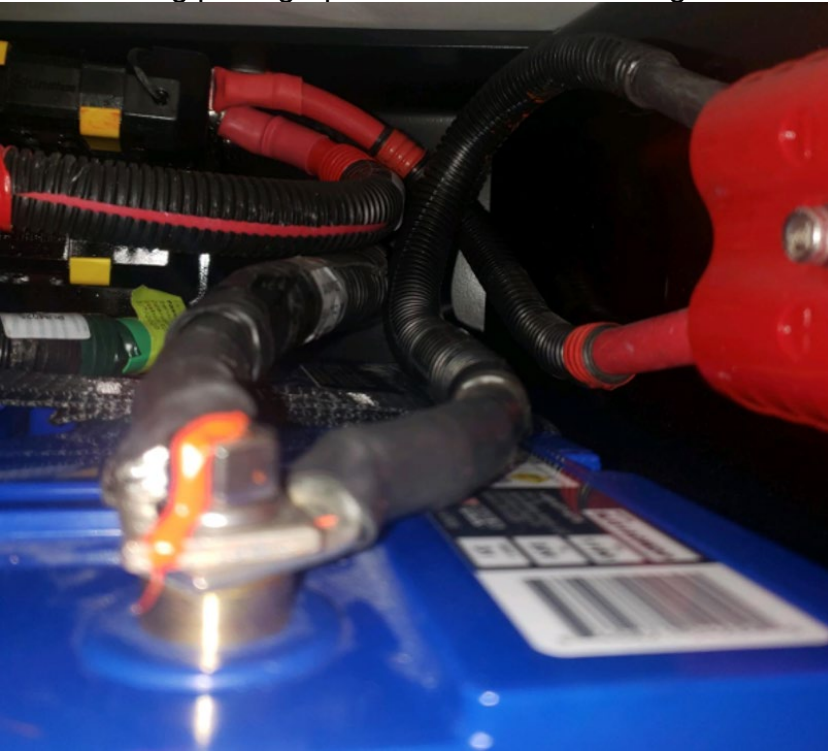
45. The following photograph shows the new routing.

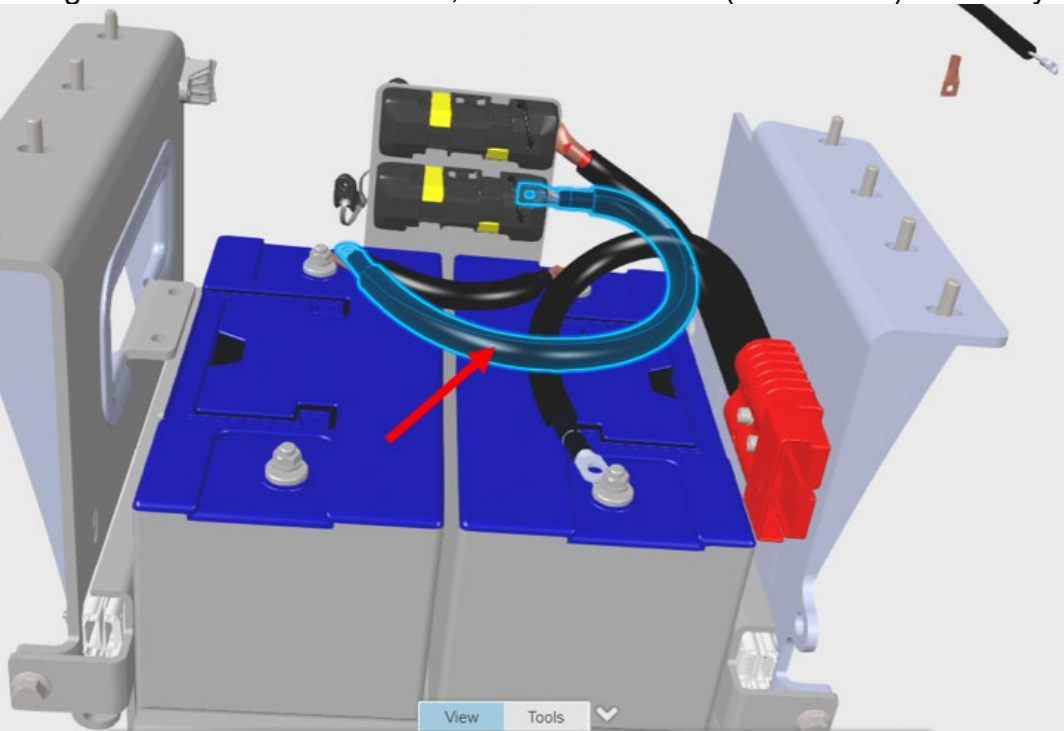
46. Using an 13mm Ratchet/Socket, reroute the Cable (EPWR 108) shown by the red arrow.

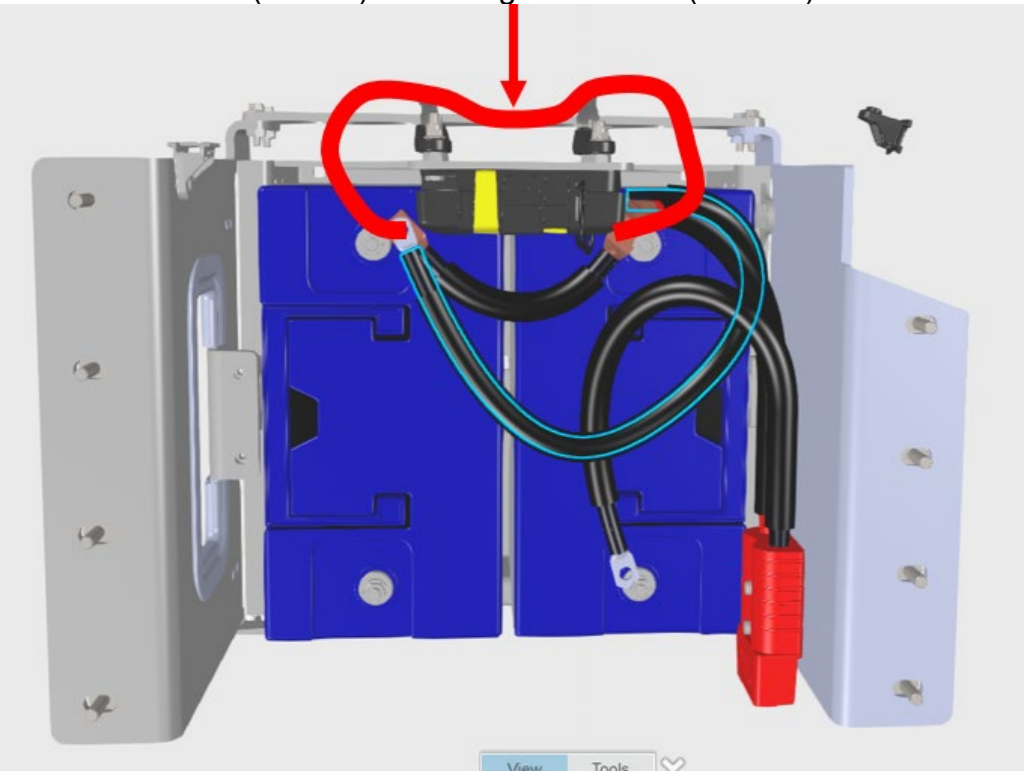
47. The new routing is shown in the following illustration. The Cable (EPWR 108) should be secured to Cable (EPWR) 106 using Cable Ties (012138).

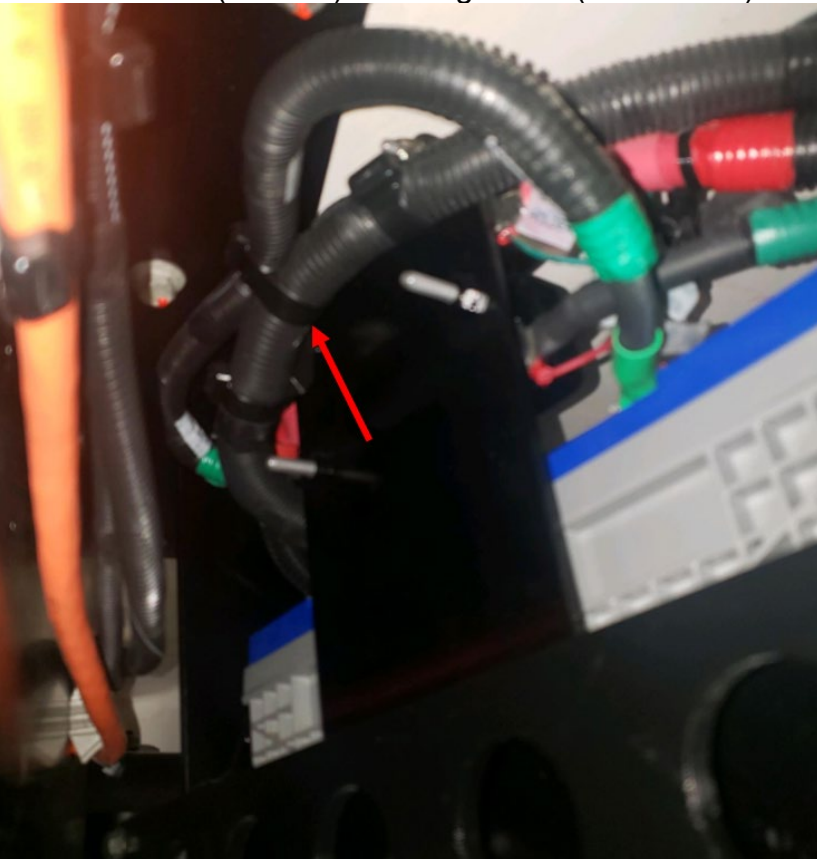
48. The new routing should appear as shown in the following photograph. The red arrow shows the Cable Ties (012138) securing Cable (EPWR 108) to Cable (EPWR 106).

49. Using a Calibrated Torque Wrench with an 13mm Socket, **torque the fuse panel fasteners to 15 Foot Pounds.**
50. Using a Calibrated Torque Wrench with an 13mm Socket, **torque the battery fasteners to 15 Foot Pounds.**
51. Using Orange Torque Stripe Paint, mark the properly torqued fasteners.
52. Close the rear hatches.
53. Remove the Lockout/Tagout devices and return the bus to service.
