TECHNICAL SERVICE BULLETIN

ISSUE DATE:	10-2-2020
SERVICE BULLETIN SUBJECT:	VIP Sensor Clamp Retrofit
VINs or MODELS AFFECTED:	Service Specified Buses
COMPLETE BY:	Next Service Opportunity
SERVICE BULLETIN #:	SC-20-140
Labor Operation Code:	WD41Z

VIP SENSOR CLAMP RETROFIT

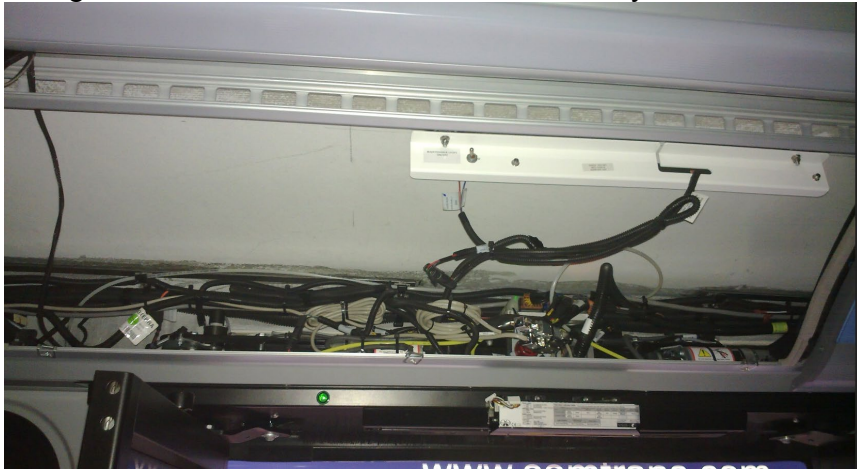
1. Complete the Proterra approved Lockout/Tagout procedure to make the bus safe for work.
2. Using a 3/16-Allen Driver, remove the Hadley Panel above the rear door.

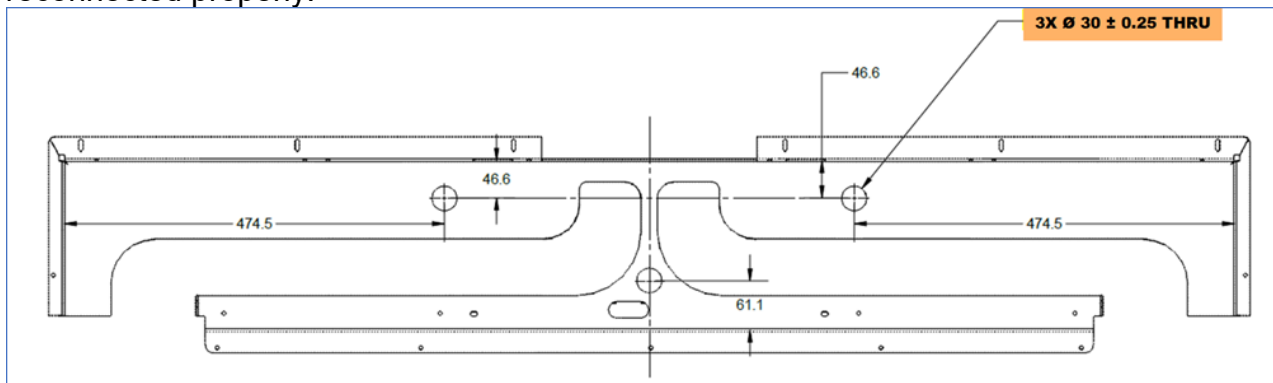
3. Using a #2 Phillips Screwdriver, remove the rear door closeout panel that holds the VIP Sensors. Make notes or take photographs of any wiring that is disconnected so that it may be reconnected properly.

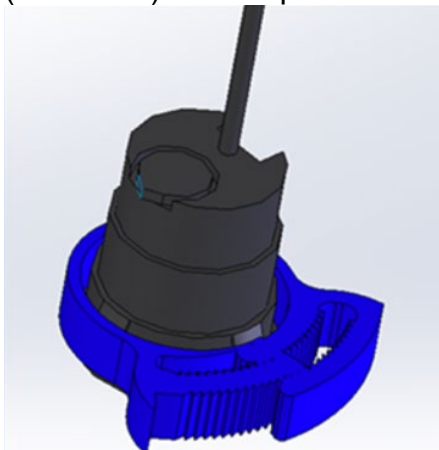
4. Using the following illustration as a guide, secure the three VIP Door sensors with Clamps (121-4723). Use Slip Joint Pliers to tightly lock the Clamps.
