DOC #	PROCESS NAME	PAGE	REVISION	STATION	BY	DATE
<b>AR890</b>	Stand Pipe Rework	1	-	SERVICE	Brad Fisher	4/8/2024

**Complaint:** Coolant leak

**Cause:** Standpipes cracking due to length and weight of valves

**Correction:** Install shorter pipes and relocate valves

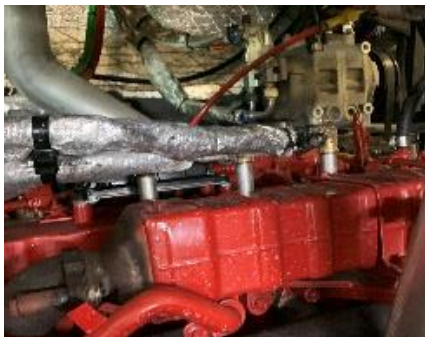
Step 2: Install two new short stand pipes with 90 degree elbows and hose couplers, use thread sealer on all pipe connections.

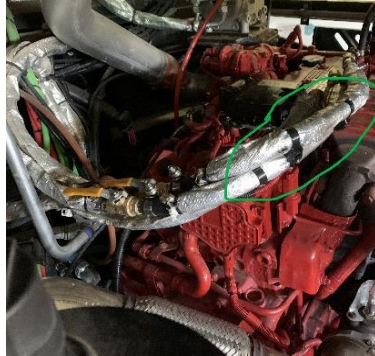
Step 5: Install hose couplers on valves and connect hoses with new constant torque clamps, torqued to 45 in/lbs.

Step 6: Route hoses and secure with cable ties as shown in picture below.
