SIB 17 01 24

COOLANT LEAK AT CHANGEOVER VALVEThis Service Information Bulletin (Revision 2) replaces SI B17 01 24 **dated April 2024**.**What's New** (Specific text highlighted):

E-Series	Model Description
G26	i4 Gran Coupe Battery Electric Vehicle (BEV)
G60	i5 Sedan (BEV)
G70	i7 Sedan (BEV)
i20	iX Sports Activity Vehicle (SAV BEV)

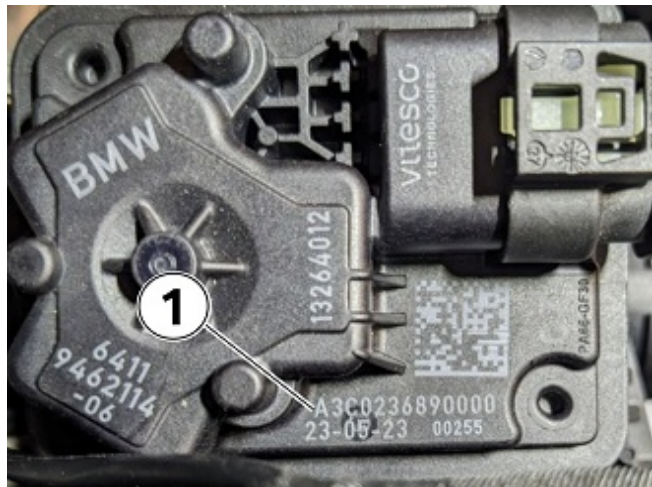
Check the production date of the remaining changeover valves (1). Improved valves were produced 5.1.2024 (January 5, 2024) and later.

Replace any* changeover valves PN 64 11 9 462 114) with a production date older than 5.1.2024 (January 5, 2024).
