Super White 040 Paint Peeling from Affected Panel(s)

YEAR(S)	MODEL(S)	ADDITIONAL INFORMATION
2016 - 2022	Tacoma

Introduction

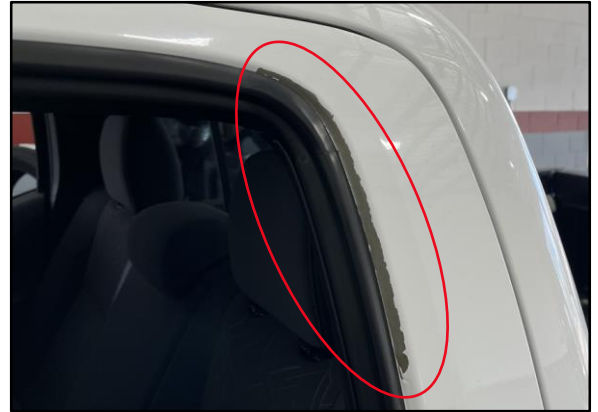
Figure 1. Paint Peeling on Door Frame

1. Confirm the condition exists.
Inspect the vehicle to determine if it exhibits paint peeling along the exterior window door frames, inner fender edges under the hood, and/or A-pillars, as shown in Figures 1 – 4.
 - A. Is the location of the paint condition on the door window frames, inner fender panels, and/or A-pillar panels?
 - **YES** — Continue to substep B.
 - **NO** — This bulletin does NOT apply. Continue diagnosis using the applicable Repair Manual.
 - B. Is the paint peeling?
 - **YES** — Continue to substep C.
 - **NO** — This bulletin does NOT apply. Continue diagnosis using the applicable Repair Manual.

2. Take a photograph of each affected panel that clearly displays the condition.
3. Upload the images of each affected panel to the [23TE08 Inspection Website](#) and send the vehicle to a body shop to have the affected panel(s) repainted.
