Keystone RV Company

SERVICE ADVISORY # 25-461

Coleman Cooktop

Models Included: Coleman Model 13B Travel Trailer

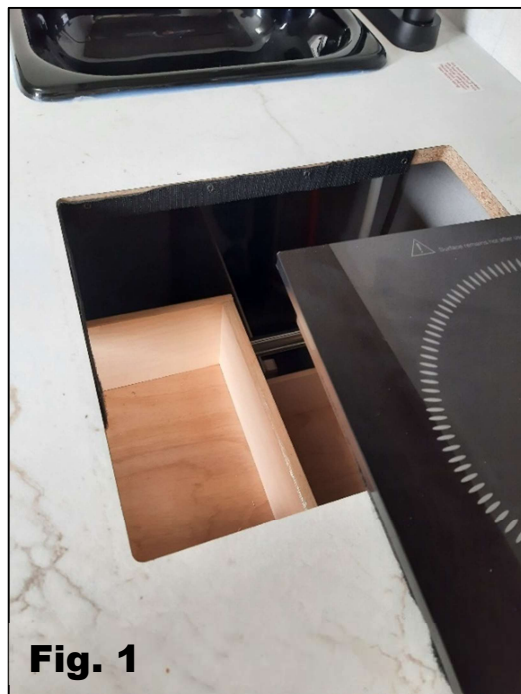
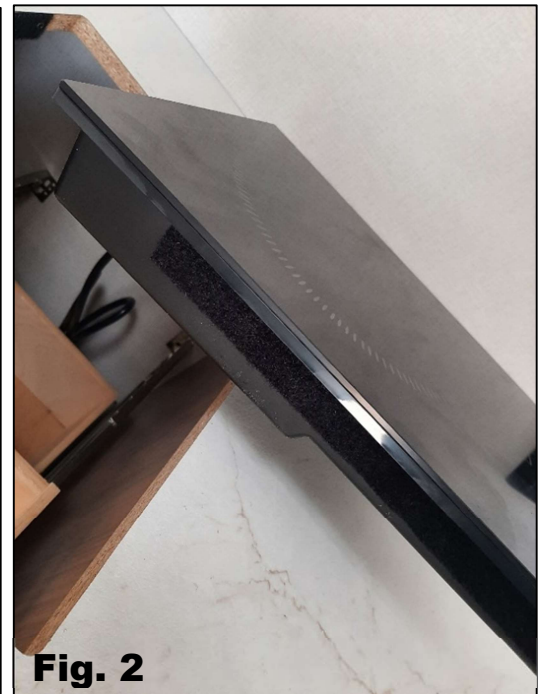
Inspect cooktop opening for installed Velcro to hold cooktop in place. If Velcro is installed on opening and cooktop as shown in Figures 1 and 2, inspection is complete. Proceed with warranty reimbursement.

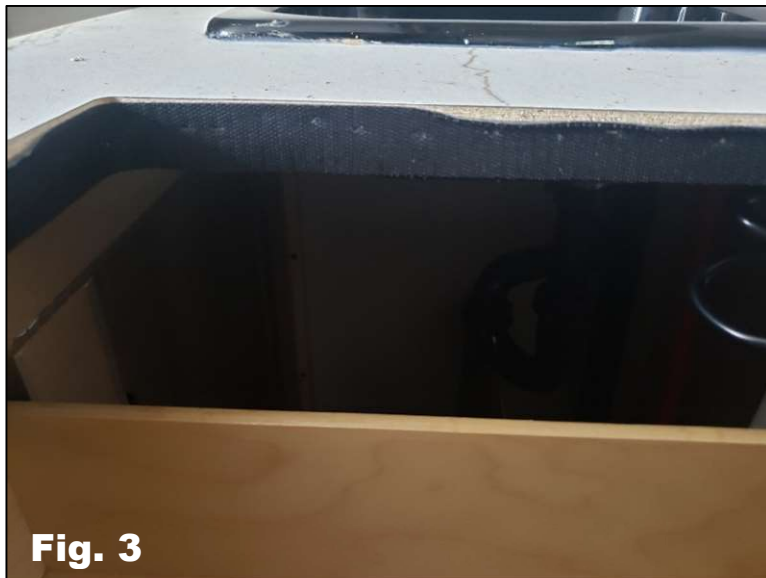
**Fig. 3****WARRANTY REIMBURSEMENT****INSPECTION ONLY**

If repair is needed, install missing Velcro in cooktop opening with staple gun, attaching staples linear in fashion as shown in Figure 3.

Utilize one continuous Velcro strip that is cut to 24 inches long on the side and along the bottom edge of the cooktop opening. Then add Velcro to cooktop in the same manner using the self-adhesive backing. Then replace the cooktop back into opening being secured by Velcro. Proceed with warranty reimbursement.
